**KOMITE NASIONAL KESELAMATAN TRANSPORTASI
REPUBLIC OF INDONESIA**

Aircraft Accident Investigation Report

PT. Trigana Air Service

B737-400F; PK-YSF

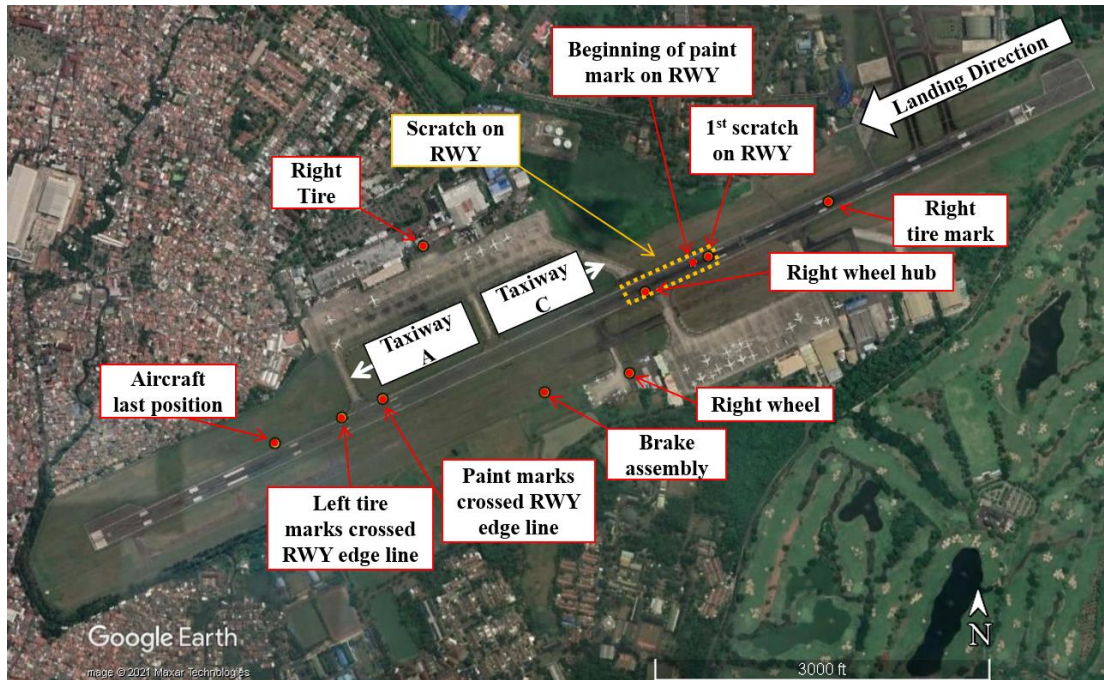
The first tire mark was found about 580 meters from the beginning Runway 24 and identified as the mark of the right main wheels, then followed by the tire mark of the left main wheels. All tire marks indicated zigzag movement of the wheels. The zigzag tire marks of the right main wheels ended about 380 meters and continued by zigzag scratch on runway, followed by paint marks. The zigzag tire marks of the left main wheels and the paint marks continued until the aircraft travelled off runway pavement.

One tire of the right main landing gear was found on the right side of the Runway 24, near the tower building after impacted to two cars that were parked. The other wheel was found on the left side of the Runway 24, after impacted to Airport Rescue and Fire Fighting (ARFF) fence. One of the brake assembly of the right main landing gear was found on the left side of the Runway 24, near the wind sock.

Figure 5: The wreckage and impact information

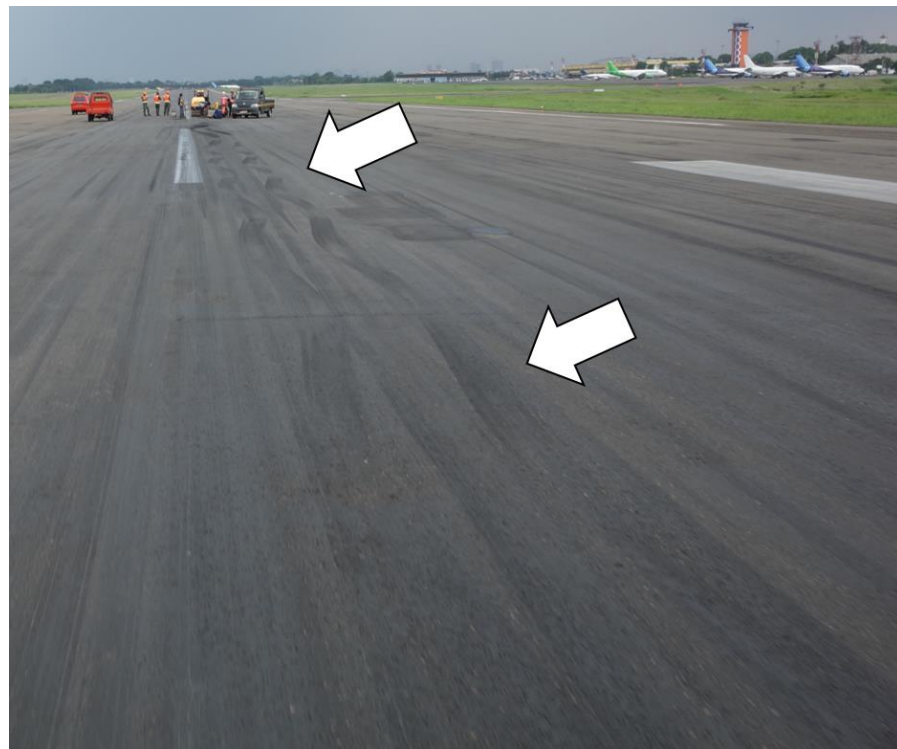
Figure 6: The zigzag tire marks of the right main wheels

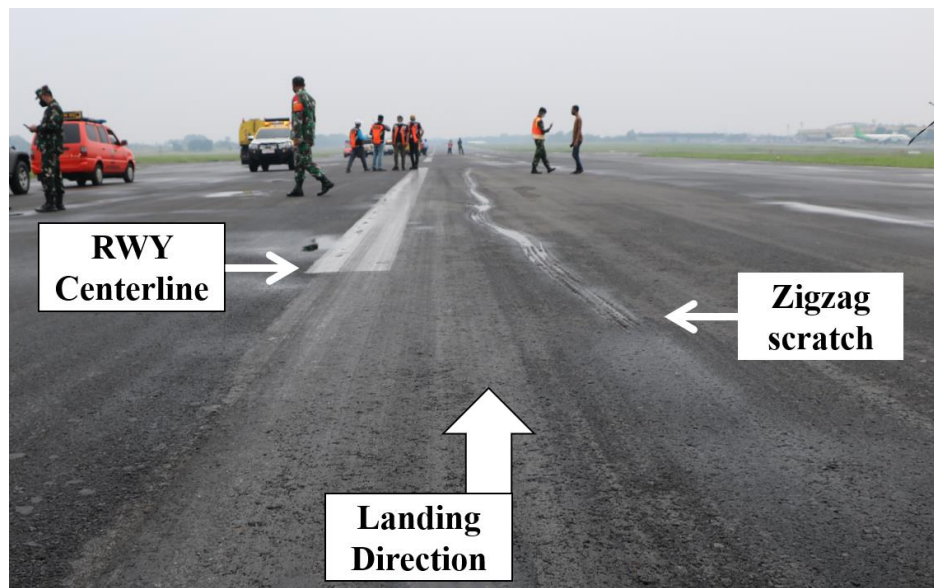
The first scratch of the runway surface was found about 360 meters after the first right tire mark, or about 20 meters before the beginning of the zigzag scratch marks of the right main landing gears. Several scratches on the runway were also found after the first scratch until near the Taxiway C.

Figure 7: The zigzag scratch marks

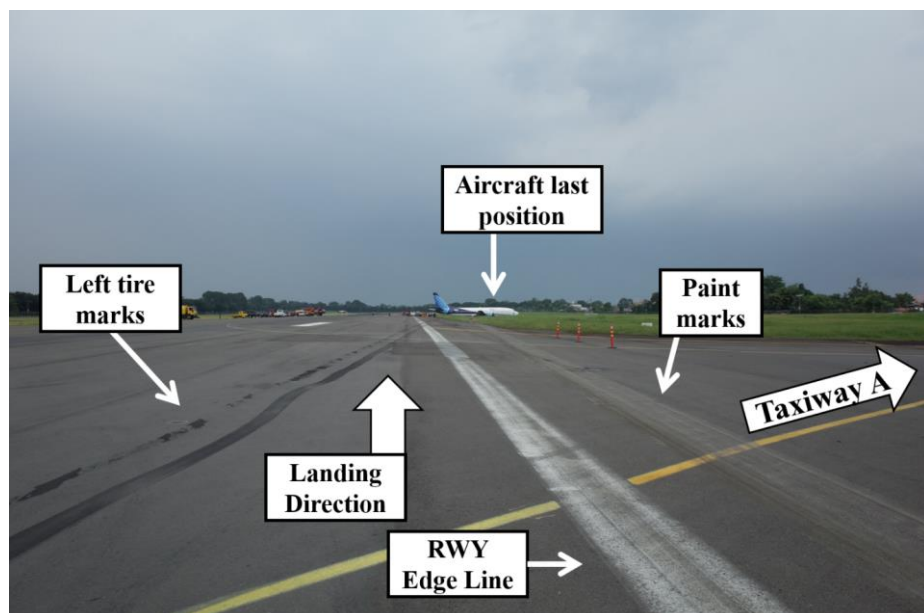
Approximately 1,900 meters from the beginning Runway 24, the paint mark crossed the right's runway edge line.

The tire marks of the left landing gear travelled off runway pavement about 2,050 meters and the aircraft stopped about 2,200 meters from the beginning Runway 24 on heading 320°.

Figure 8: The left tire marks and the paint marks

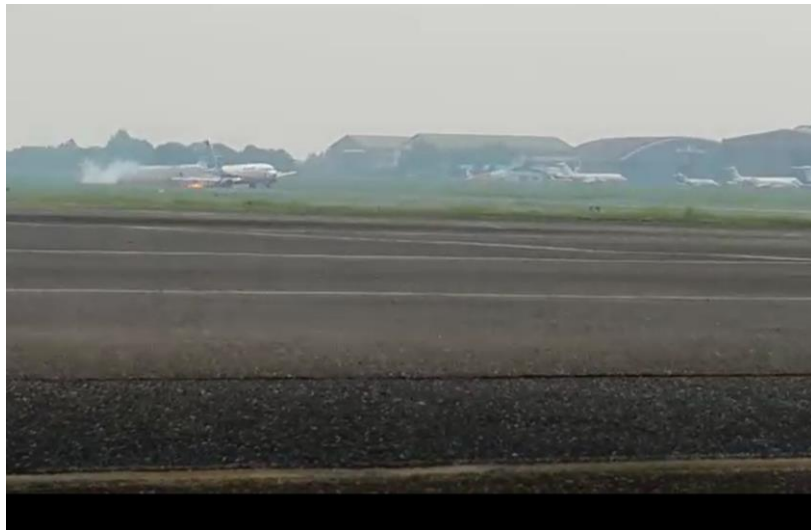
An amateur video recorded sparks appeared on the right side of the aircraft, shortly after the aircraft touched down.

Figure 9: The sparks on the right side of the aircraft on landing as recorded by the amateur video

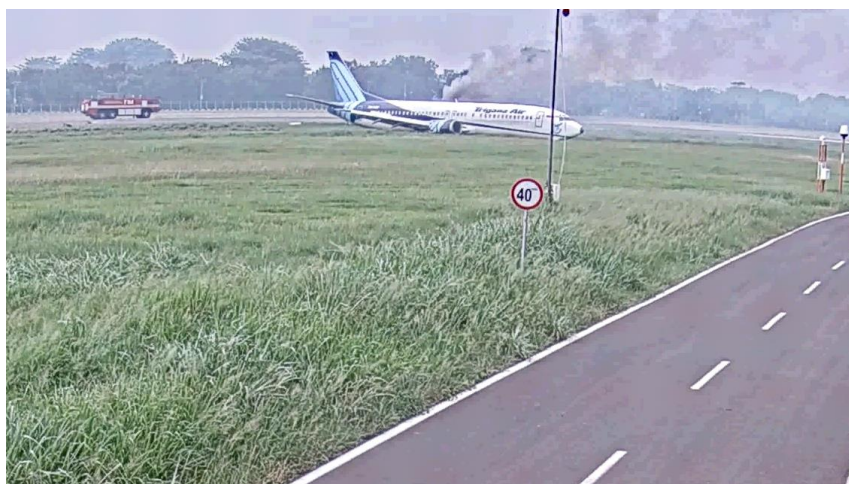
The aircraft stopped about 1126 LT and the ARFF team arrived about one minute later. After the aircraft stopped, the controller informed to the pilots that the fire was visible on the left side of the aircraft. The airport Closed-Circuit Television (CCTV) recorded that the black smoke was visible on the left side of the aircraft.

Figure 10: The black smoke as recorded in the airport CCTV
