**KOMITE NASIONAL KESELAMATAN TRANSPORTASI
REPUBLIC OF INDONESIA**

1st INTERIM STATEMENT

Aircraft Accident Investigation Report

Robinson R44 Raven II; PK-RTO

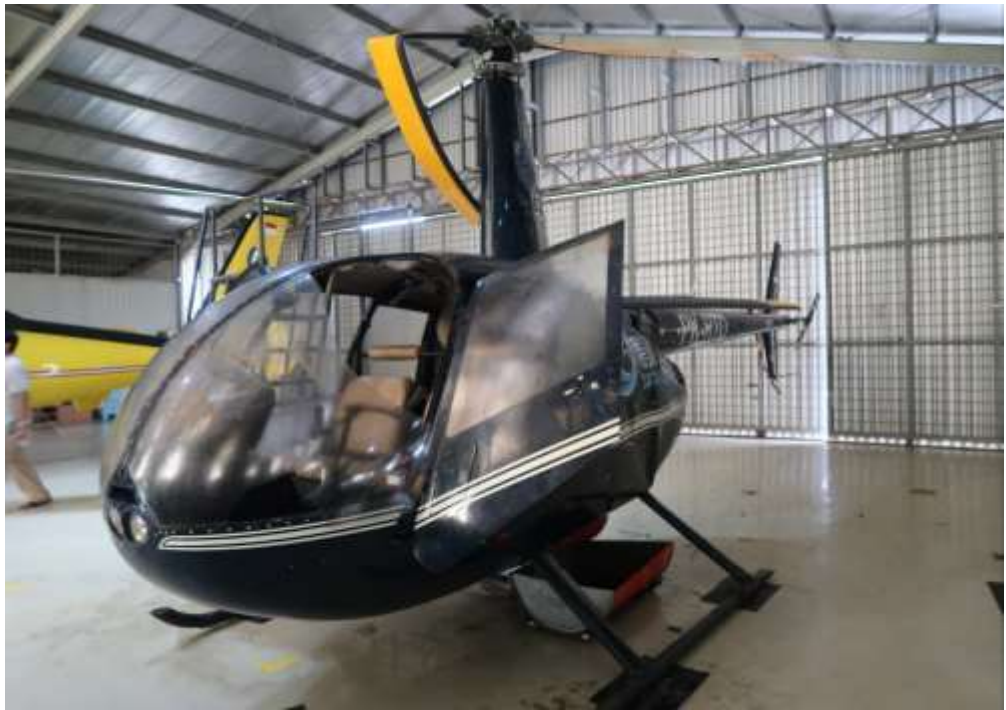
Figure 1. The broken windshield and main rotor blade bent

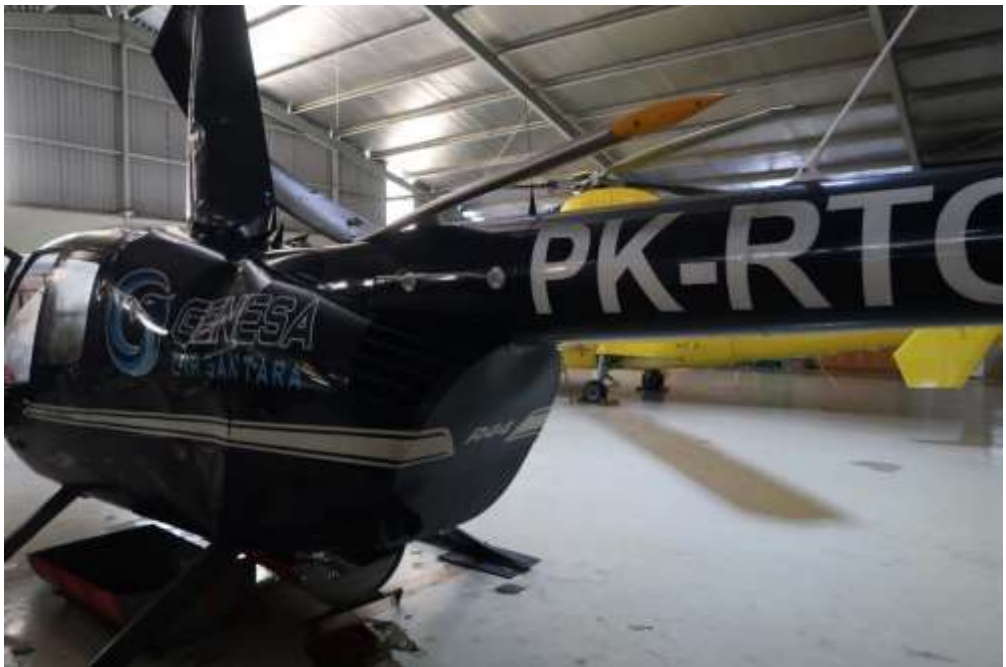
Figure 2. Damaged on the fuselage

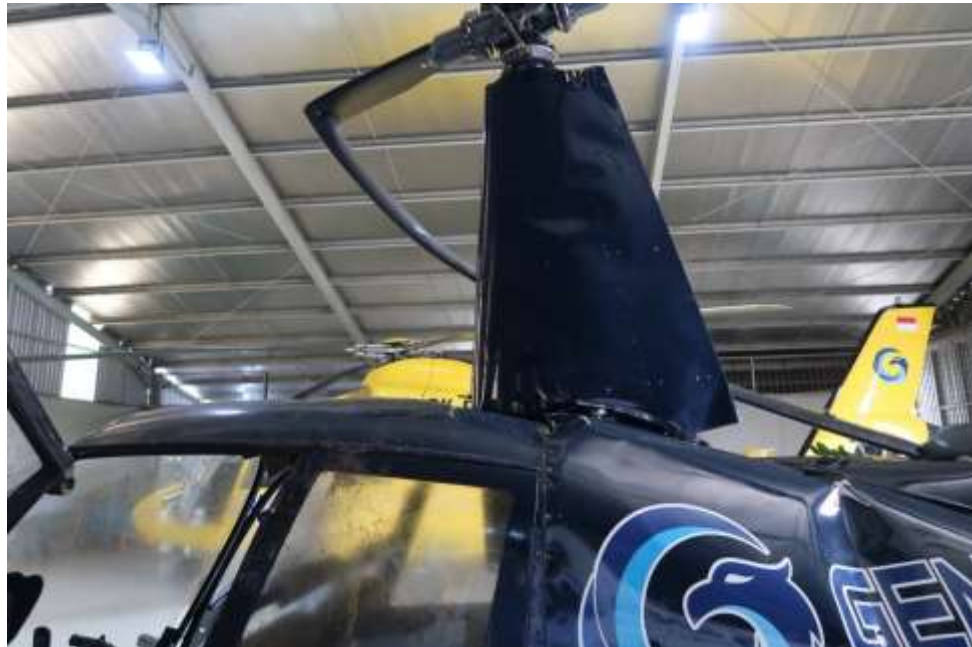
Figure 3. Main rotor mast cowling bent forward

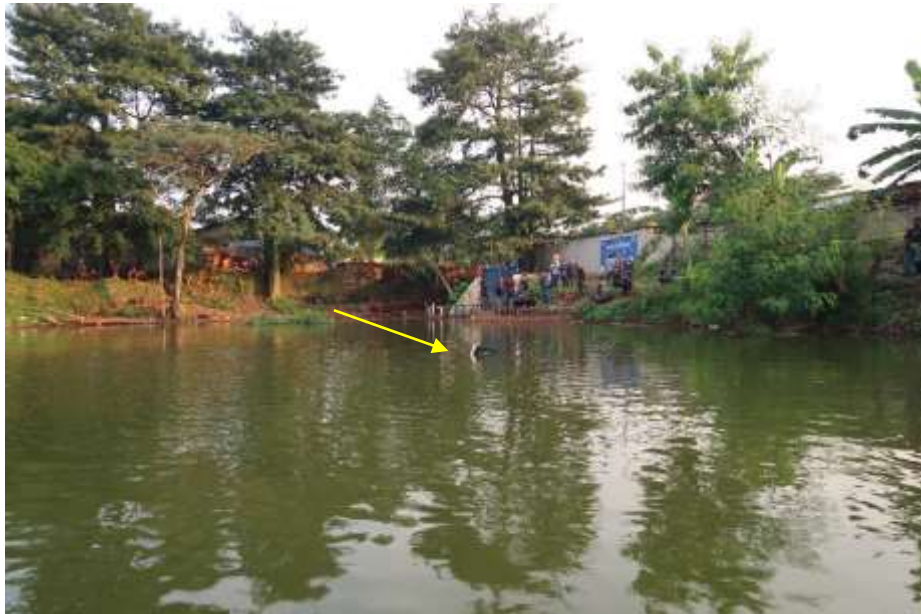
The helicopter was submersed in a shallow water lake, located about one Nm South of the runway. The helicopter was found in position tilted to the left. There was no scar or mark on a tree or building found near the accident site.

Figure 5. The helicopter position immersed on the shallow lake, part of the right cockpit door appeared on the water surface (the right door opened by the personnel during the evacuation of the helicopter properties).
