**KOMITE NASIONAL KESELAMATAN TRANSPORTASI  
REPUBLIC OF INDONESIA**

**Aircraft Accident Investigation Report**

**DHC-6-300; PK-OTW**

**2 Nm South West of Bilorai Airport, Papua**

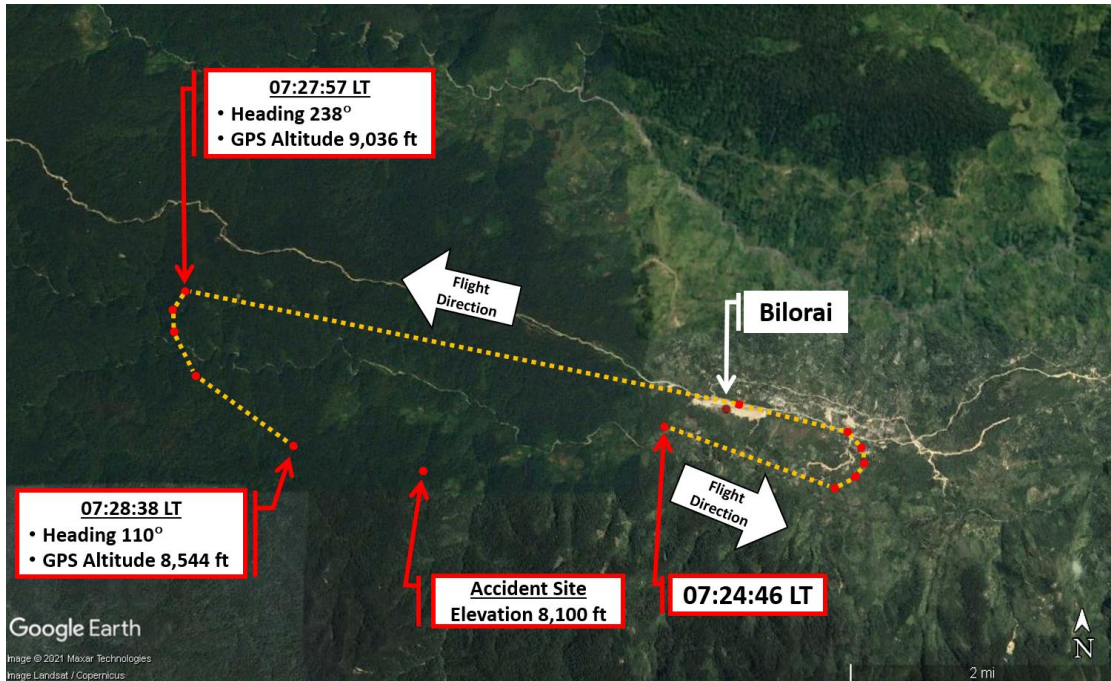
**Figure 1: Flight trajectory based on flight following data (Source: Google Earth, annotated by KNKT)**

Based on the data transmitted from the flight following system, at 07:27:57 LT, the aircraft was about 3 Nm outbound from Bilorai on direction of 238°.

At 07:28:38 LT, the last data of the flight following system recorded that the aircraft was on direction of 110°.

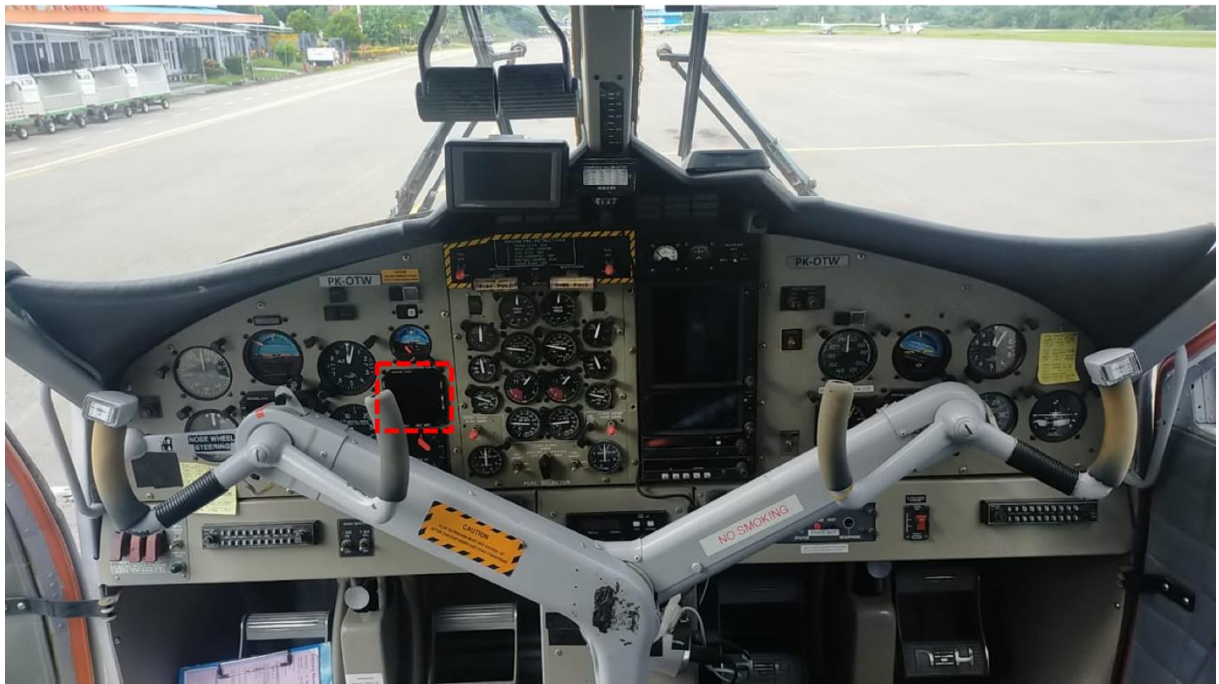
**Figure 2: The ST3400 TAWS/RMI location (red square)**

The ST3400 TAWS/RMI in PK-OTW aircraft located at the Pilot in Command (left) side instrument panel (see the red square on the following figure).

Therefore, KNKT recommends the aircraft operator to ensure all TAWS installed in their aircraft are functioning and able to generate alert as intended.

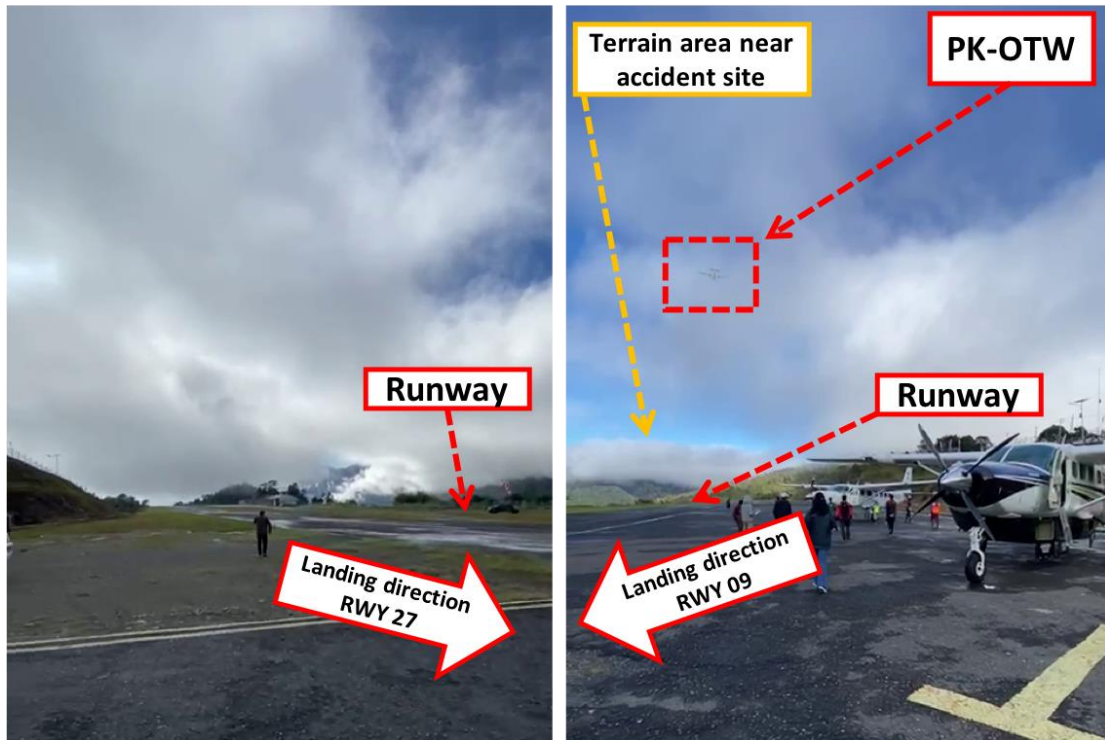
**Figure 5: The images from video footage when the PK-OTW was making a go around**

A video footage taken from Bilorai apron area, captured the weather condition when PK-OTW was making a go around and flew overhead the airport. The video indicated that the final area of Runway 27 and the terrain area near the accident site were covered by clouds.

Therefore, KNKT recommends the aircraft operator to ensure all flights under VFR shall be conducted at or above the required weather minima.

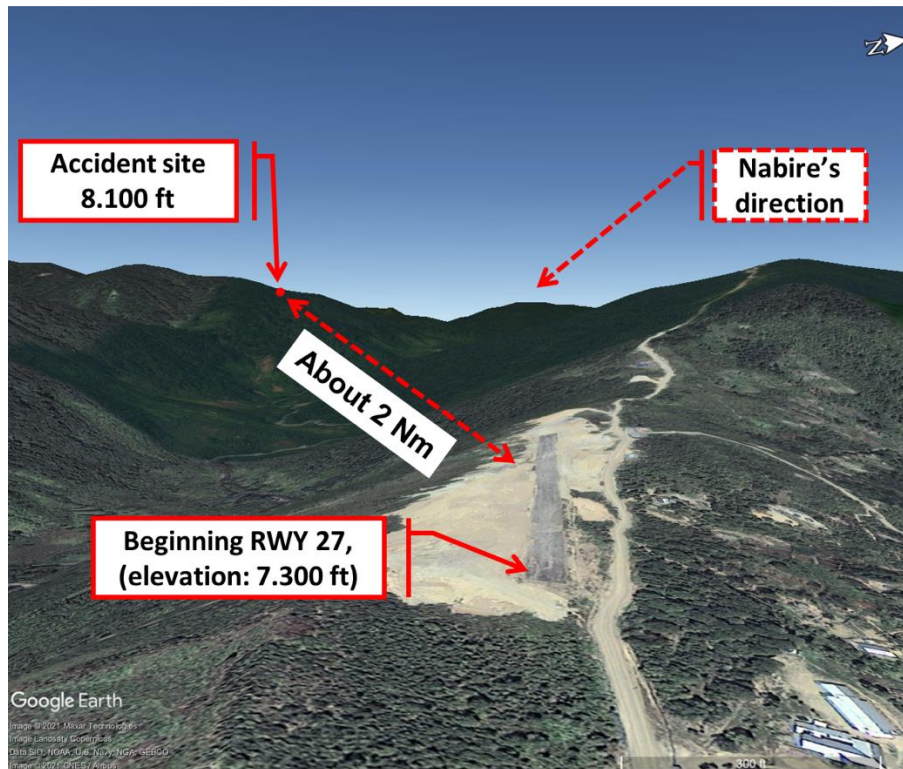
Figure 6: The accident site (Source: Google Earth, annotated by KNKT)

The aircraft was found on a hillside area with elevation about 8,100 feet which located about 2 Nm South West of Bilorai on bearing 260°.
