**KOMITE NASIONAL KESELAMATAN TRANSPORTASI
REPUBLIC OF INDONESIA**

Aircraft Accident Investigation Report

Cessna 208 Caravan; PK-SNN

Ilaga Airport, Papua

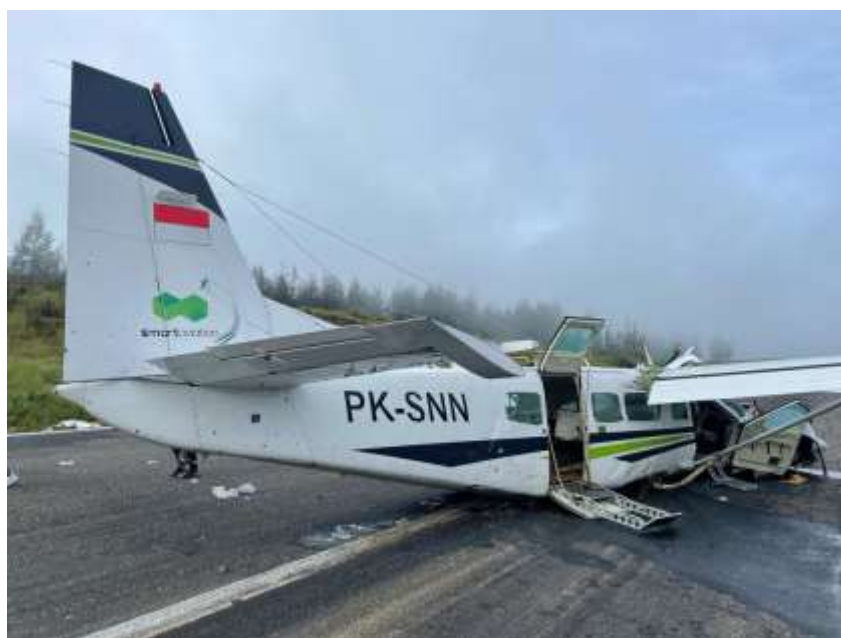
About 0725 LT, PK-SNN made approach landing and impacted to the embankment about 15 meters before the runway. The aircraft stopped about 90 meters from the beginning runway 25.

Figure 1: The aircraft condition after accident

The aircraft was substantially damage.

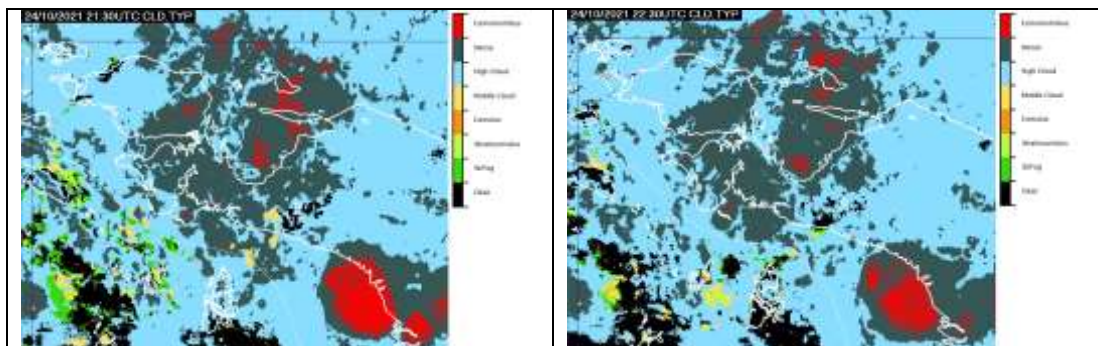
The meteorological station was not available in Ilaga. The *Badan Meterologi, Klimatologi, dan Geofisika* (BMKG – the agency of meteorology, climatology and geophysics of Indonesia) provided the satellite images of the cloud that showed the high cloud covered the surrounding area of Ilaga as shown in the figure below.

Figure 2: Satellite image of the cloud surrounding Ilaga area during the occurrence

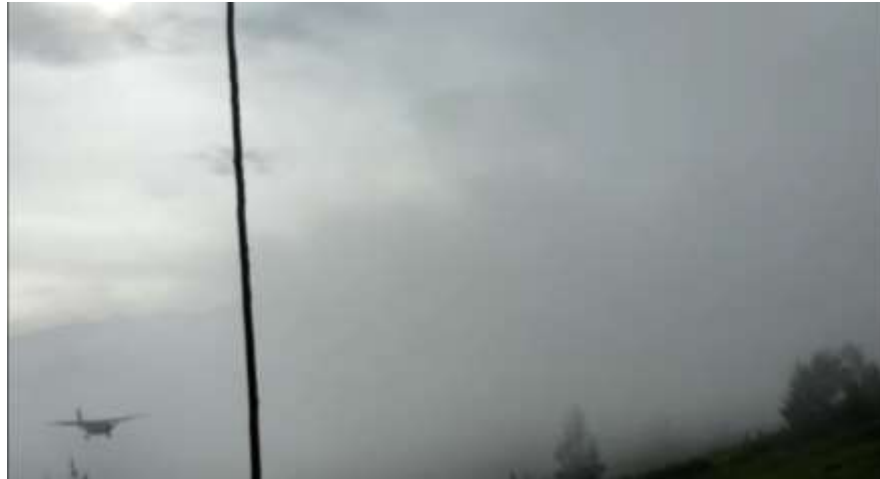
The witnesses who were on the apron of Ilaga stated that the beginning of runway 25 was covered by ground fog.

The investigation received a video footage recorded the accident aircraft that was on approach and landing. The video also showed the ground fog on the beginning runway 25 as shown in the figure below.

Figure 3: The accident aircraft and the ground fog on the beginning runway 25

The KNKT recommend to develop a system to ensure the implementation of company procedures to confirm safe aircraft operation.
