**KOMITE NASIONAL KESELAMATAN TRANSPORTASI
REPUBLIC OF INDONESIA**

KNKT.21.12.20.04

Aircraft Accident Investigation Report

Eurocopter AS 350 B3; PK-ODB

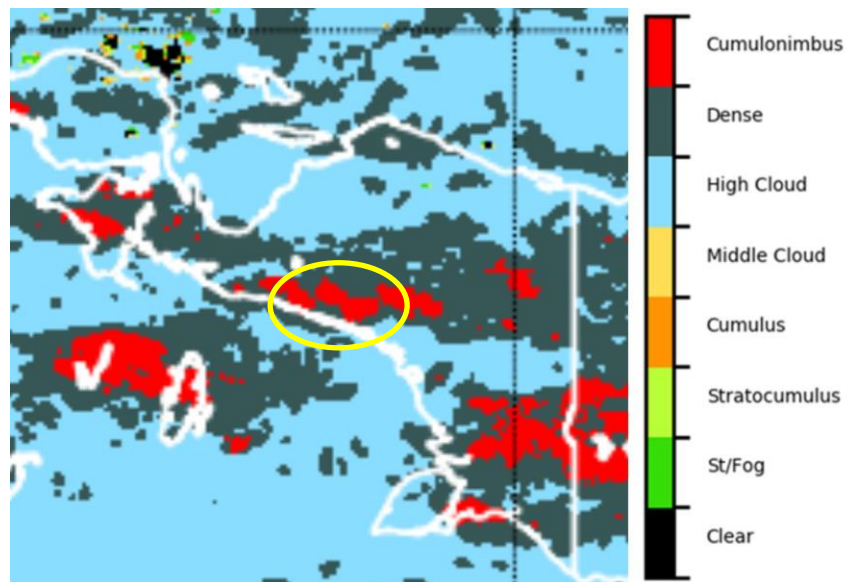
Figure 1: The satellite image of weather condition at the accident area

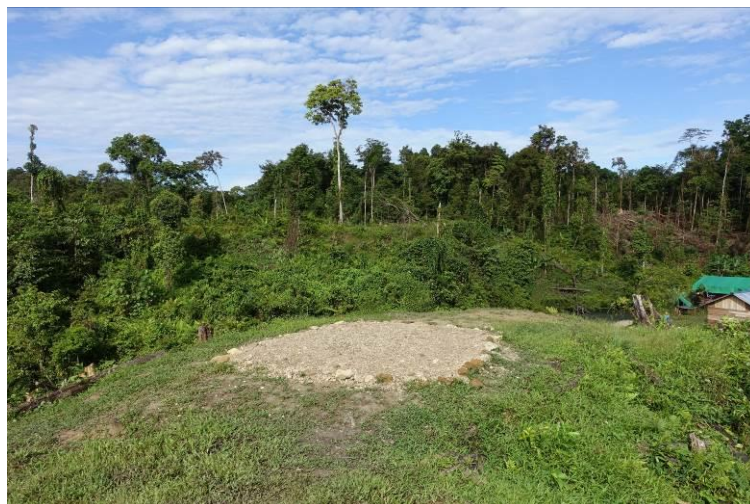
The Camp 99 Helipad located on the coordinate of 4° 56' 44" S; 140° 05' 18.7" E. The helipad was not a registered helipad and situated on a limited space with the dimension of about 5 × 5 meters. The Camp 99 Helipad is shown in the figure below.

Figure 2: The Camp 99 Helipad

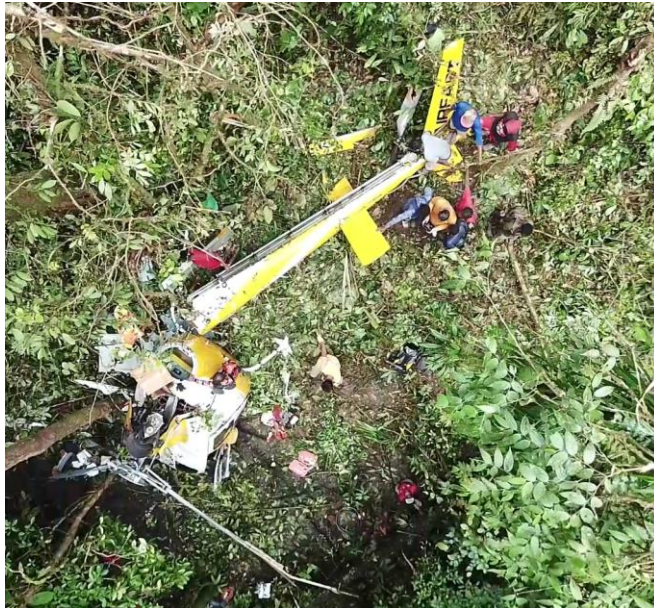
Figure 3: The aerial view of the helicopter.

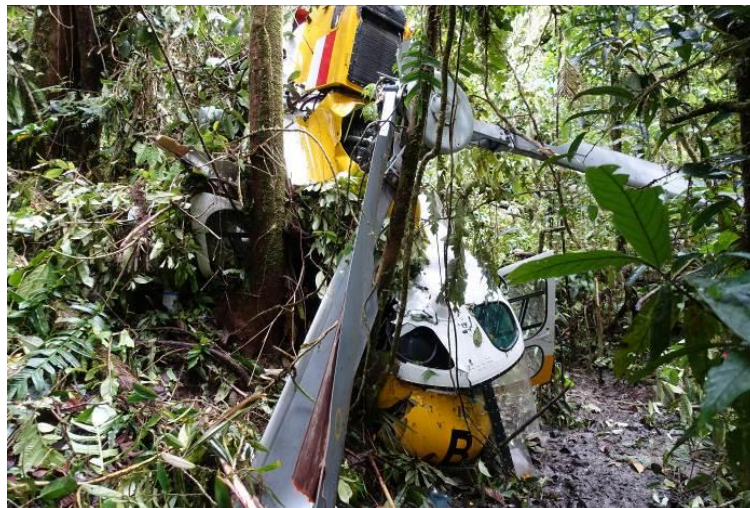
The helicopter rest in upright position with the cockpit roof was collapse as shown in the figure below.

Figure 4: The rest position of the helicopter.

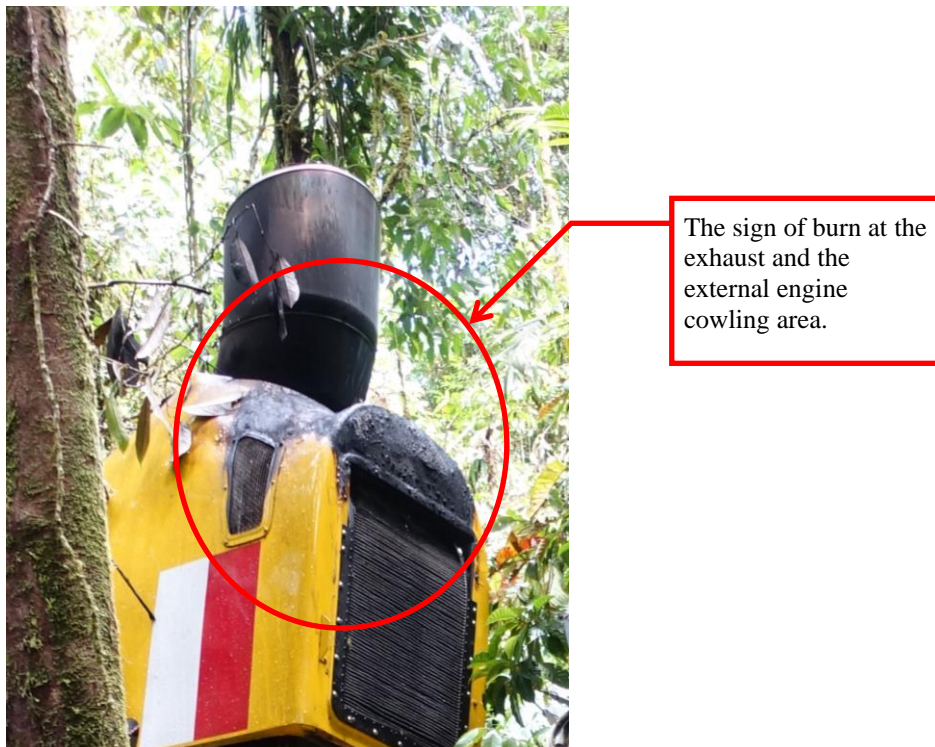
The sign of burn at the engine cowling area was found as shown in the figure below.

Figure 5: The sign of burn on the near engine area

This evidence confirmed as reported by the witnesses that during the evacuation of the occupants, they saw a fire on top of the helicopter. The fire was self-extinguished during the heavy rain.
