**KOMITE NASIONAL KESELAMATAN TRANSPORTASI
REPUBLIC OF INDONESIA**

PRELIMINARY

Aircraft Accident Investigation Report

**PT. Travira Air
Sikorsky S 76++; PK-TVY
Soehanah Rig Helipad, Matak
Republic of Indonesia
20 July 2021**

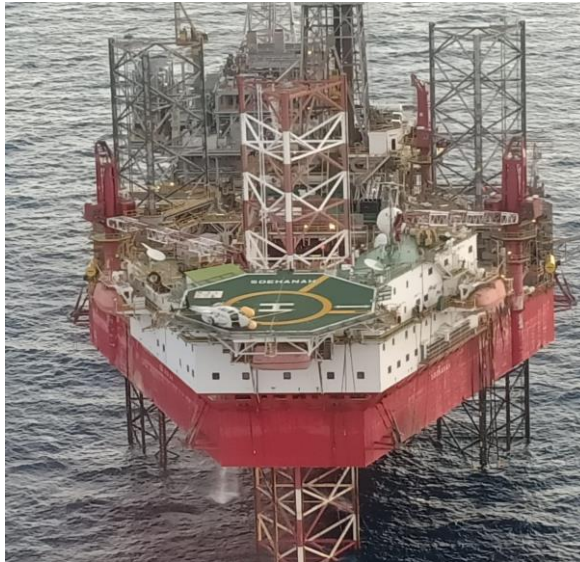
Figure 1: The Soehanah helipad and the last position of helicopter

The helicopter stopped about 12 meters from the center of D-Value, on radial about 210° and tumbled to the right.

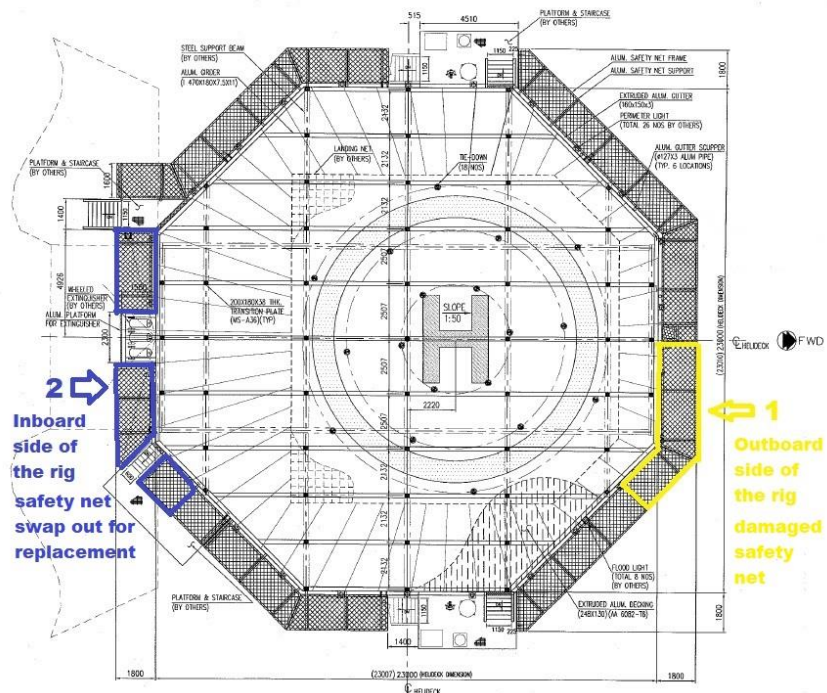
The Soehanah helipad exhibited surface safety net damage which required minor repair.

Figure 2: The damage to the helipad

Several scratch marks were found on the helipad surface. The dimension and location of the scratch were not documented.

On 28 July 2021, the rig operator issued a Notice to Airmen regarding the helipad condition after the occurrence.

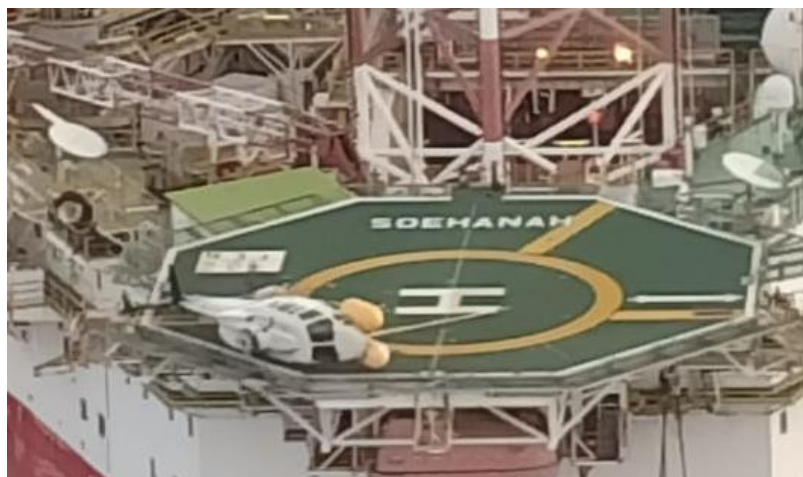
Figure 3: The helicopter on the Soehanah helipad

The main rotor and tail rotor blades were broken and scattered from the helicopter. Most of the main rotor blades were thrown overboard into the water and unable to be recovered.

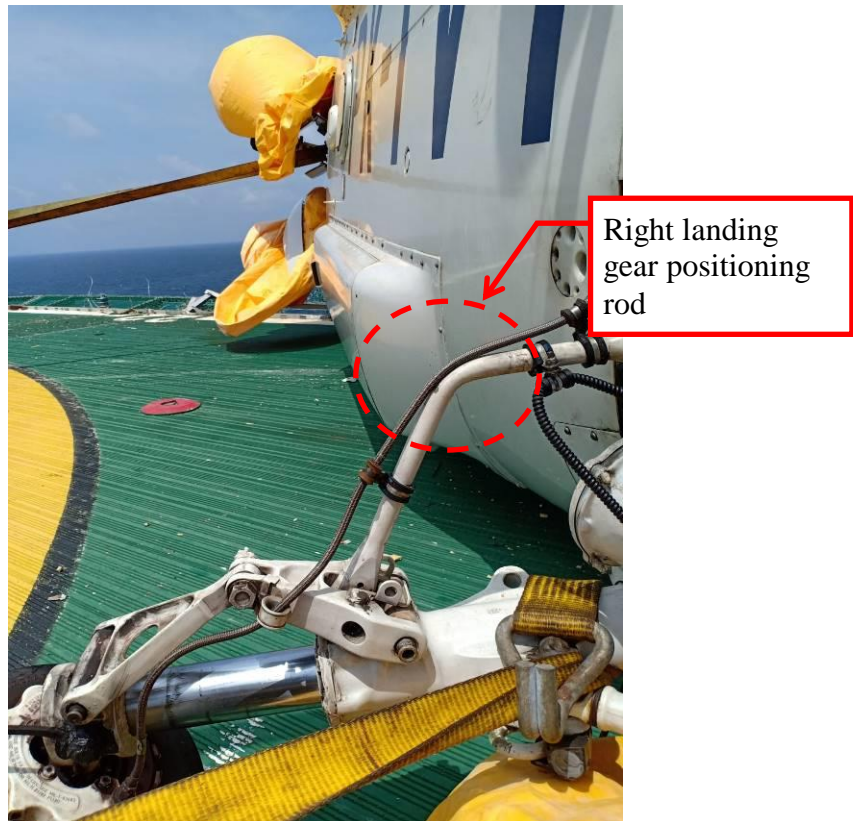
All of the floating devices were inflated. All the landing gears were intact. The positioning rod of the right main landing experienced bend about 120° inward.

Figure 4: The bend of right landing gear positioning rod
