**KOMITE NASIONAL KESELAMATAN TRANSPORTASI  
REPUBLIC OF INDONESIA**

**KNKT.22.05.04.04**

**Aircraft Serious Incident Investigation Report**

**ATR 72-212A; PK-WGF**

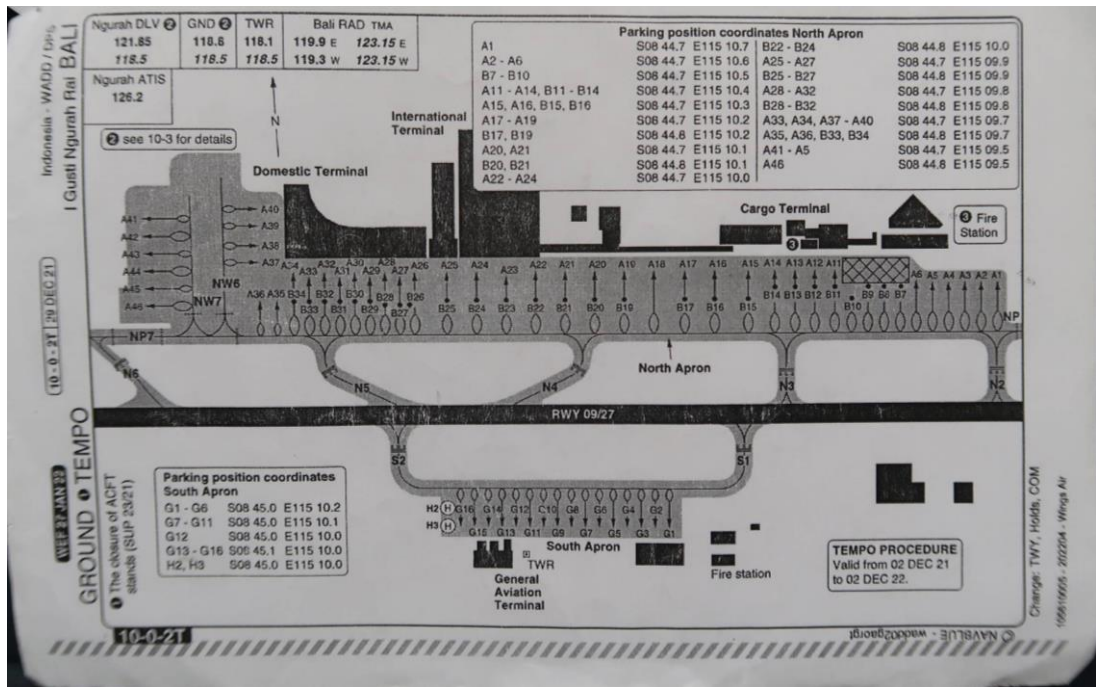
**Figure 1: The aerodrome chart which was available in the cockpit**

Figure 1 shows the aircraft parking/docking chart for Bali which was available in the cockpit:

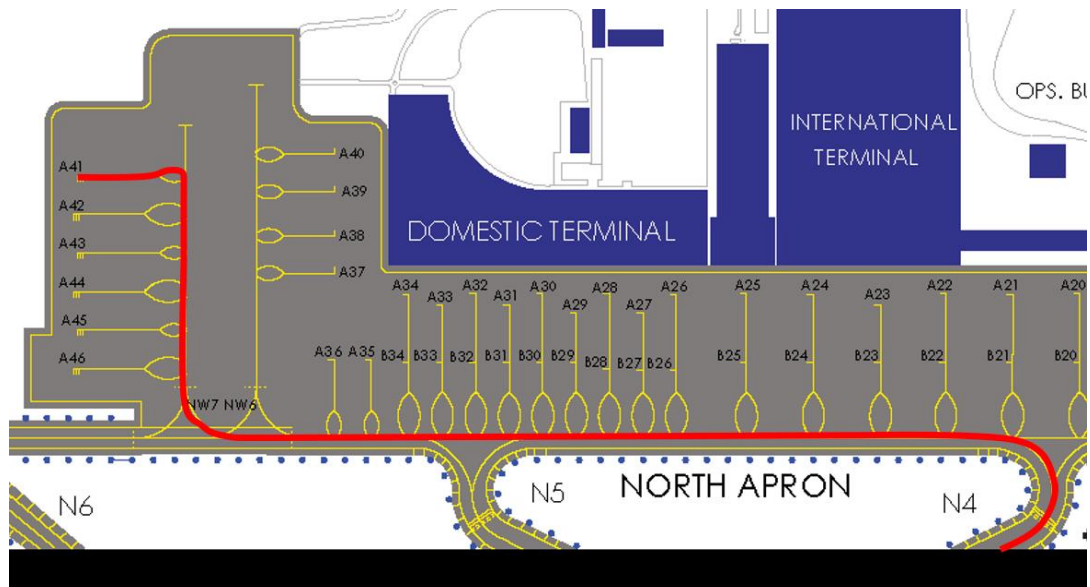
**Figure 2: The illustration of the taxi route from N4 to Parking Stand A41**

According to the Aeronautical Information Publication (AIP) Volume II Chapter WADD AD 2.24-2A1, from Taxiway N4 to Parking Stand A41, an aircraft must taxi via Apron Taxiway and Taxiway NW7 as illustrated by red line in Figure 2.

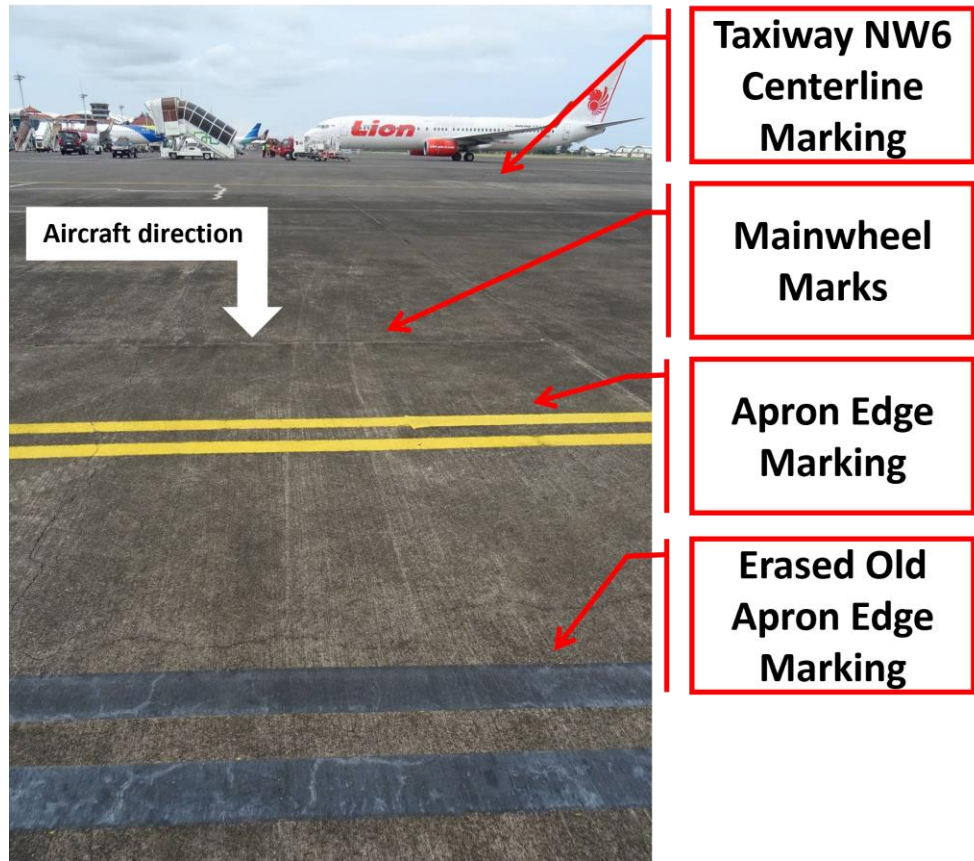
**Figure 3: The marks of the main wheel**

Examination of the incident site, as shown by Figure 3 and Figure 4, found that the aircraft performed 90° turning maneuver to the left from the Taxiway NW6 guidelines between two taxiway lights prior to stop in the ditch.

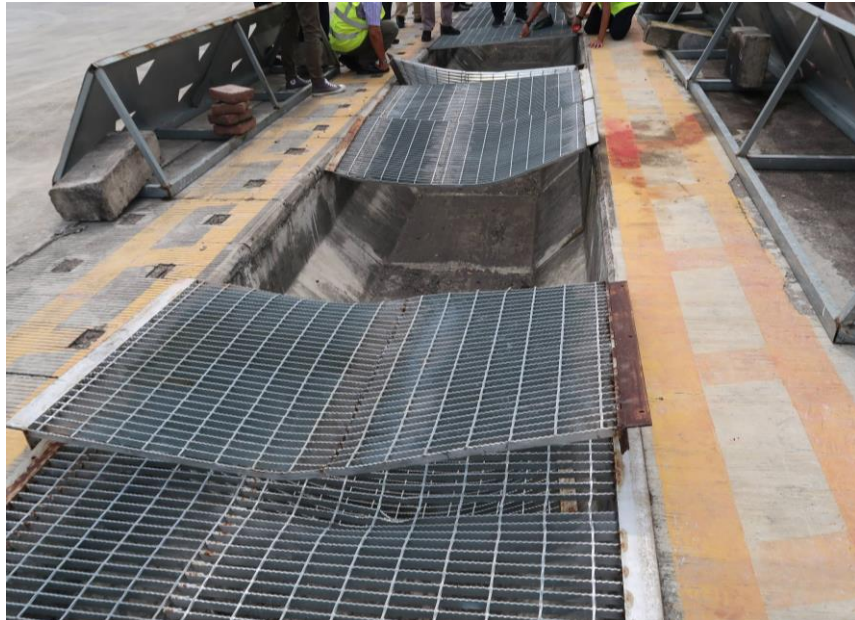
**Figure 5: The damage to the ditch metal structure covers**

Some parts of metal structures covering the ditch were damaged.

The incident caused damage to the ditch metal structure covers as shown on Figure 5. The damage on the aircraft was mainly on the bottom part of the fuselage. The outer tire of the right main wheel was found flat. The damage includes:

1. Repaired the metal structure covering the ditch and repainting the apron marking.

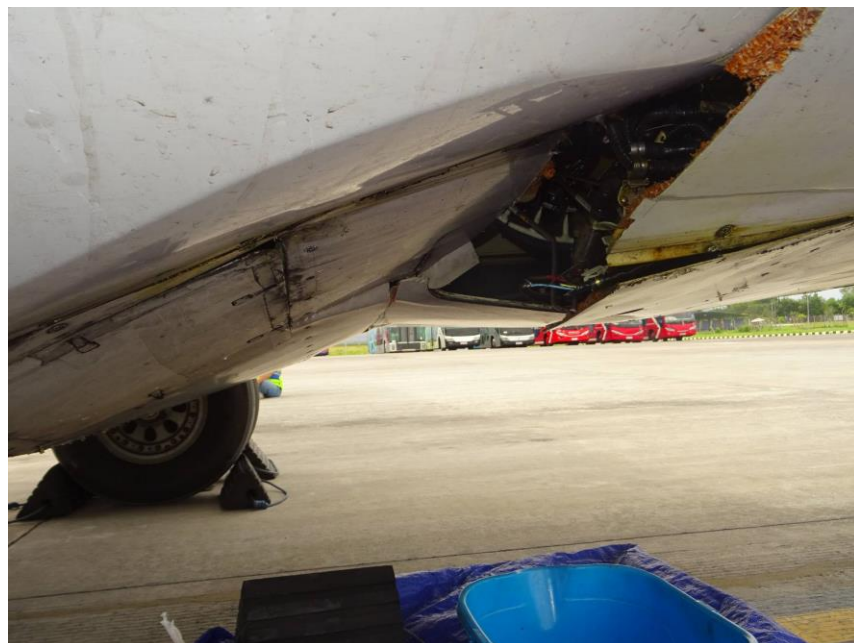
**Figure 6: The crack on the lower fuselage aft of the main landing gear compartment**

- Scratch on the lower tail section,
- Bent on some walls of the main landing gear compartment,
- Crack on lower fuselage aft of the main landing gear compartment as shown on Figure 6.
