**KOMITE NASIONAL KESELAMATAN TRANSPORTASI
REPUBLIC OF INDONESIA**

Aircraft Accident Investigation Report

PT. ASI Pudjiastuti (Susi Air)

PC-6/B2-H4; PK-BVM

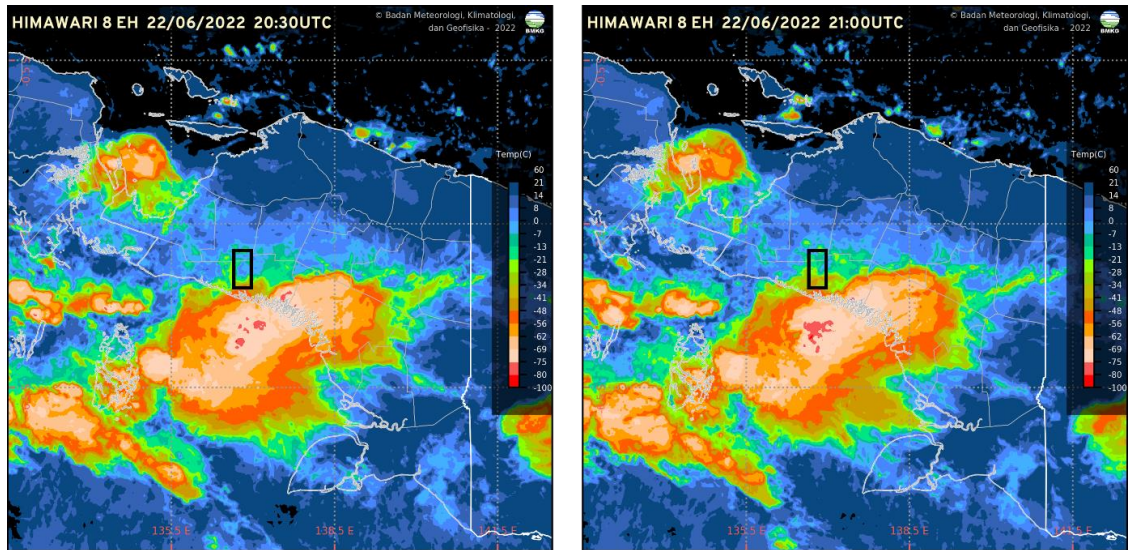
Passengers on board the aircraft during the accident flight recalled that the weather along the flight was clear including at the area around Duma. Local people from a village near the accident site also described the weather during the accident was clear.

Figure 1: The satellite image of area near flight route and accident site (inside the black square, annotated by KNKT)

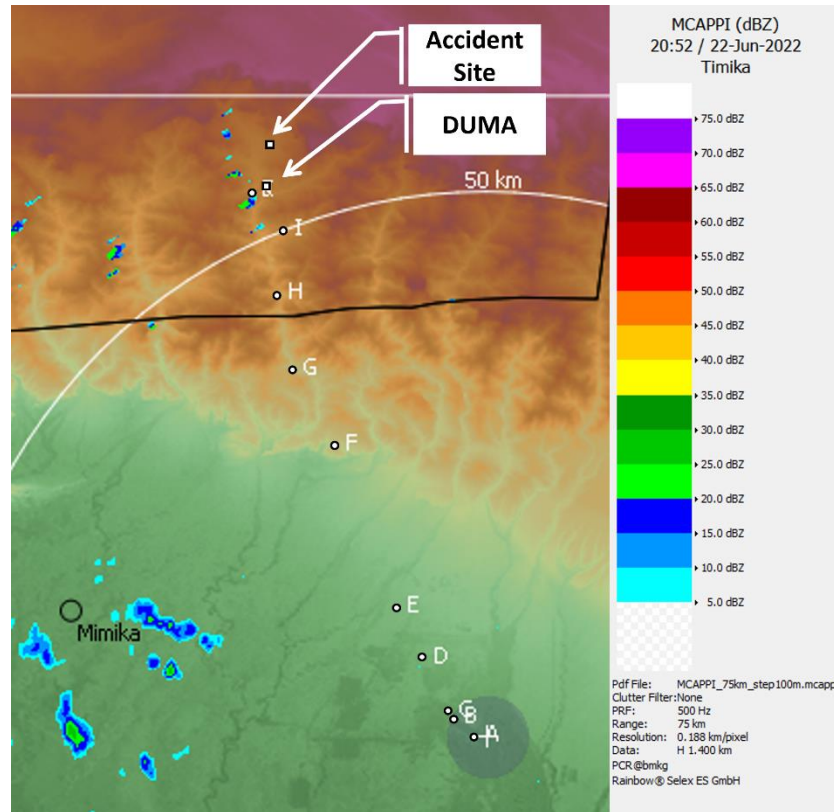
The superimposed of the aircraft flight following data to the weather radar image at 2052 UTC (0552 LT)⁹ provided by the BMKG, indicated that the radar intensity level along the flight route, last recorded position and the accident site, at the height of about 1,400 meters (4,500 feet) was more than 25 dBz¹⁰. This means that the area did not indicate any significant development of clouds and the estimated visibility was more than 10 km¹¹.

Figure 2: The superimposed flight following data (dot with alphabet notation) with BMKG weather radar image at 2052 UTC (0552 LT)

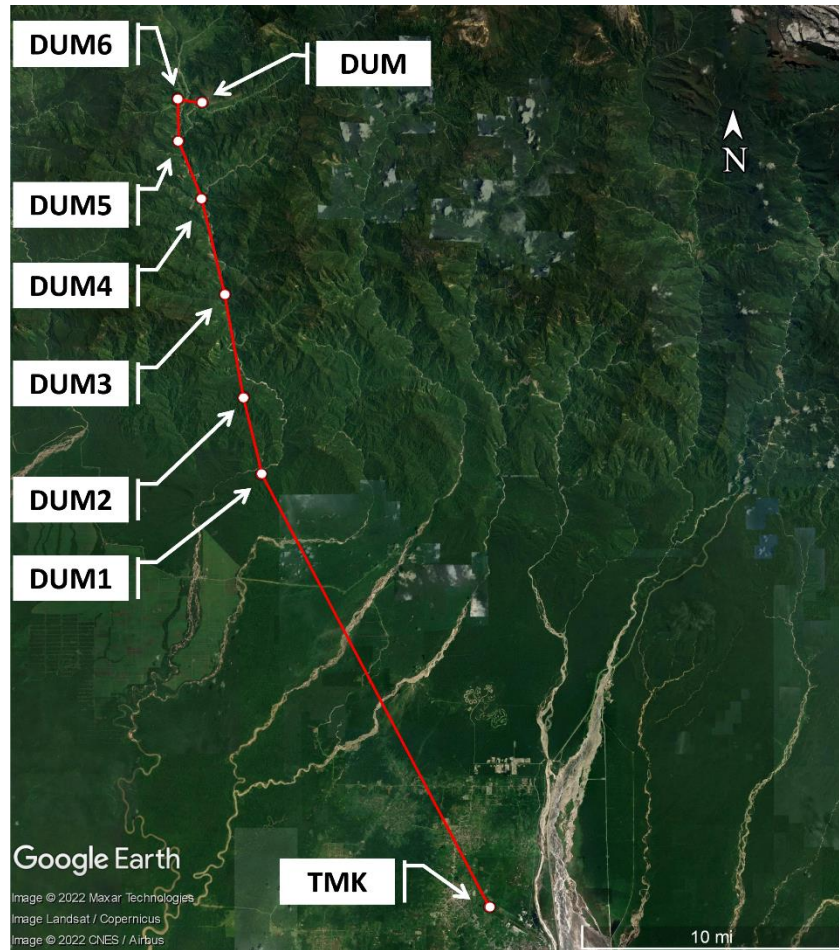
Based on the best practice among pilots within the company, pilots would use a stored GPS flight plan as reference to navigate the aircraft to Duma. The GPS flight plan for Timika to Duma consisted of several GPS waypoints points as illustrated in the figure 3. The location of Duma was included as a waypoint in the aircraft GPS (noted as DUM) and had not been included as an aerodrome in the navigation database. All the coordinate used in the GPS flight plan for Timika to Duma was not included in any company documents.

Figure 3: The GPS flight plan of Timika to Duma flight

Therefore, KNKT recommends the Susi Air to ensure adequate information that can be used as reference, including relevant information for flight to Duma in the ARB is provided to the pilot.

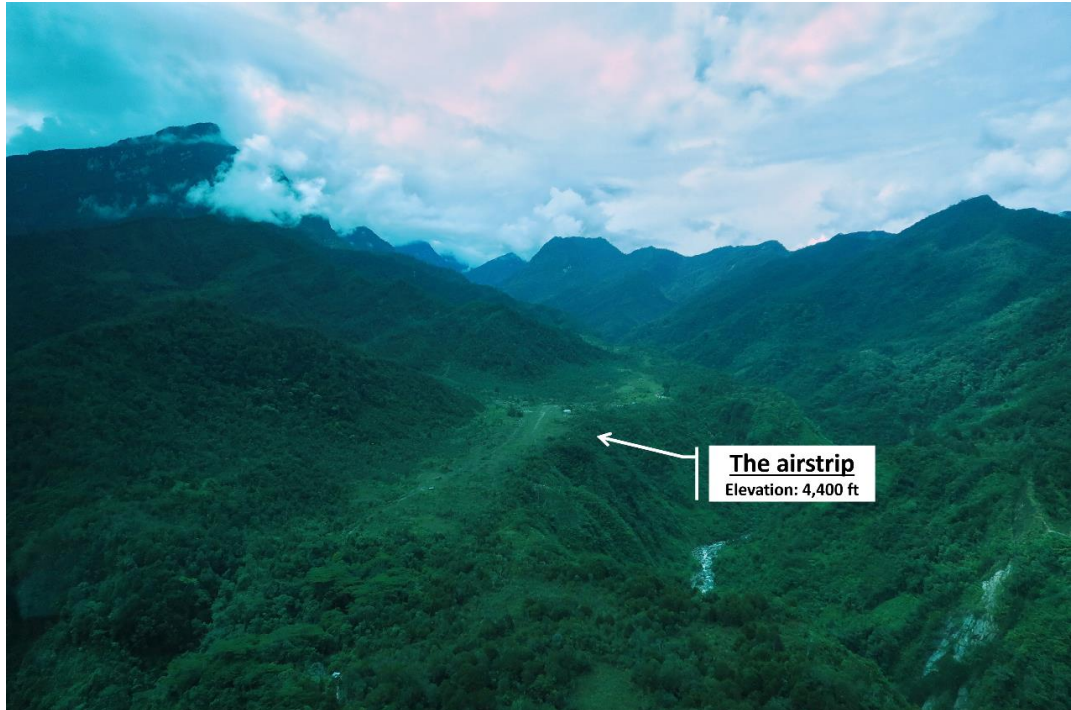
Duma was located on mountainous area on coordinate 04°04.41' S 136°42.73' E with elevation of 4,400 feet. The runway surface was grass with designation number of 08 – 26, the runway dimension was 320 meters length and 25 meters width.

Figure 4: The surrounding area of the airstrip as seen from the final area of Runway 08

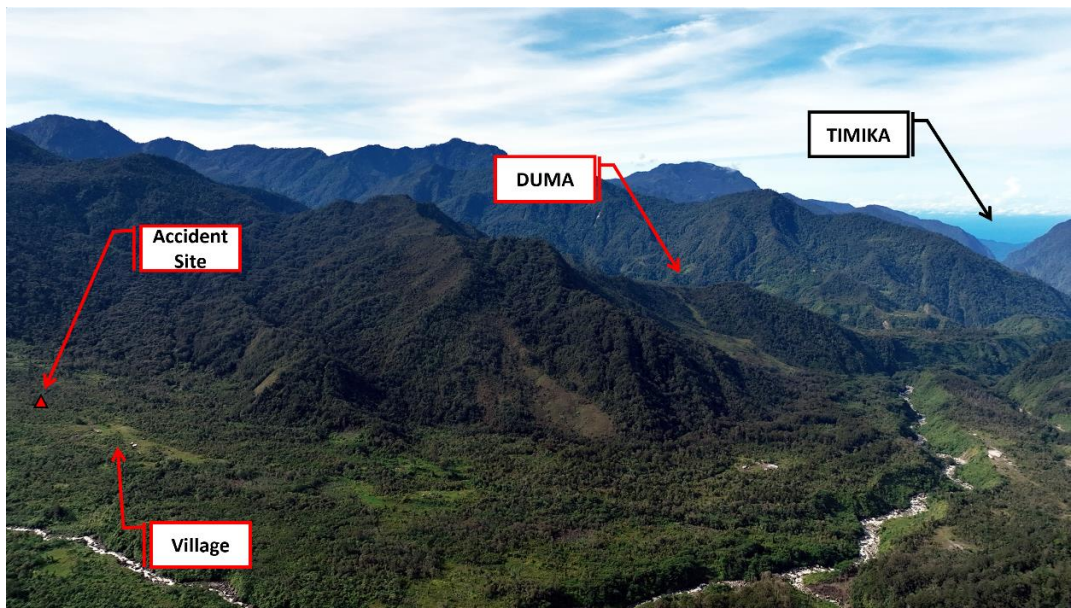
The aircraft was found about 3 Nm, North direction of Duma on coordinate $4^{\circ} 2'26.08''$ S $136^{\circ}42'56.76''$ E. The elevation of the accident site was about 5,400 feet.

Figure 5: The accident site location

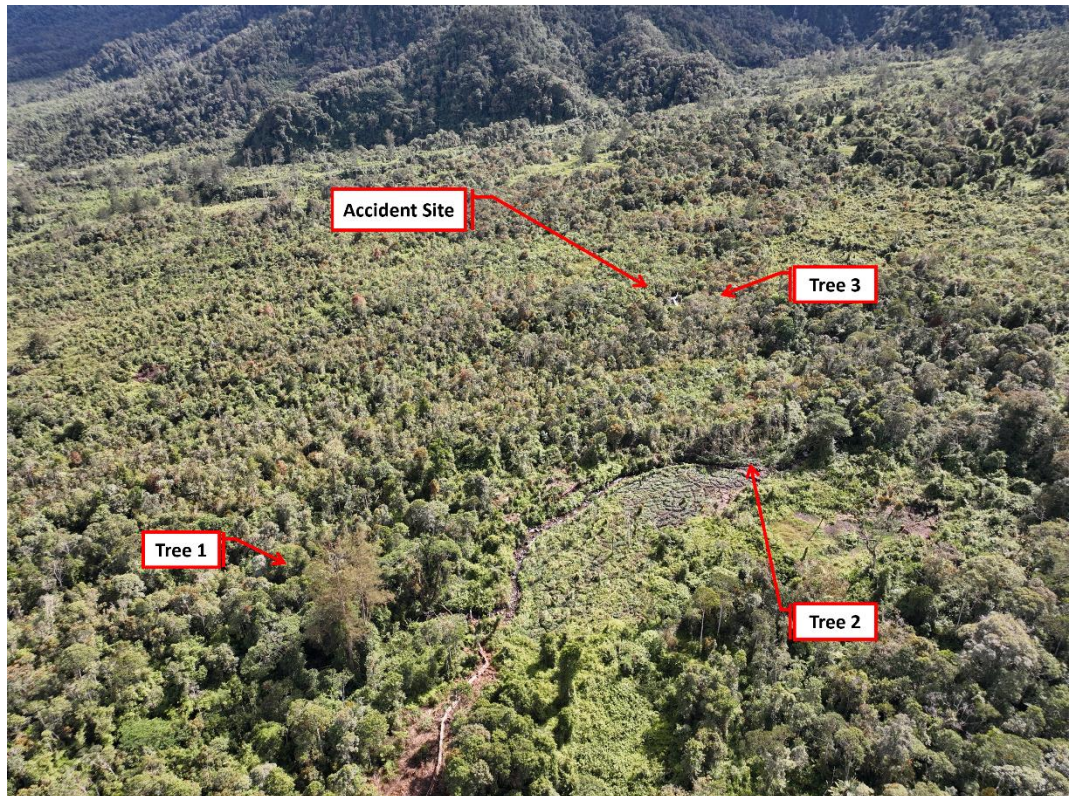
The accident site was close to a village which located about 500 meters in Southwest direction. Local people witnessed the aircraft was flying low in Northeast direction and impacted a tree with height about 30 meters (named as Tree 1 in this report).

The impacted Tree 1 was the highest tree in that area. An impact mark also found on a tree about 125 meters on 054° direction from the impacted Tree 1. This second impact mark named as Tree 2 in this report. The third impact mark was found on a tree (named as Tree 3) which located on 031° direction and 121 meters from the Tree 2. The aircraft was found on 32 meters on 318° direction from Tree 3 (see figure 6 and 7).

Figure 6: The impacted trees

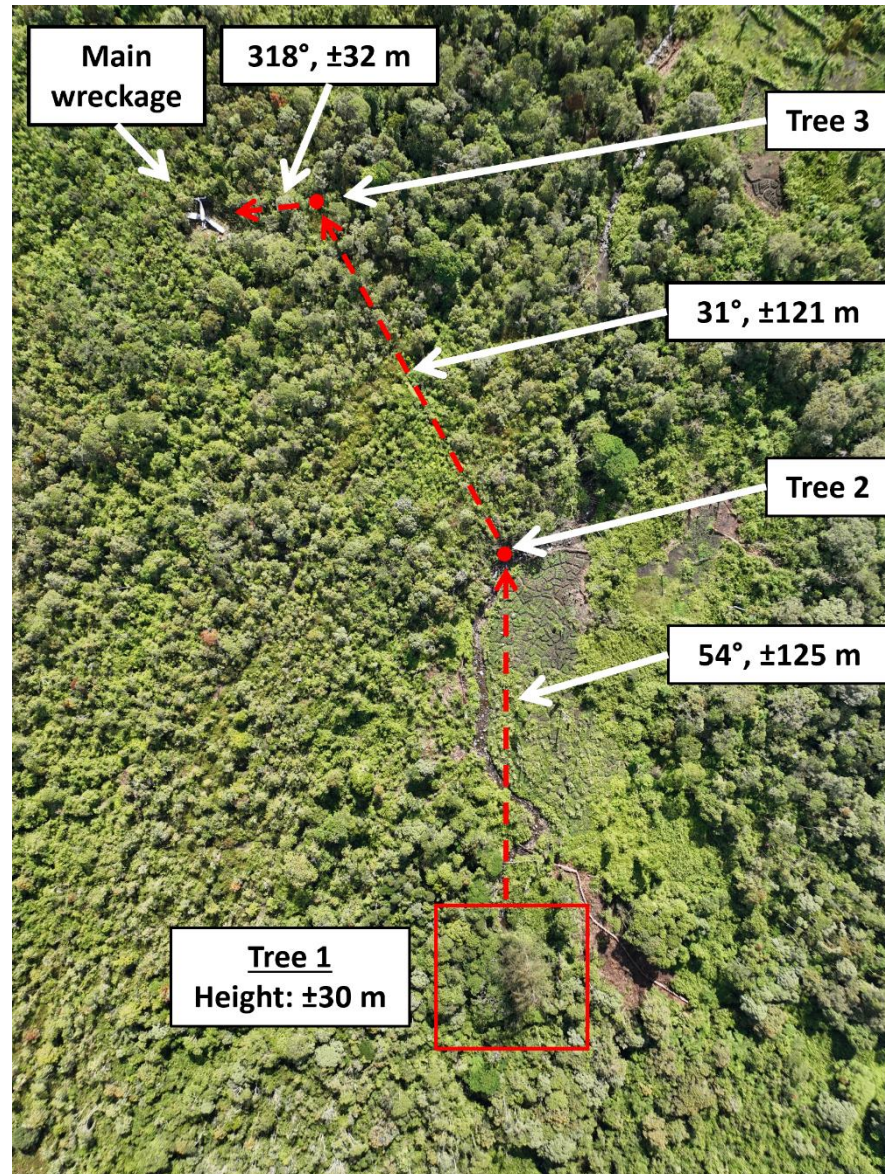
Figure 7: Detailed of the accident site location

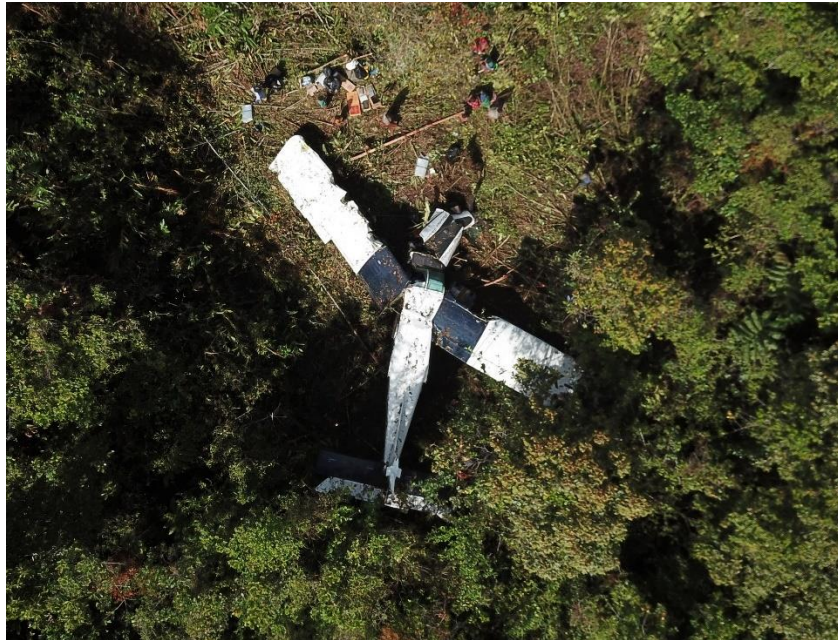
- Marks of fuel spills were found at the accident site.
- Main wreckage was on a heading of 220 degrees.
- Nose section was broken.
- The propeller blades were found damaged, the blade angle was in feather position, and the Propeller Control Lever was in MAX FINE position.
- The Idle Control Lever was in low idle position.
- The Power Lever was close to reverse position.
- Left wind shield was broken.

Figure 8: The wreckage condition from above

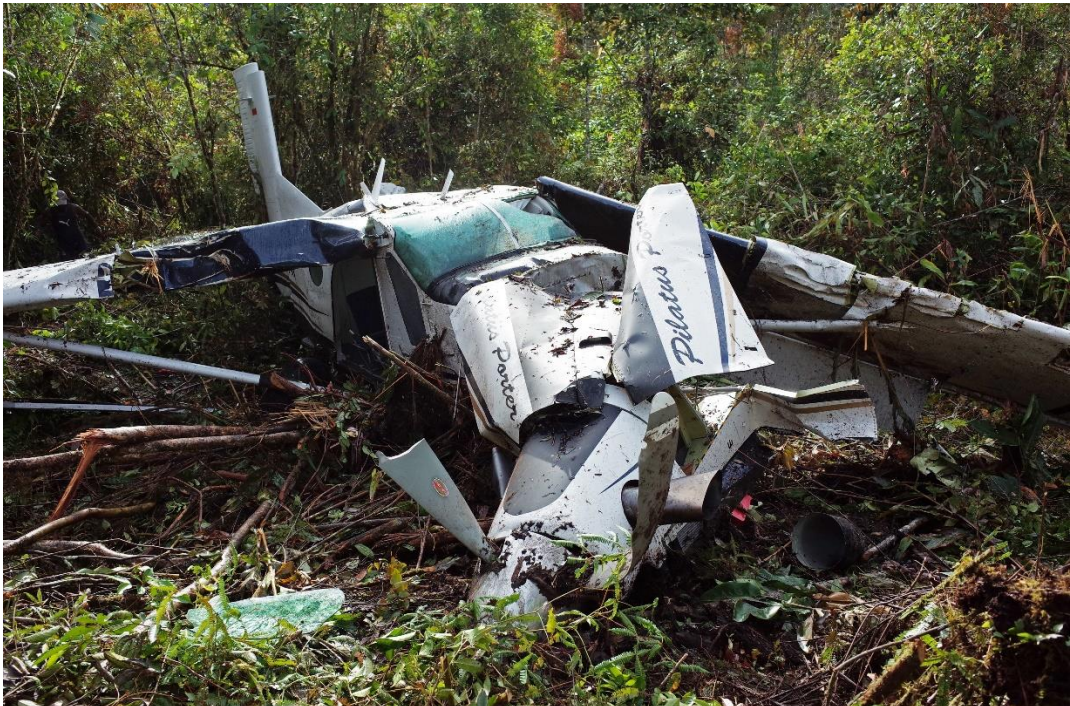
Figure 9: The damaged nose section of the aircraft

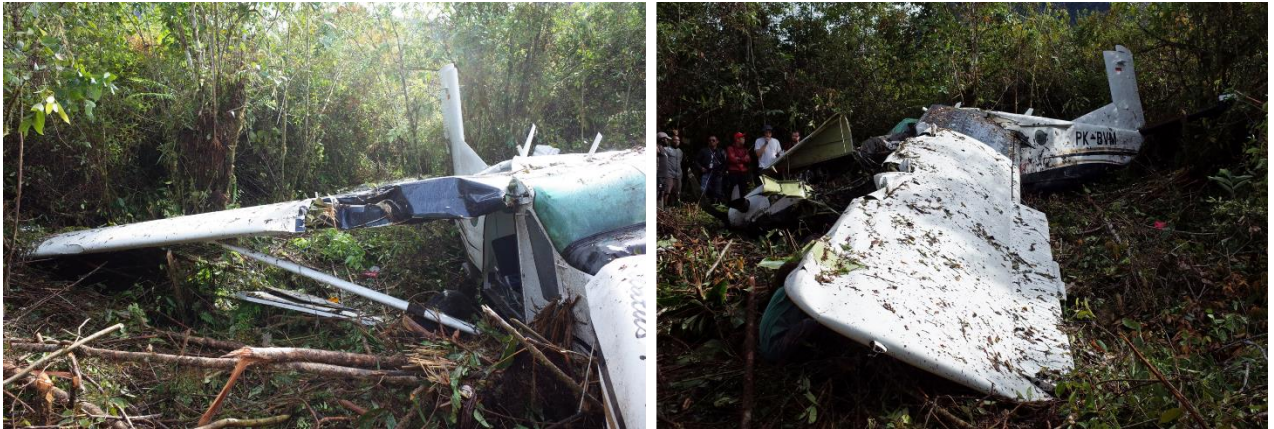
- Left and right wings were detached from its wing root, and the leading edge of both wings were damaged.

Figure 10: The damaged wings
