Aircraft Accident Investigation Report

PT White Sky Aviation

Bell 505; PK-WSU

Ungasan Heliport, Bali

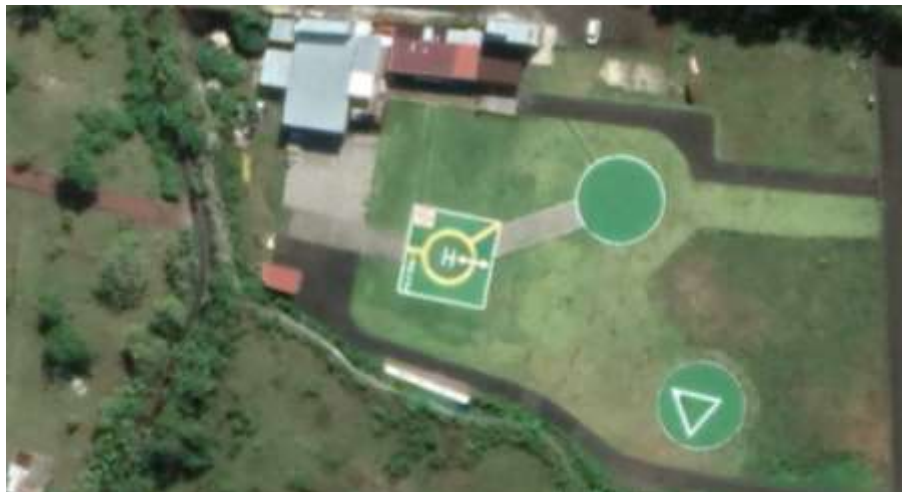
Figure 1. Fly Bali heliport layout

The heliport located at Ungasan Village, Kuta Selatan regency, Badung district, Bali.
