Aircraft Serious Incident Investigation Report

Asia Cargo Airlines

Boeing 737-300F; PK-YGV

14 August 2022

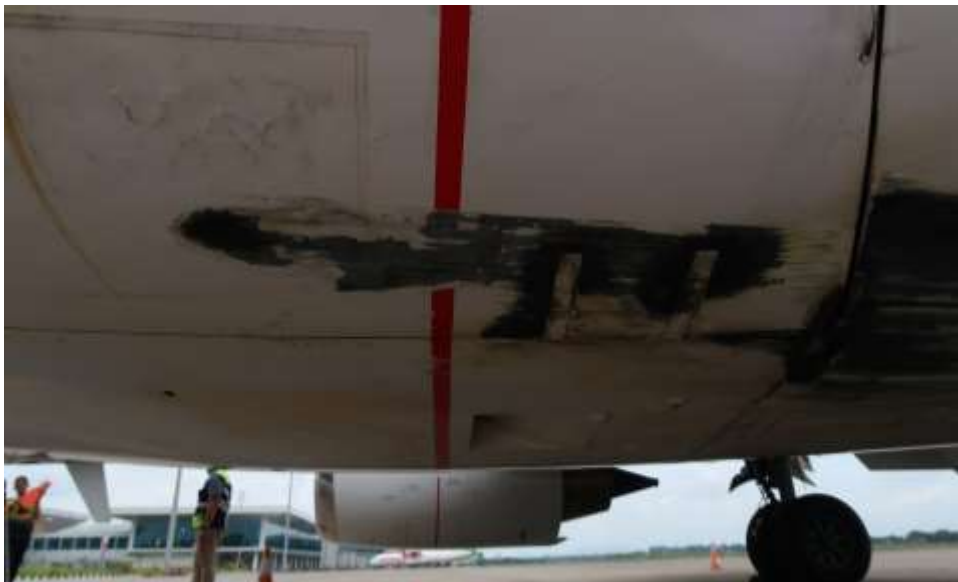
The aircraft was slightly damaged as illustrated by Figure 1 to Figure 4. There were scratches on lower surface of the left engine cowling. The damage was also found on the left wing as scratches on the lower surface of the slat leading edge and wing tip, wrinkles and dents on the upper surface.

Figure 1 Scratches on lower surface of the left engine cowling

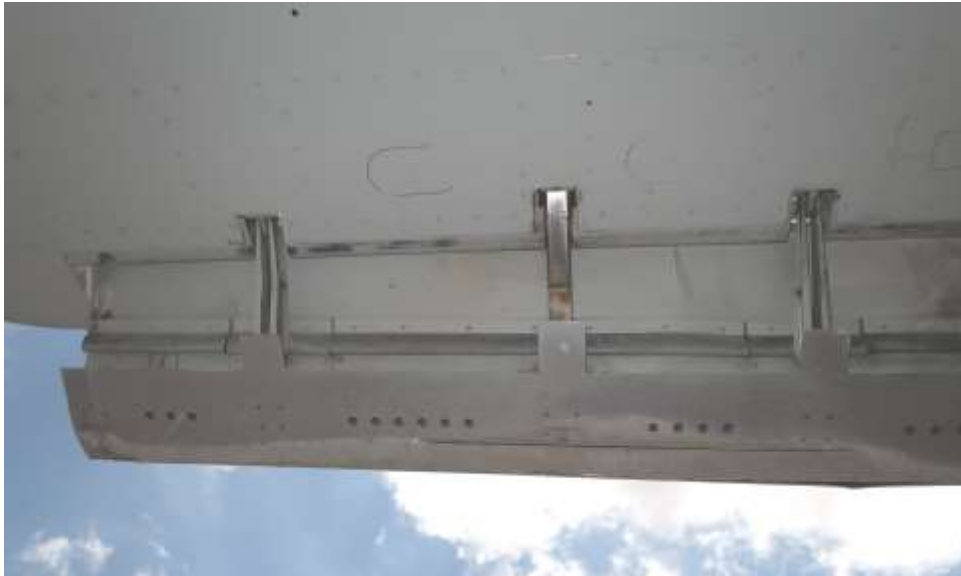
Figure 2 Scratches on the lower surface of the slat leading edge

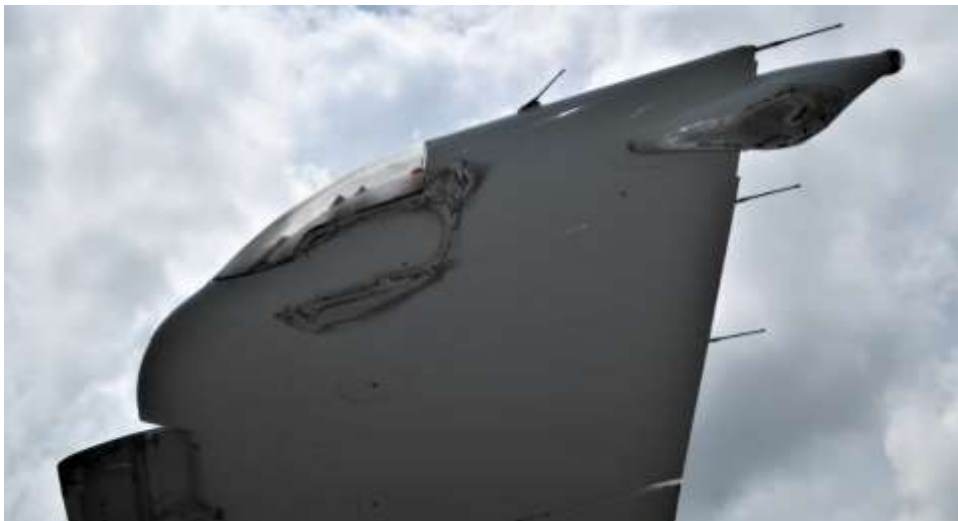
Figure 3 Scratches on the left wing tip

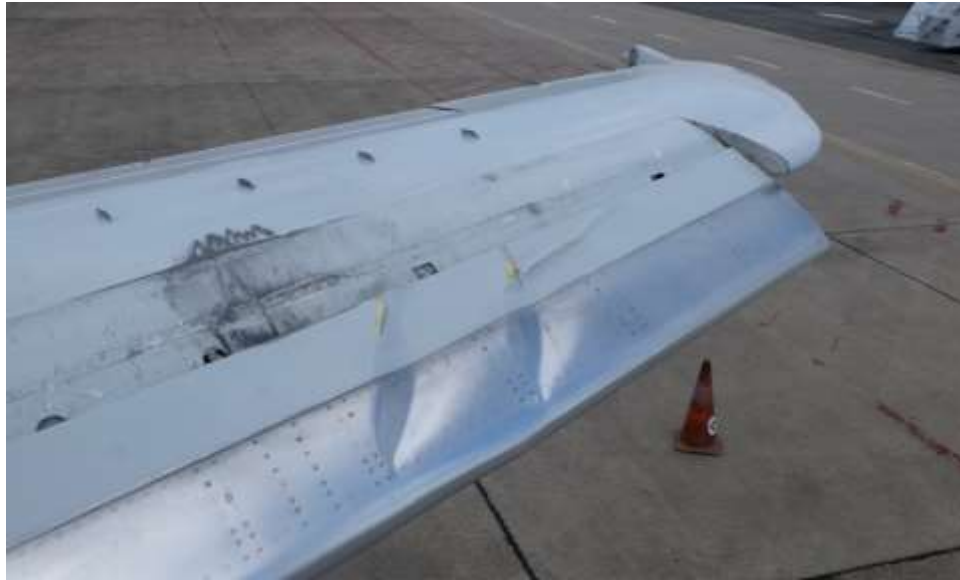
Figure 4 Wrinkles and dents on the wing upper surface

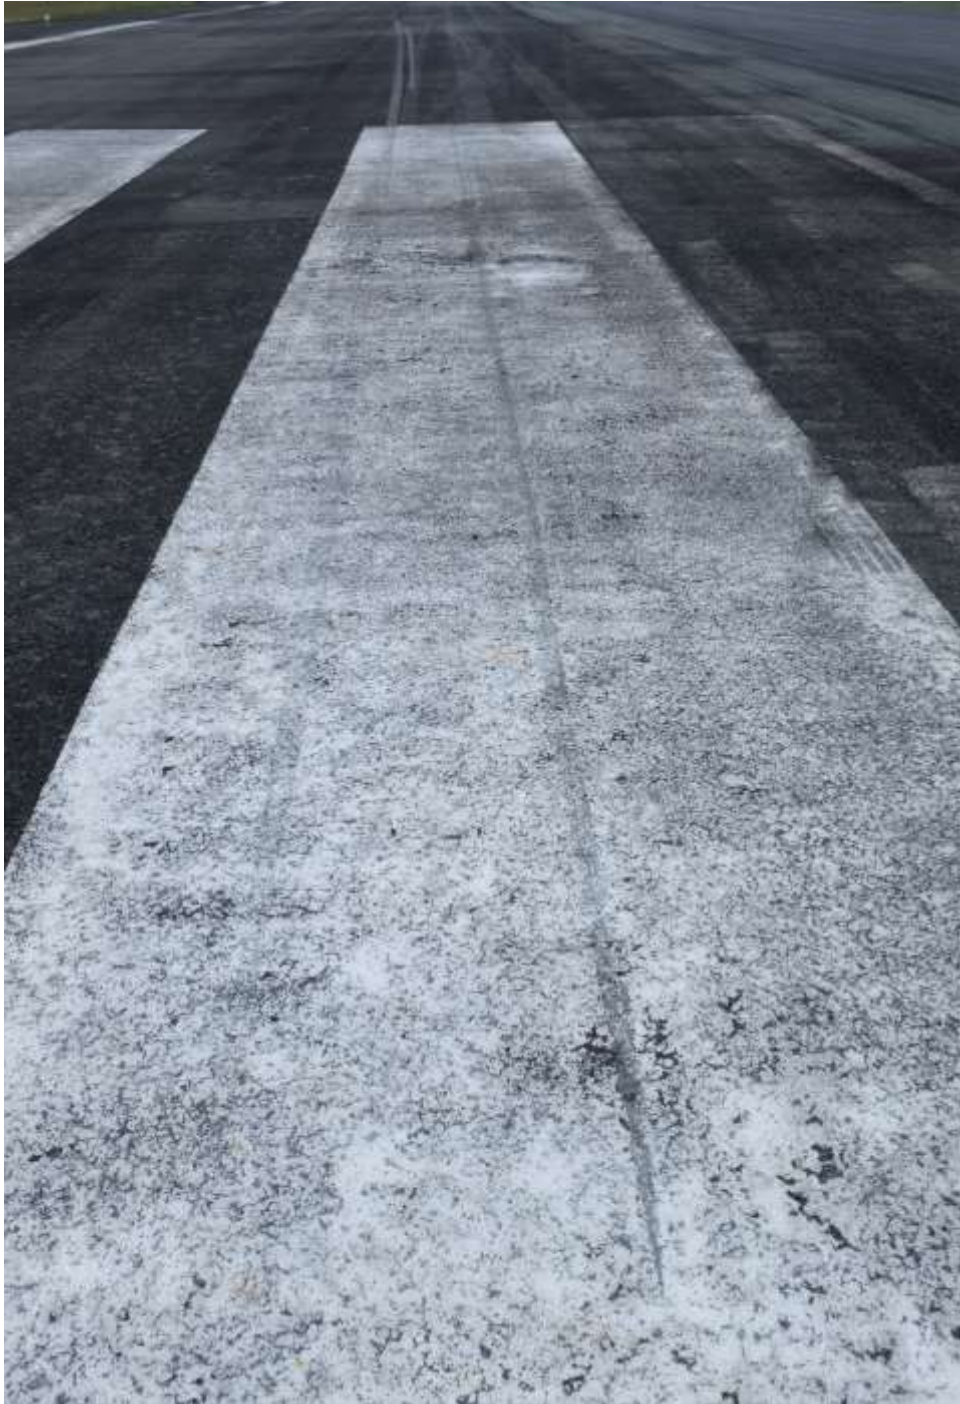
1. About 600 meters from the threshold Runway 10, a 14 meters long scratch mark was found in the left side of the runway centerline approximately 14 meters from the left runway edge as shown on Figure 5.

Figure 5 Fourteen meters long scratch mark on the runway

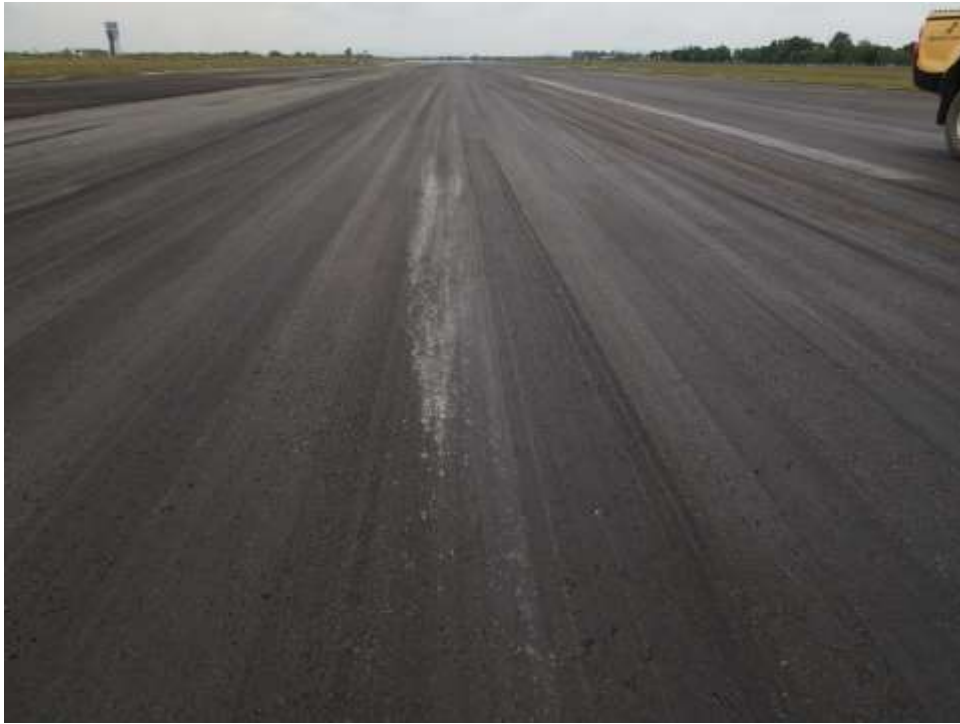
2. About 700 meters from the threshold runway 10, metal scratch mark with white paint colour was found with the dimension about 2 meters in length and 50 centimeters in width as shown on Figure 6.

Figure 6 Two meters long scratch mark on the runway
