**KOMITE NASIONAL KESELAMATAN TRANSPORTASI
REPUBLIC OF INDONESIA**

Aircraft Accident Investigation Report

PT Smart Cakrawala Aviation

Cessna Caravan C208B EX; PK-SNW

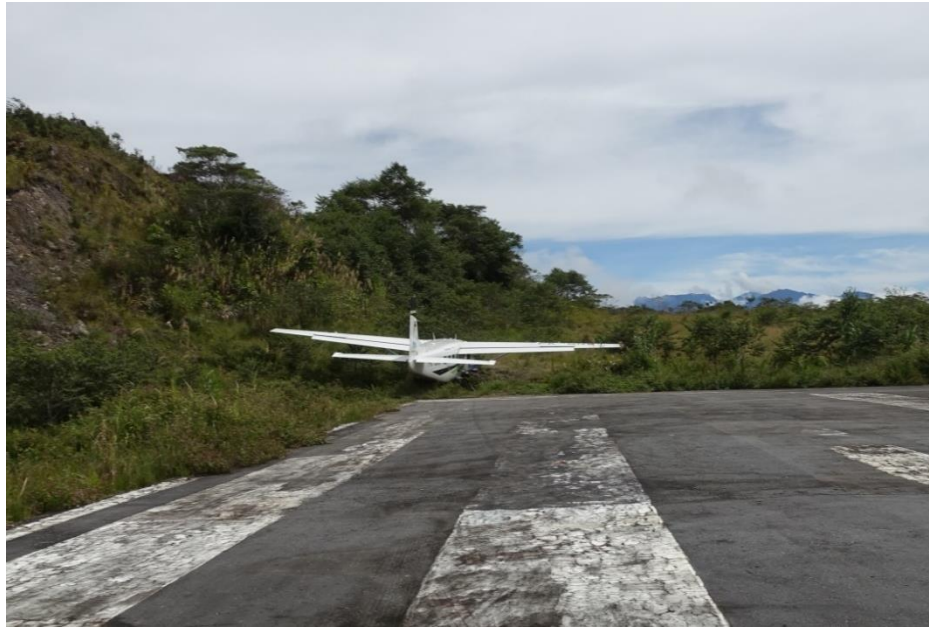
The aircraft impacted an embankment and came to a stop beyond the end of Runway 35. The pilots and the passengers evacuated the aircraft safely on their own.

Figure 1: The aircraft condition after it stopped

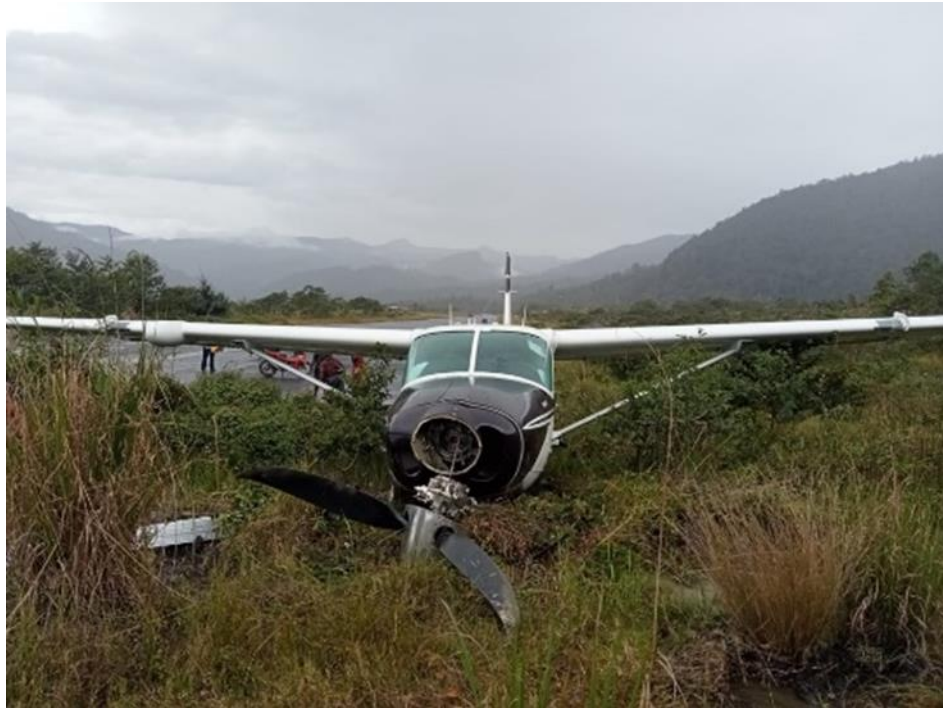
The aircraft was substantially damaged. The nose landing gear collapsed, and the propeller assembly detached from the propeller gearbox. All propeller blades were found bent.

Figure 2: The damaged of the nose section and the propeller

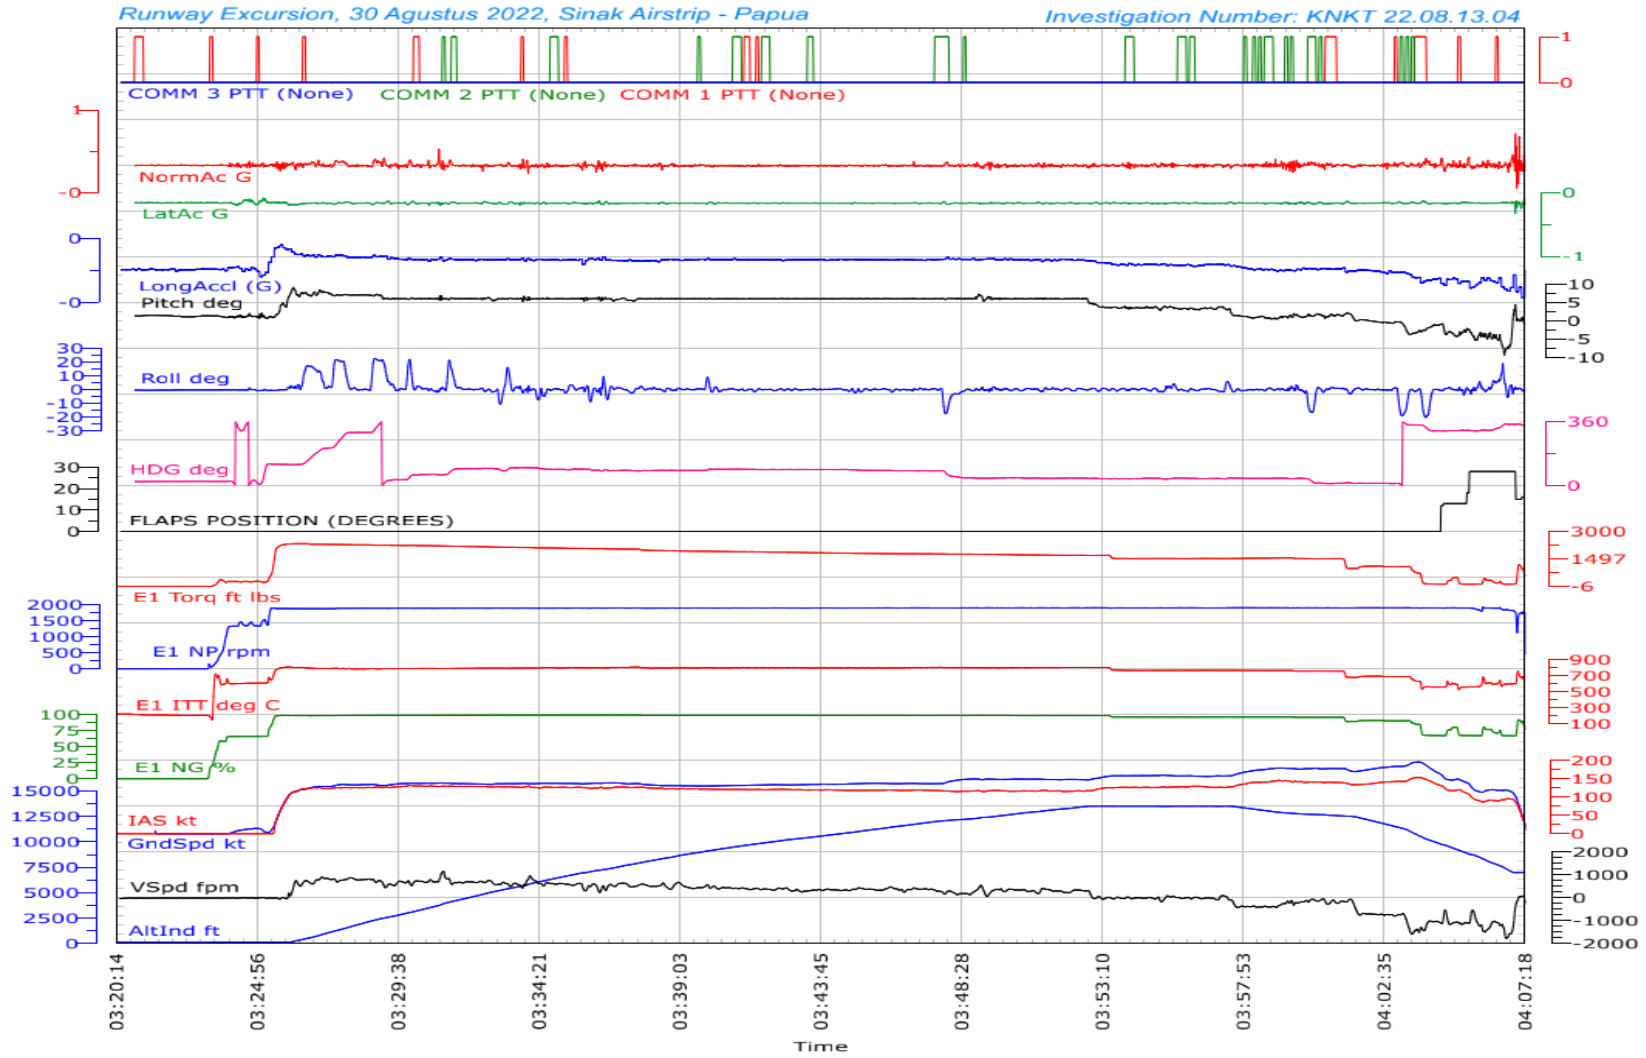
Figure 5: The significant parameters of the occurrence flight

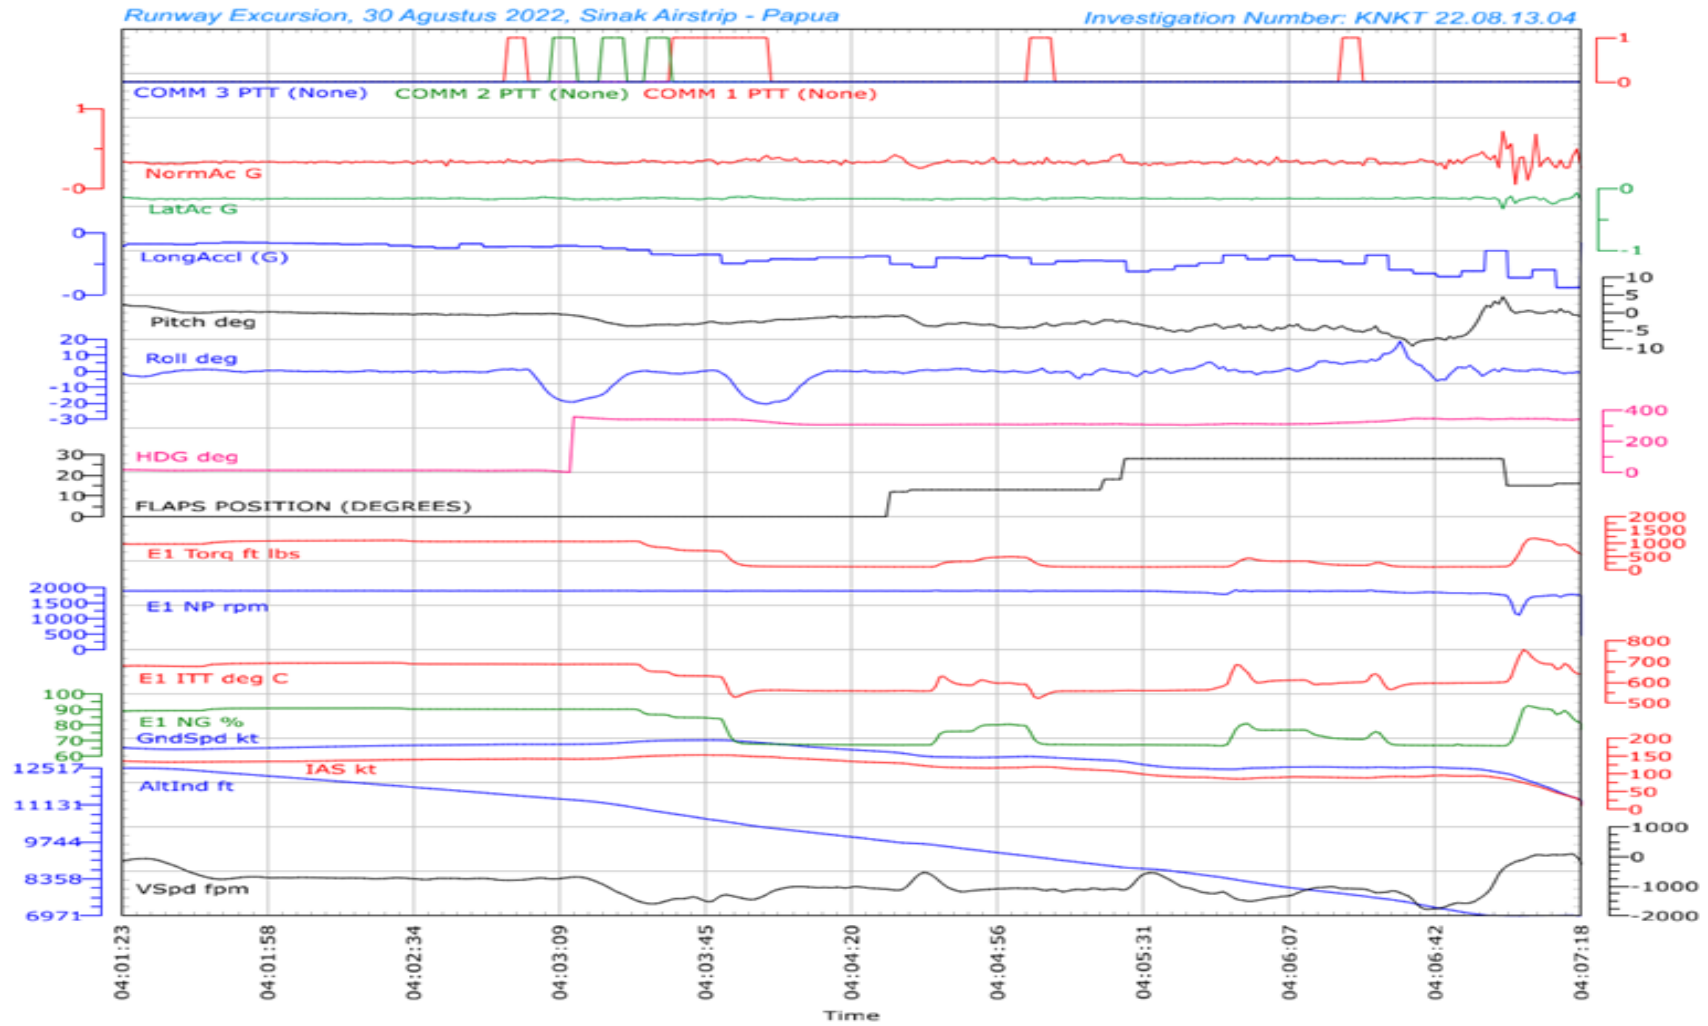
Figure 6: The significant parameters during the aircraft approach to the landing.

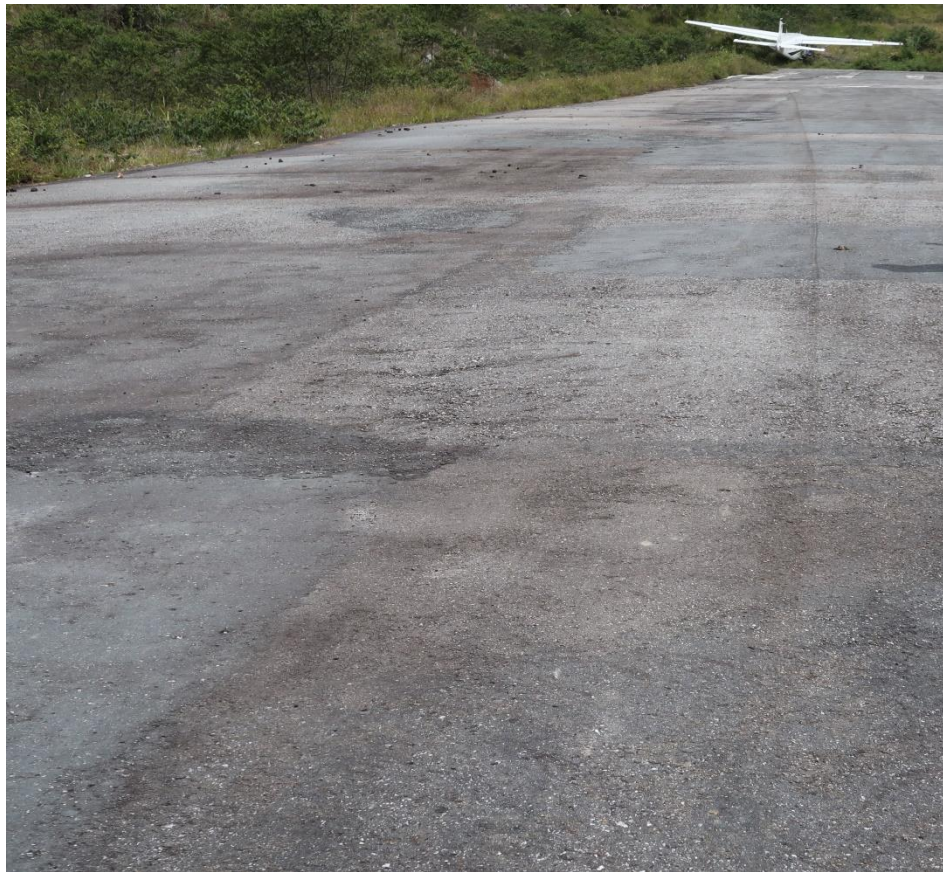
The right tire marks found on the left side of the runway centerline, approximately 670 meters from the beginning of Runway 35.

Figure 7: The tire mark found on the runway

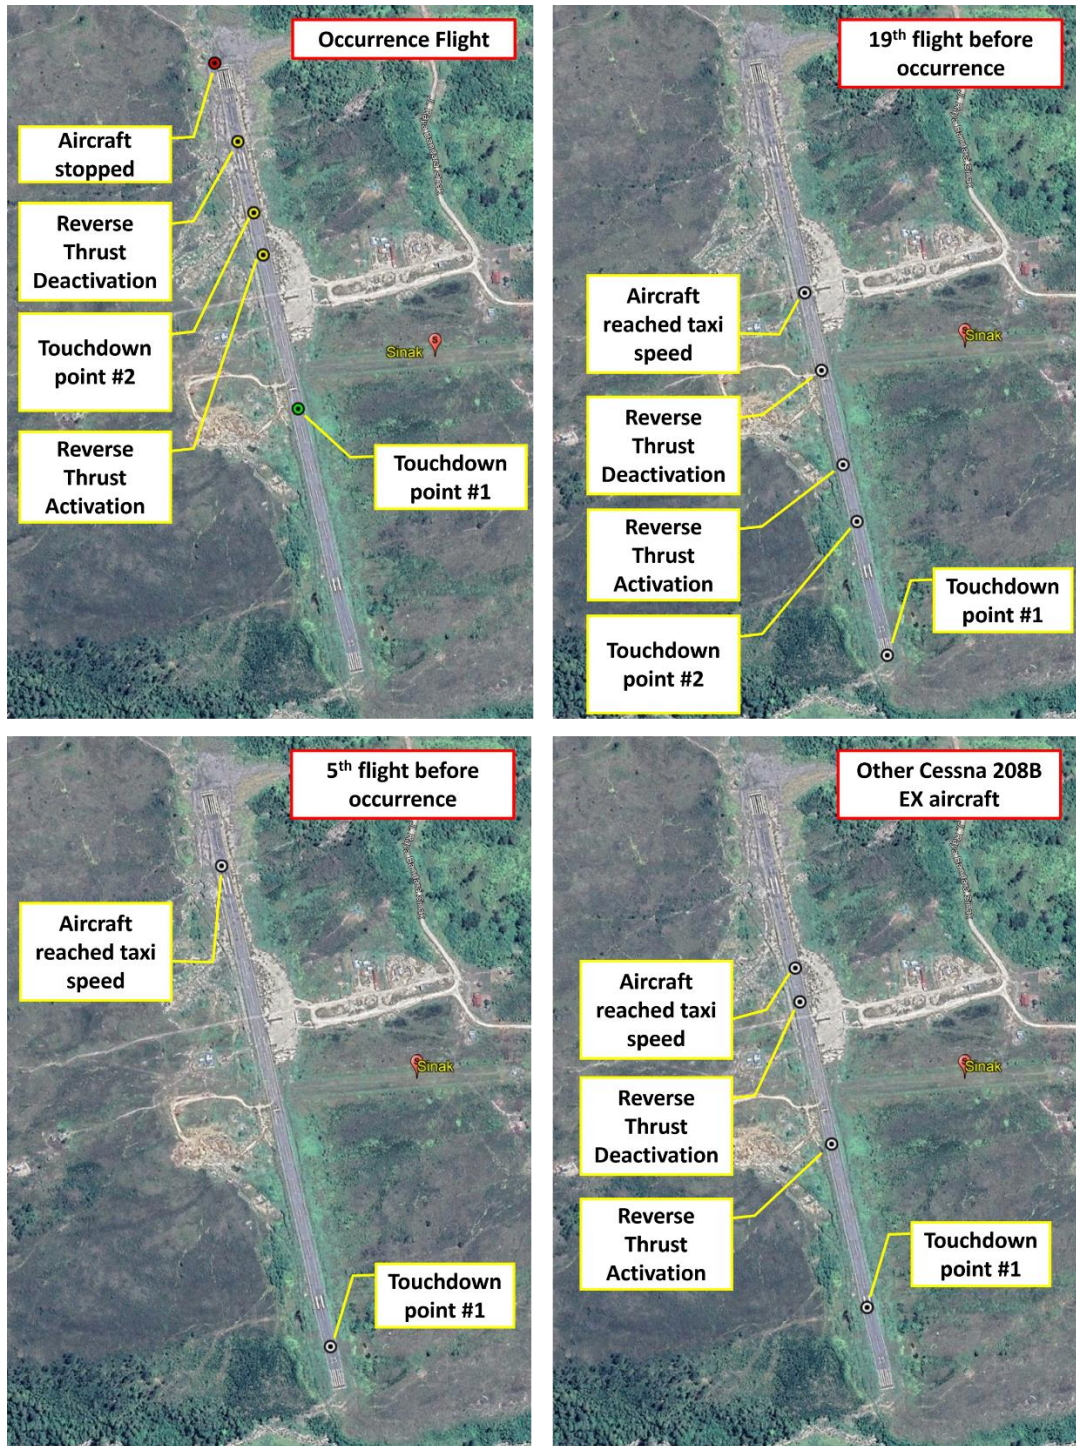
Figure 8: The comparison of aircraft landing behavior in Sinak Airport

Compared to the previous flights to Sinak, the touchdown point of the occurrence flight was beyond the touchdown zone marking of the Runway 25.

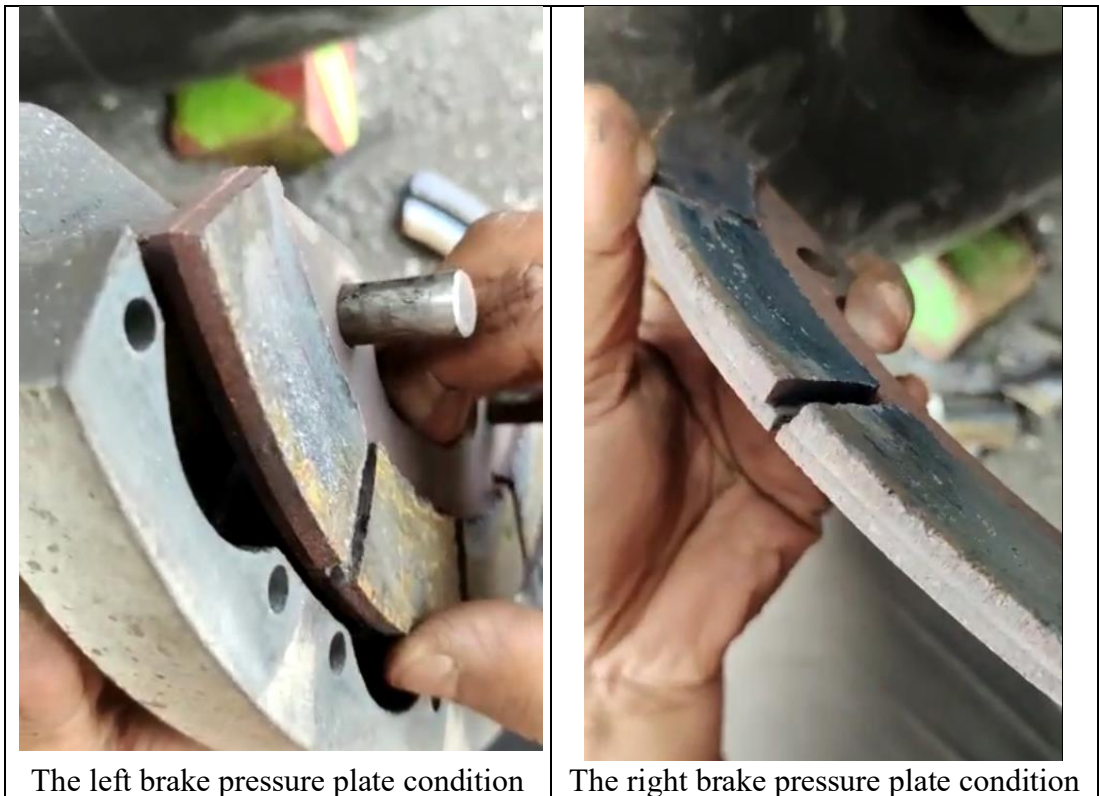
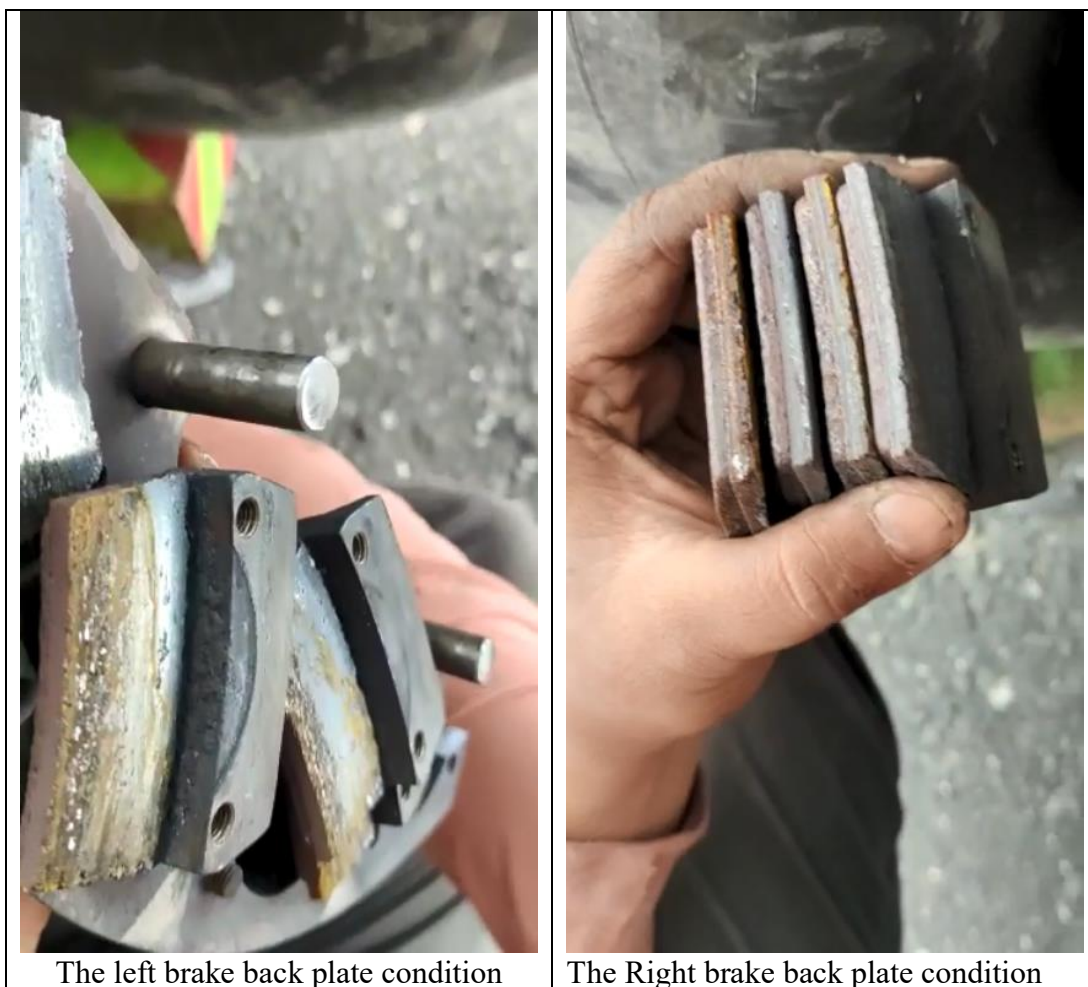
After the occurrence, the engineers from the aircraft operator performed a brake test by pressing the brake pedals and found that the feedback pressure from both brakes were normal. Both brake units were then disassembled to check their condition, and all brake linings were visually considered as acceptable.

Figure 10: All brake linings condition

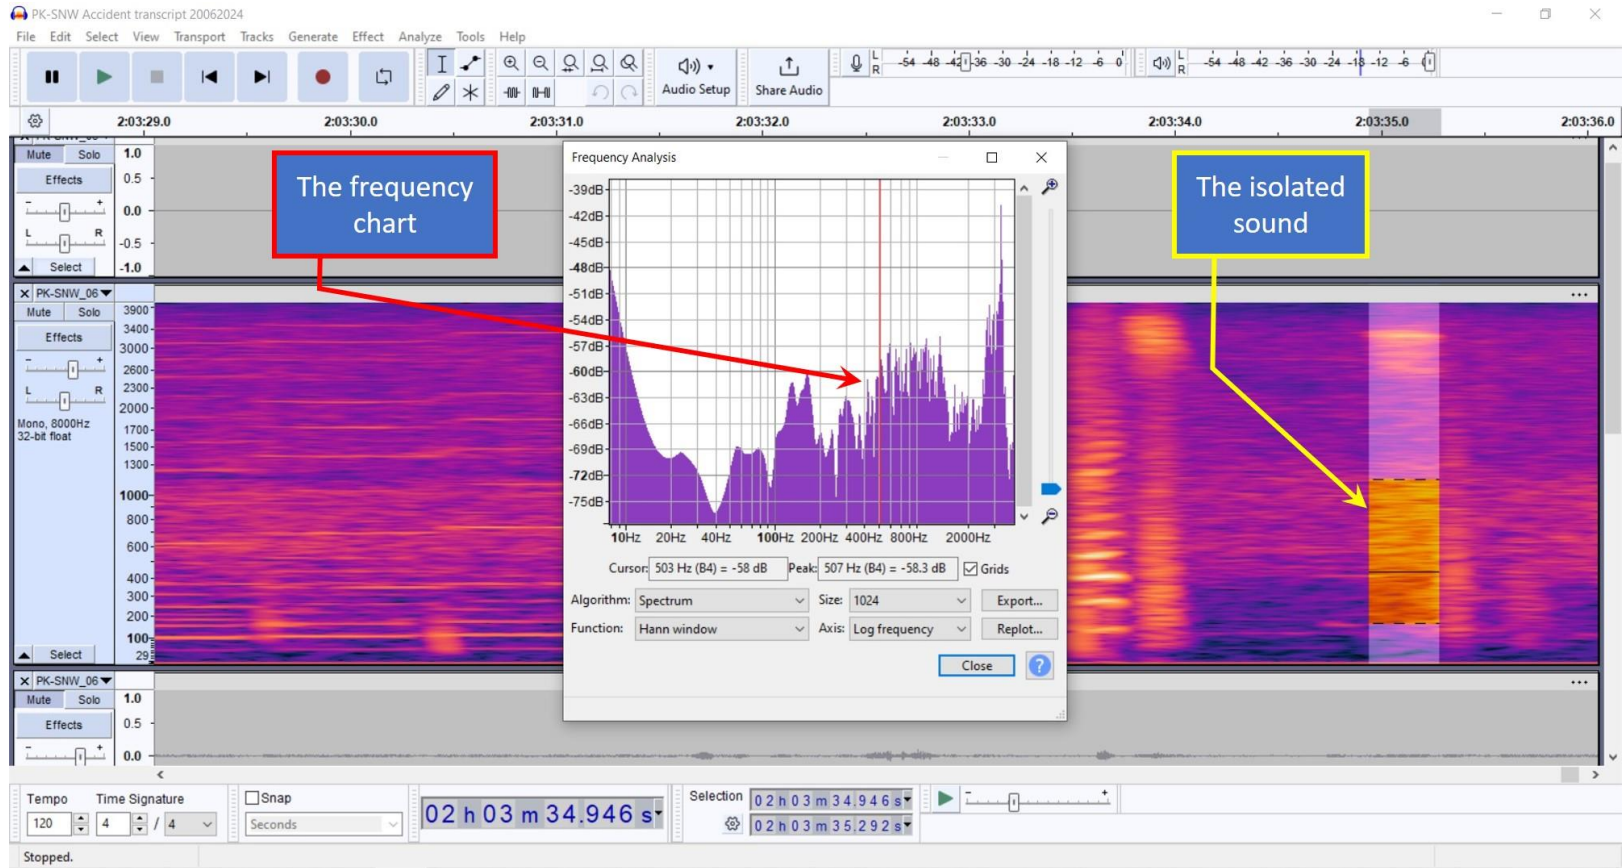
Figure 11: The isolation of Stall Warning aural waveform at 04:06:54 UTC

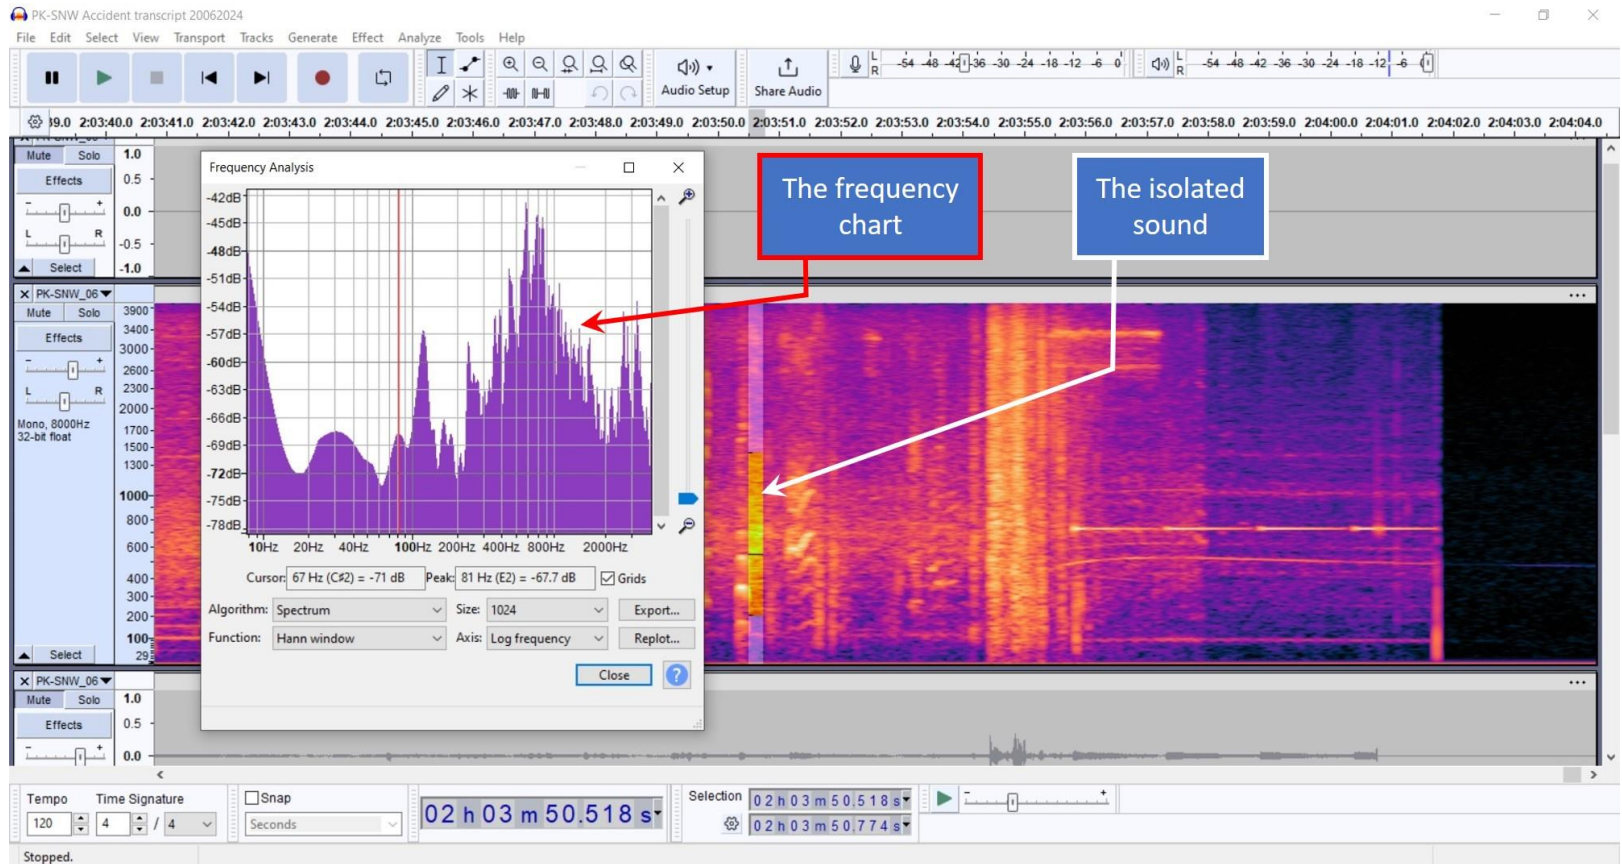
Figure 12: The isolation of Stall Warning aural waveform at 04:07:12 UTC
