**KOMITE NASIONAL KESELAMATAN TRANSPORTASI
REPUBLIC OF INDONESIA**

Aircraft Accident Investigation Report

Cessna Caravan 208B EX; PK-SNW

Runway of Sinak Airport, Papua

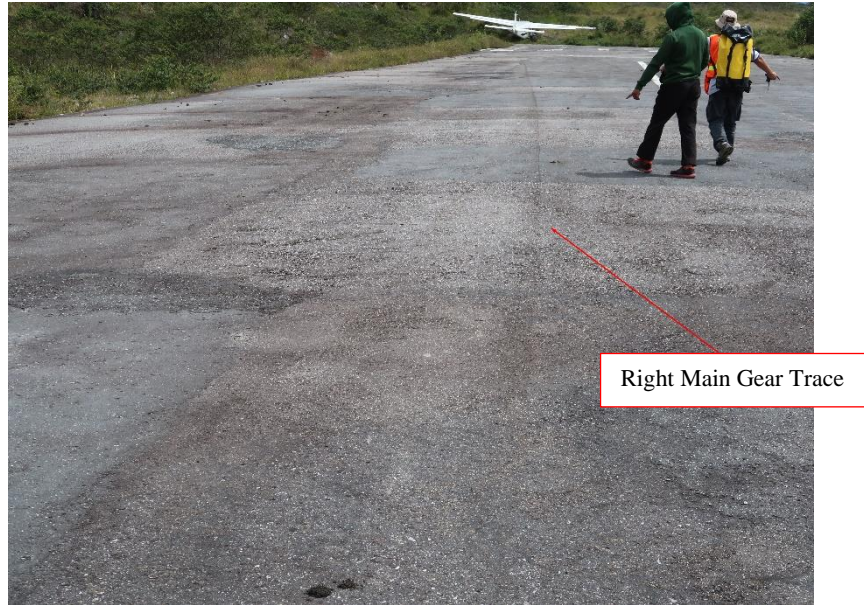
Figure 2 : PK-SNW path on the runway

The mark of the aircraft touchdown on the runway was not clearly visible. The marks of the tire path leading to the end of the runway showed deviating to the left from the runway centerline towards the last position of the aircraft was visible.

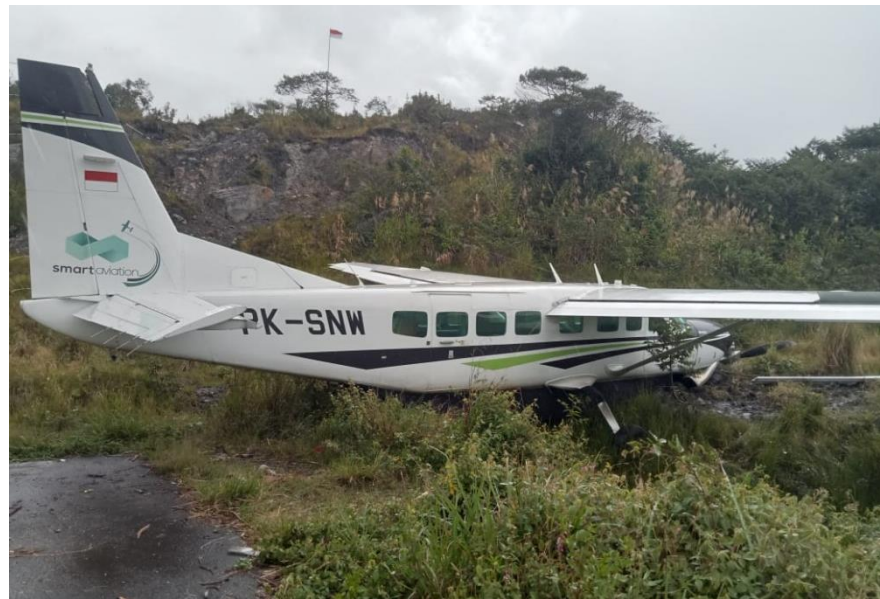
Figure 3 The aircraft condition after stopped

The aircraft stop on a ditch passed the runway end.

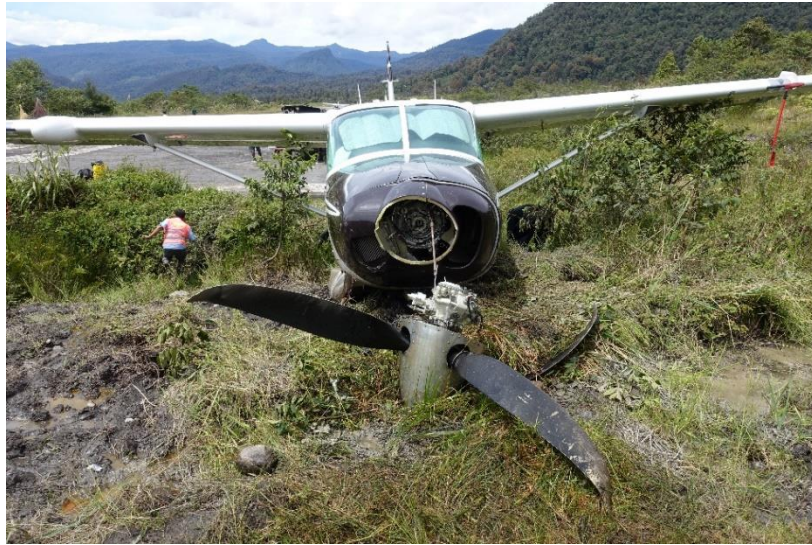
Figure 4 The damaged of the propeller and the blades

- a. Propeller and the gearbox was damaged and detached from the engine.

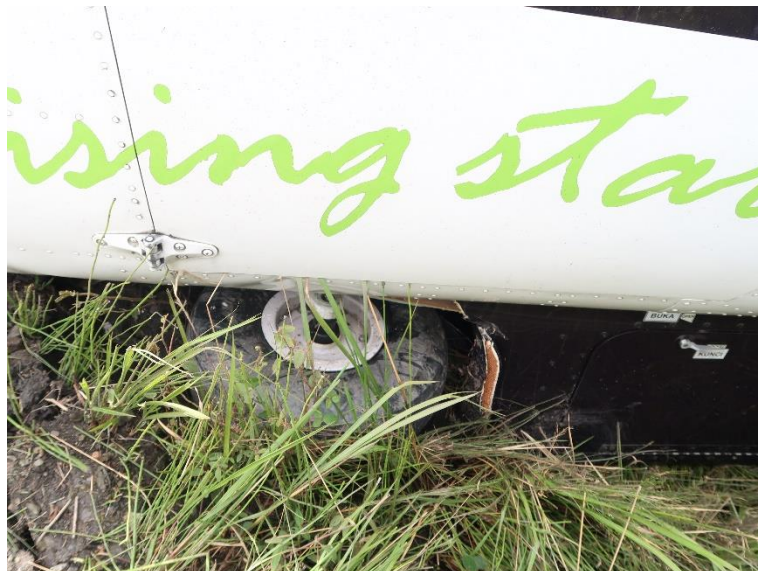
Figure 5 The damaged of the nose landing gear

- b. Nose landing gear was detached and collapse underneath the fuselage.
