**KOMITE NASIONAL KESELAMATAN TRANSPORTASI  
REPUBLIC OF INDONESIA**

**Aircraft Accident Investigation Report**

**Cessna Caravan 208 B; PK-RVA**

**25 October 2022**

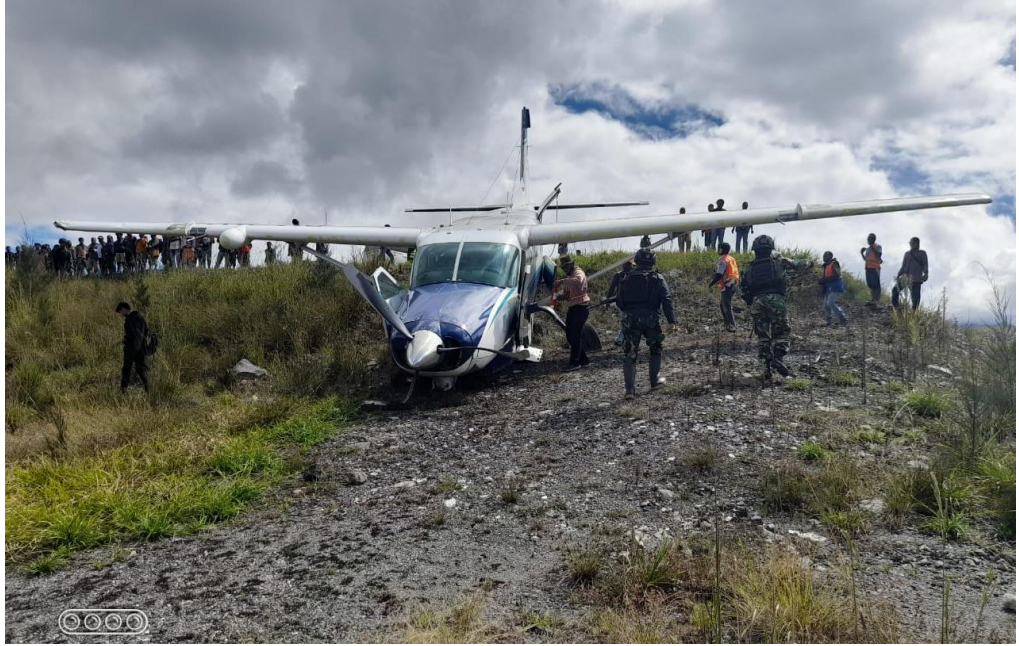
**Figure 1: Damage to the aircraft propeller**

1. The propeller blades were bent.
2. The left landing gear strut bent upward and the left main wheel tire deflated.
3. The right wingtip dented and wrinkled skin on the right-wing root.
4. The nose landing gear strut was broken, and the nose wheel was detached.

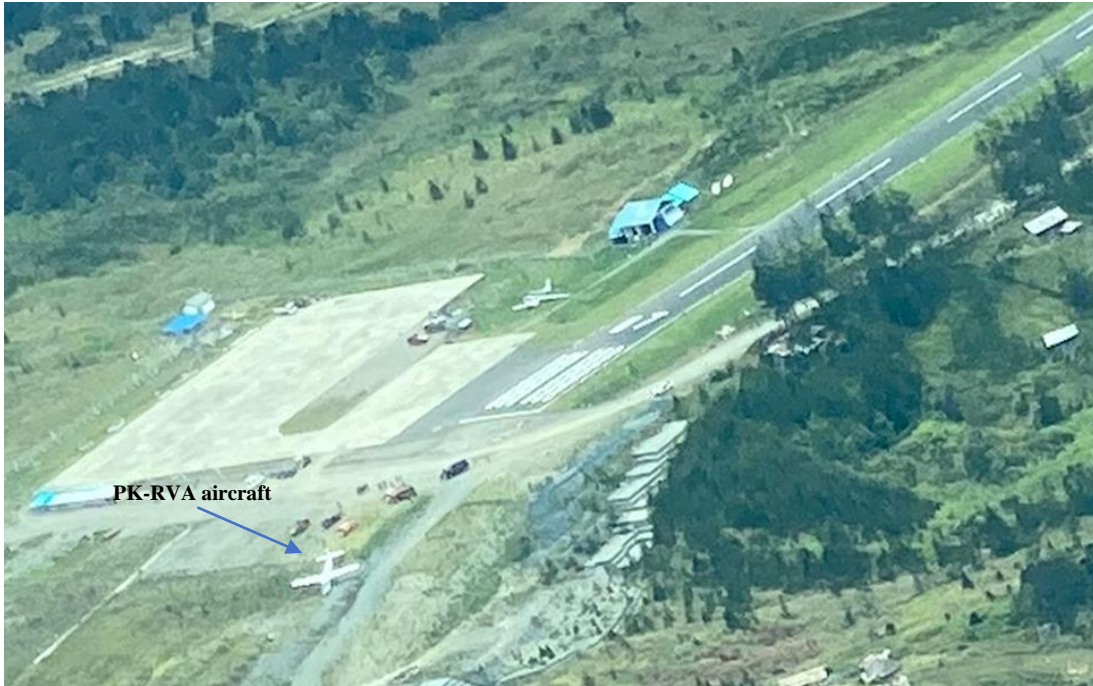
**Figure 11: The last aircraft position relative to the runway**

There was no marking found on the runway from the time the aircraft touched down until it exited the runway. The last position of the aircraft was about 77 meters beyond the runway.

The detached nose wheel was found on the right side of the aircraft, not far from its last position.

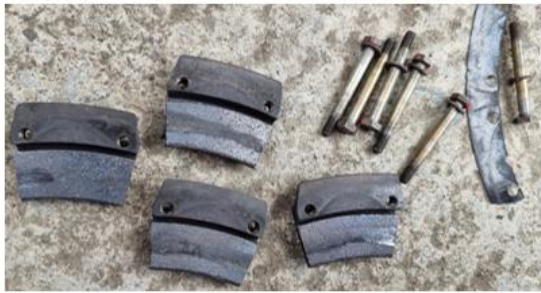
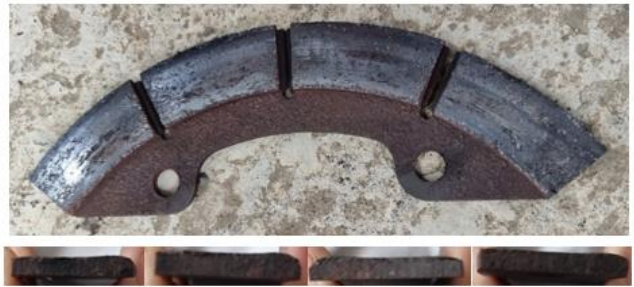
**Figure 12: Brake lining backplate and pressure plate condition**

An examination was conducted on the right brake, which had exhibited performance issues. The investigation included measurements of the brake lining using a vernier caliper. The brake lining on the back plate had recently been replaced; therefore, its condition and thickness were essentially like new and well within the specified limits. Additionally, the brake lining on the pressure plate was measured and found to be within the acceptable limit, with a thickness exceeding the minimum requirement of 0.1 inch (2.5 mm).

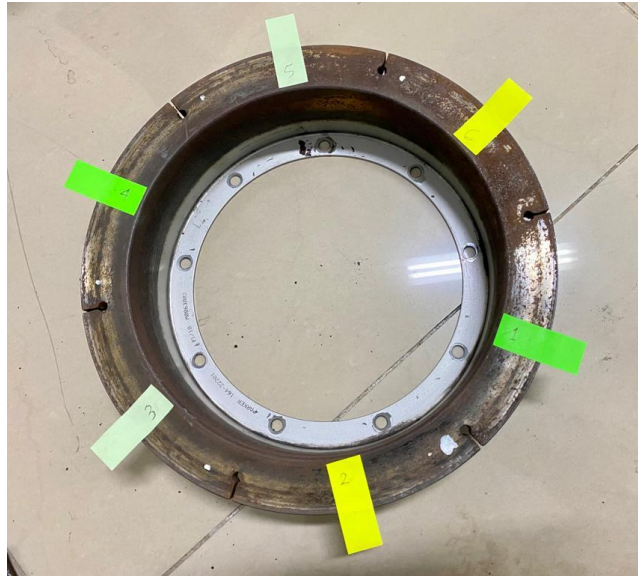
**Figure 14: Positions of the measurements that were taken (dimension A-A)**

Examinations of the brake disc after the occurrence revealed that the average thickness was below the minimum limitation. The operator was required to check the brake disc thickness periodically during scheduled detailed inspection of the brakes every 50 hours. The procedure stated that the brake disc should be replaced if the thickness is found to be below the minimum requirement. However, the investigation could not find records of the last 50-hour detailed inspection of the brake system maintained by the operator.
