**KOMITE NASIONAL KESELAMATAN TRANSPORTASI  
REPUBLIC OF INDONESIA**

**KNKT 22.10.15.04**

**Aircraft Accident Investigation Report**

**PT Reven Global Airtranspor  
Cessna Caravan 208 B; PK-RVA**

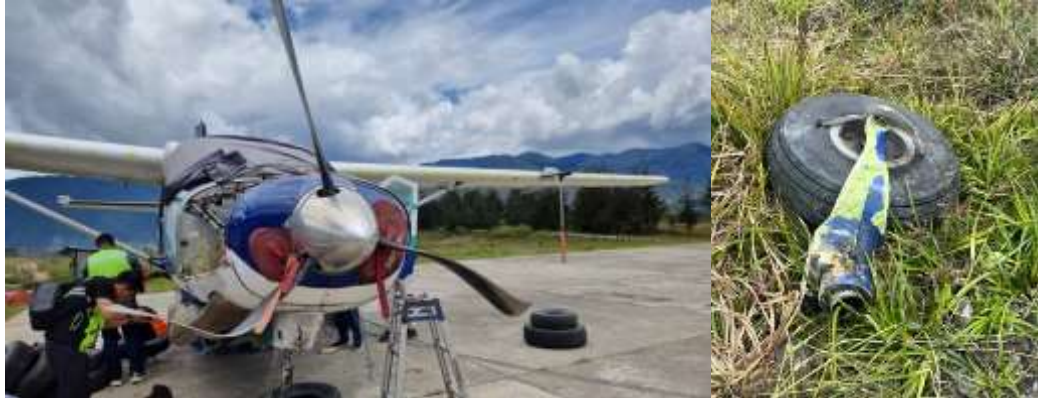
The aircraft was substantially damaged. The propeller blades number 2 and 3 were bent. The left landing gear strut bent and the tire deflated. The right wingtip was dent. The nose wheel strut broken and the nose wheel detached.

**Figure 1.1 Damage to the Aircraft propeller and nose wheel strut detached**

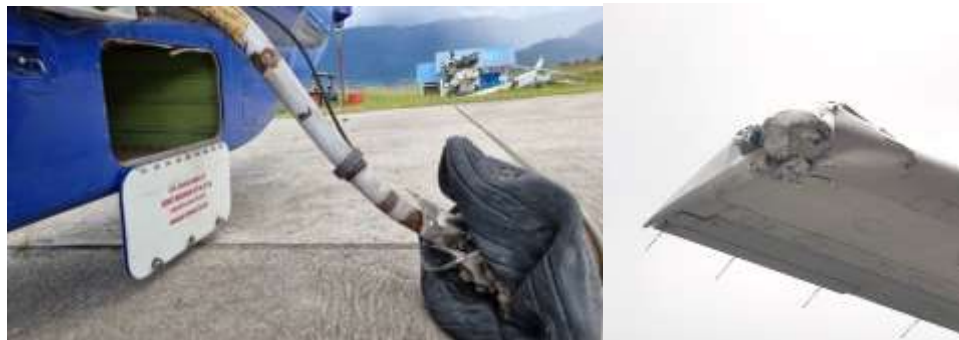
**Figure 1.2 Damage to the left gear and right wingtip**

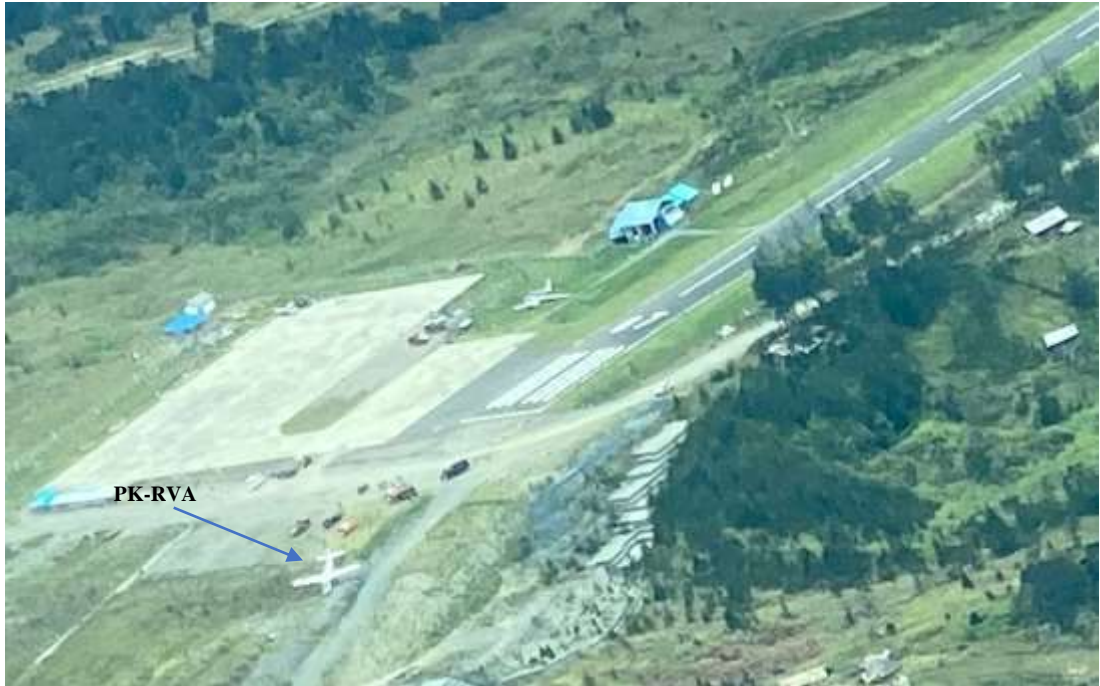
The tyre mark of the aircraft during touch down and landing roll on the runway was not clearly visible. The last position of the aircraft is shown in the figure below.

**Figure 1.4 Aerial view of the PK-RVA at the accident site**
