**KOMITE NASIONAL KESELAMATAN TRANSPORTASI  
REPUBLIC OF INDONESIA**

**KNKT.22.11.16.04**

**Aircraft Serious Incident Investigation Report**

**Douglas DC-3C; C-FTGX**

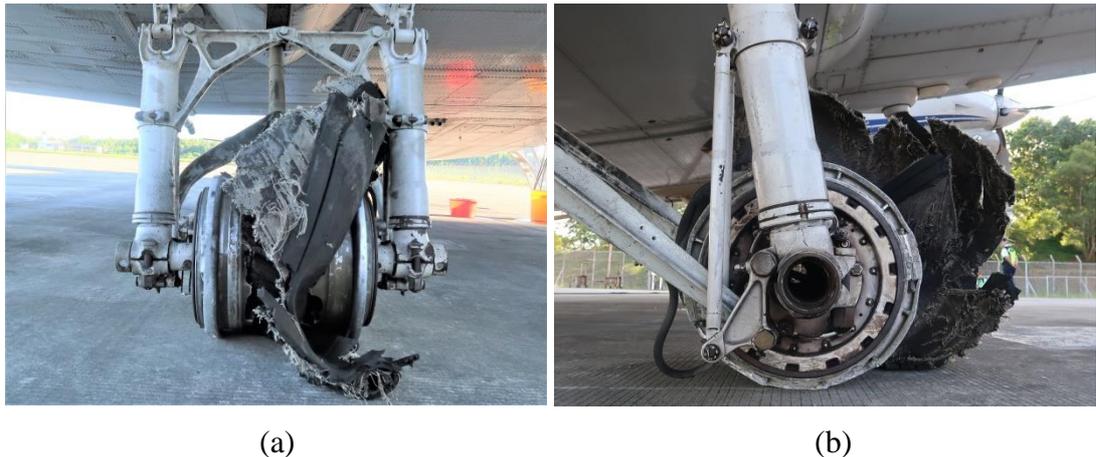
**Figure 1: Damage to aircraft right landing gear**

The aircraft's right landing gear was damaged due to a blown tire as shown in Figure 1. The tire was torn apart, the bead seat area of the wheel rim was broken into pieces (a), and the wheel flange was worn out (b) due to friction during taxi.

19. The aircraft touched down at Runway 07. Right after touched down, the tire burst and the right wing rose up.
20. The pilot confirmed that the right tire was torn apart, and the wheel rim was broken through the side mirrors.

24. The wheel flange was worn out due to friction during taxi.
25. There was no evidence of in-flight or post-impact fire.
26. There were no injuries to persons as a result of this occurrence.

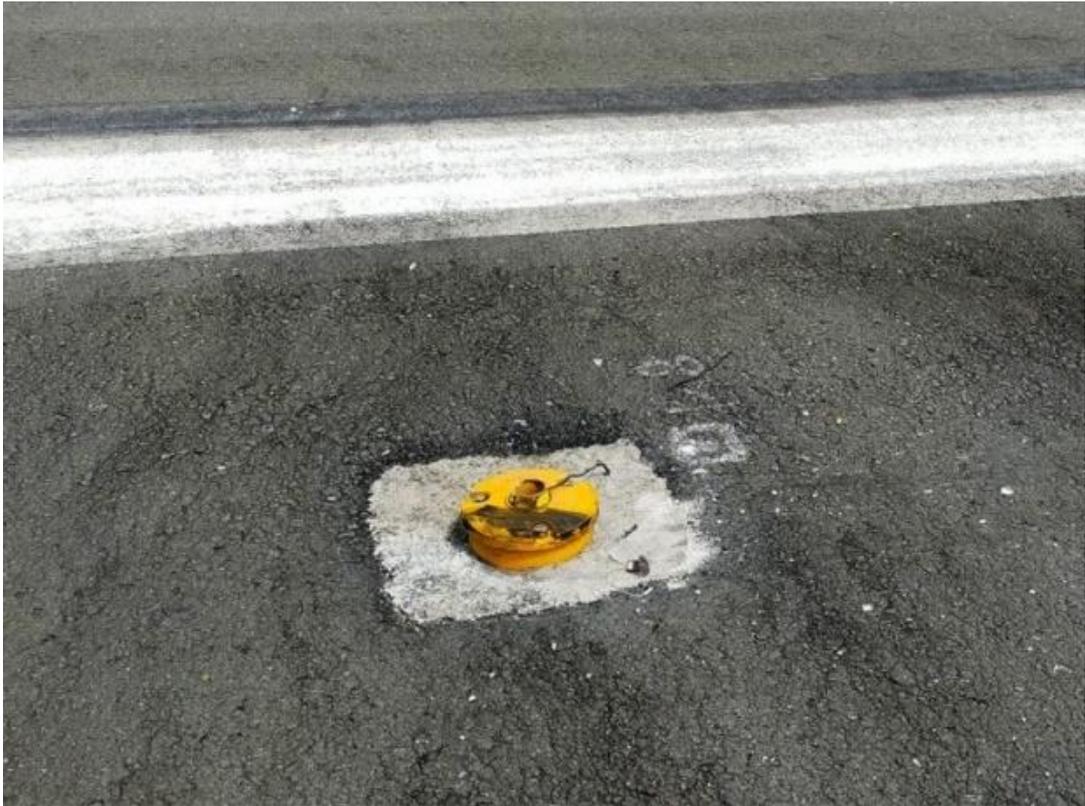
**Figure 2: Damage to runway edge light**

A runway edge light was damaged as shown in Figure 2. The light was impacted with the right wheel while the aircraft veered off to the right ran through the runway side strip. There were scratches on the runway, taxiway, and apron, as illustrated in Figure 3 since the aircraft continued taxi to the parking stand with the damaged right wheel.

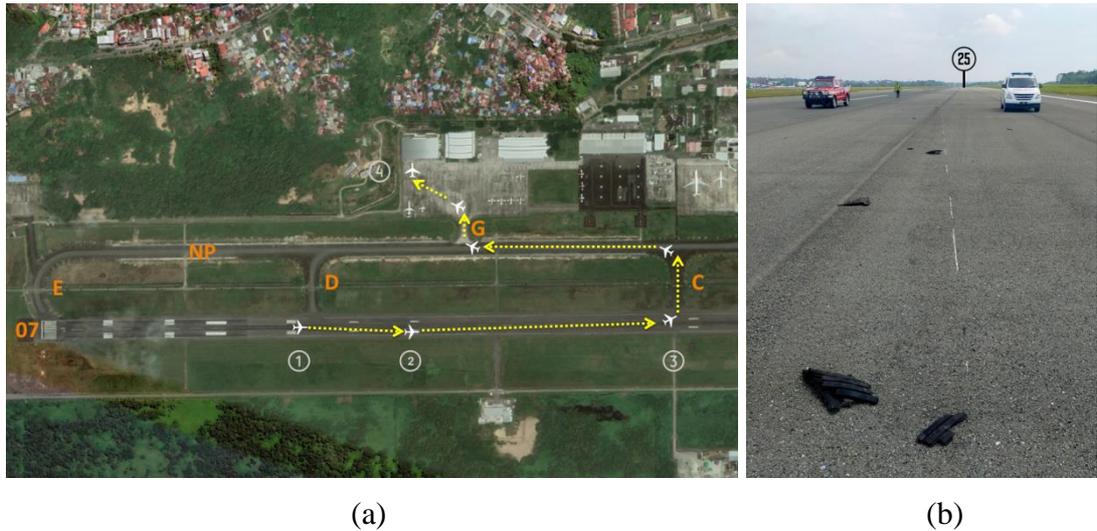
**Figure 5: Aircraft trip and wreckage trail illustration**

Based on the evidences on the runway, the aircraft trip and wreckage distribution was illustrated by Figure 5 (a) and described as follows:

1. The aircraft touched down mark was found on the runway before the taxiway D (Point-1) located about 680 meters from the beginning of Runway 07.
2. The aircraft veered off to the right, and the right wheel hit a runway light at Point-2 located approximately 240 m from taxiway D intersection.
3. Fragments of the rims and tires were found approximately 900 meters along the runway between Point-1 and Point-3 in accordance with the aircraft direction.
4. The aircraft continued taxi to the apron through taxiway C-NP-G and parked on parking stand number 41 illustrated as Point-4.
