Aircraft Serious Incident Investigation Report

Robinson R66; PK-VPJ

Ungasan, Bali

1 December 2022

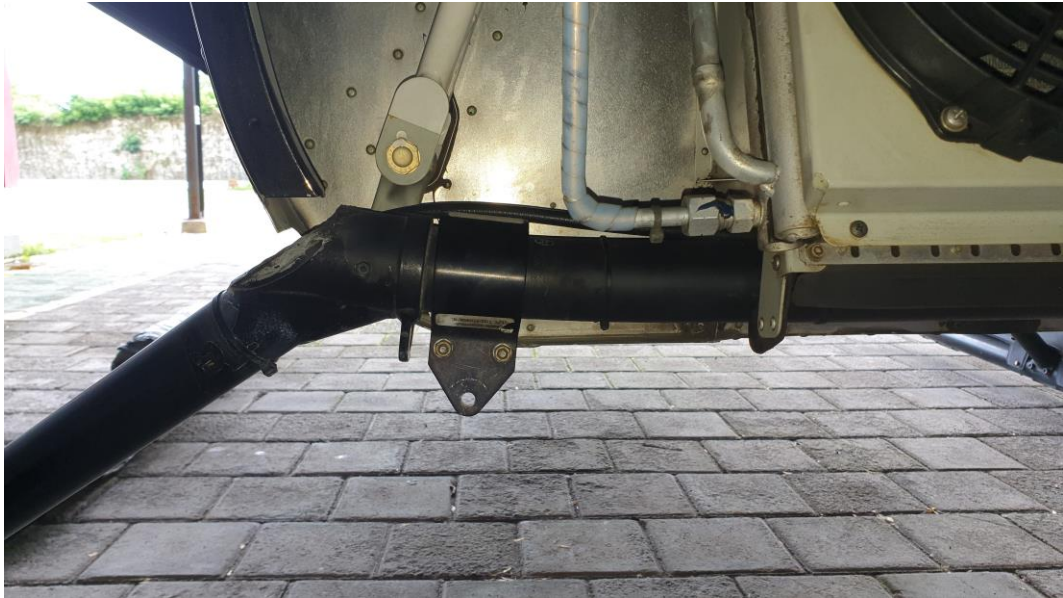
The aircraft was minor damaged. The aft cross tube skid was found yielding beyond limitation. The distance from tail skid to ground was found 36 inch where the minimum was 38 inch.

Figure 1. Damage of the aft cross tube skid.
