Aircraft Accident Investigation Report

PT Carpediem Aviasi Mandiri

Bell 206 B3; PK-CDO

Mining 1, Kawe, Papua

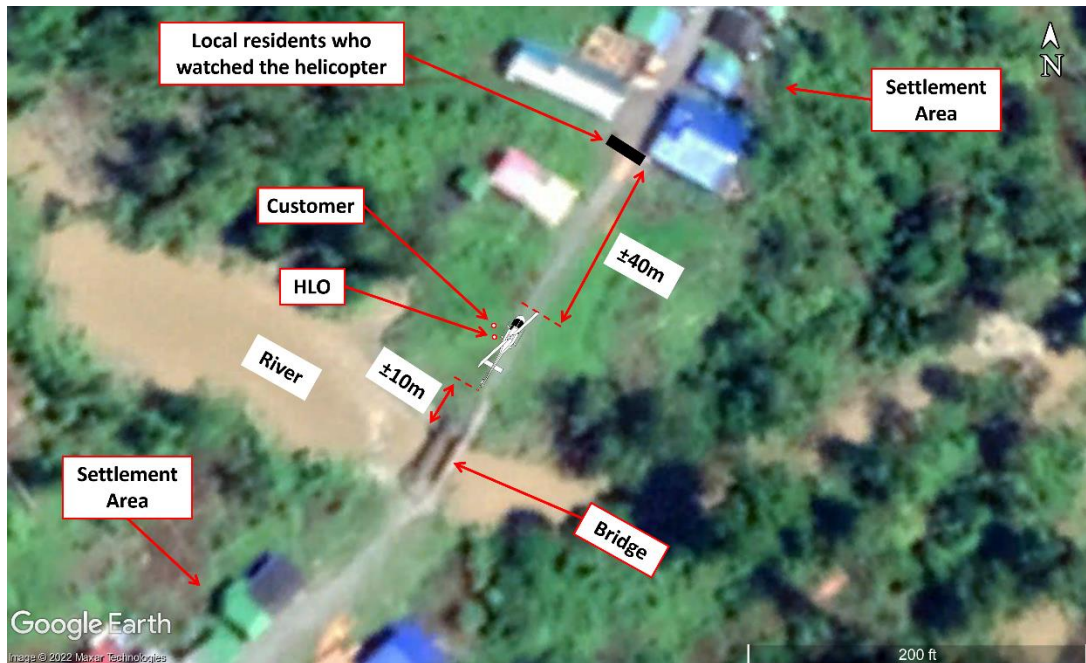
Figure 1: The illustration of the accident site (annotated by KNKT)

After the helicopter had landed properly, the HLO disembarked from the helicopter and saw the customer who went to the left side of the helicopter. The HLO observed that there were no people near the helicopter that might endanger the unloading process and advised the customer to stand on his left side while the HLO unloaded the cargo (see figure 1).

When unloading the cargo, the HLO heard a loud sound from the rear section of the helicopter. The HLO looked to the source of the sound and saw a person has laying on the ground. About the same time, the HLO noticed that the customer ran away from the helicopter followed by several residents who were standing in front of the helicopter. The HLO thought that a dangerous security situation was unfolding as several people ran away from the helicopter. Thereafter, the HLO went to the helicopter and advised the pilot to take off immediately. The pilot, who was also aware of this assumed security issue, decided to take off momentarily.

The M1 landing spot was an unprepared helipad on coordinate 5° 0'29.26" S 140°9'5.70" E which located near mining area. The landing spot situated at unpaved road which connected houses in the settlement area (see figure 1).

The landing spot at Mining 1 (M1) was unpaved road which connected houses in the settlement area at M1 which potentially generates people movement from behind and front of the helicopter. The people's movement behind the helicopter was considered a hazard as the movement was outside pilot's sight. In addition, there was no ground company personnel available at M1 except the HLO on board the helicopter to ensure all people movement were within pilot's sight. Based on those conditions, the determined mitigation action for helicopter operation in Papua area was not sufficient to mitigate the hazard at M1. In addition, the determined mitigation actions were not transposed into detailed procedures nor guidance for pilot and/or HLO. The absence of detailed procedures nor guidance to implement the mitigation action made the hazard of people movement during helicopter operation at M1 landing spot not mitigated properly, increasing the risk of people being seriously injured.

Therefore, KNKT recommends the Carpediem Air to review the method for ensuring that the people movement could be controlled properly.

Responding to the safety recommendation, the aircraft operator issued operational memo addressed to all helicopter pilot which requires pilot to analyze and supervise the safety and security of the people and cargo movement from and or to, within the helicopter dangers area. If there were no sufficient company personnel available during ground handling activities while helicopter engine is running, the pilot is required to ask the available personnel such as site leader person to act as watchers in the danger zone that is invisible by pilot (i.e., tail rotor or rearward area), and any area as necessary.

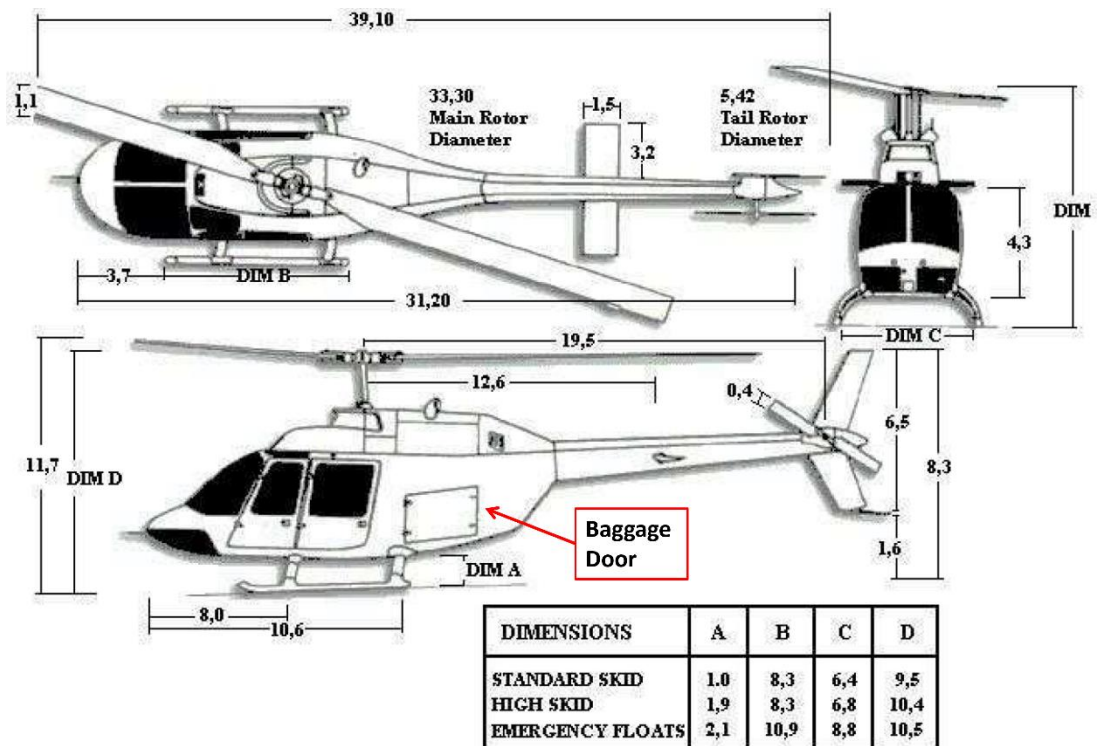
Figure 2: Helicopter dimensions and baggage door location (annotated by KNKT)

During the takeoff, the pilot noticed that the BAGGAGE DOOR caution light was illuminated as the HLO had not closed the baggage door. The HLO informed the pilot that he saw a person laying on the ground and was concerned about their security. The pilot then decided to return to Iwot Helipad as there was no other abnormal indication of the helicopter system.

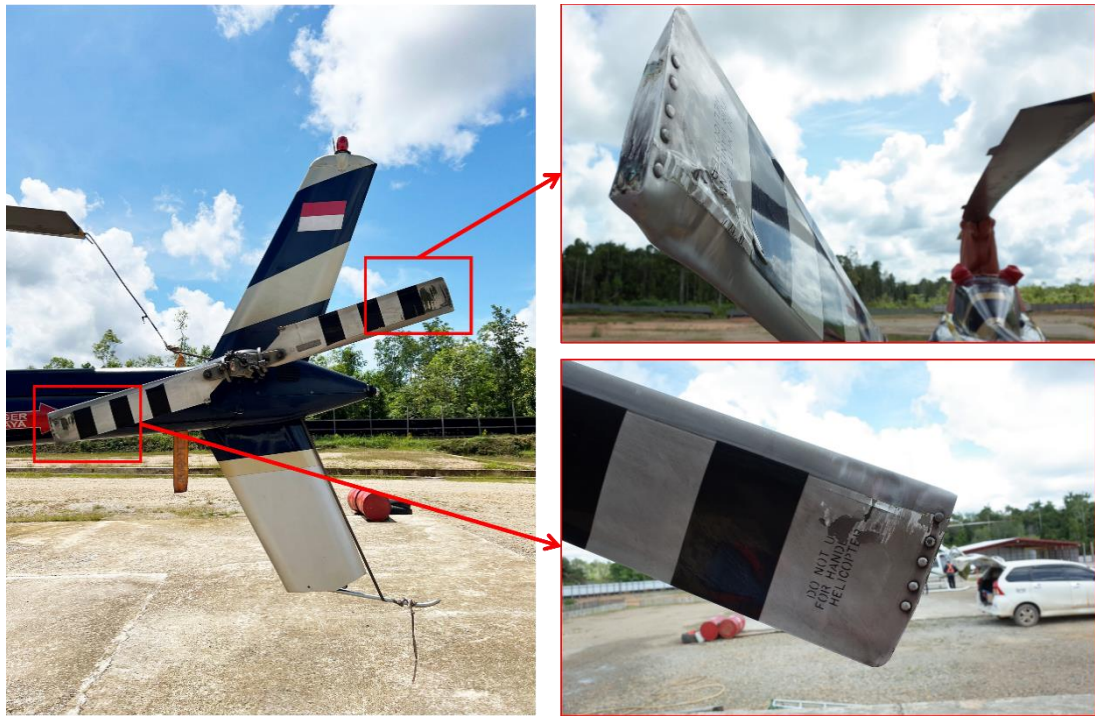
Figure 3: The dent on the tail rotor blades

Both tail rotor blades were dented as shown in the figures below:

The visual inspection after the accident identified that the tail rotor driveshaft and flexible coupling discs were normal. The inspection also did not find any debris on the magnetic chip detector.

16. Both tail rotor blades were damaged. The visual inspection after the accident identified that the tail rotor driveshaft and flexible coupling discs were normal. The inspection also did not find any debris on the magnetic chip detector.
