**KOMITE NASIONAL KESELAMATAN TRANSPORTASI
REPUBLIC OF INDONESIA**

Aircraft Accident Investigation Report

Bell 206 B3; PK-CDO

Mining 1, Kawe, Papua

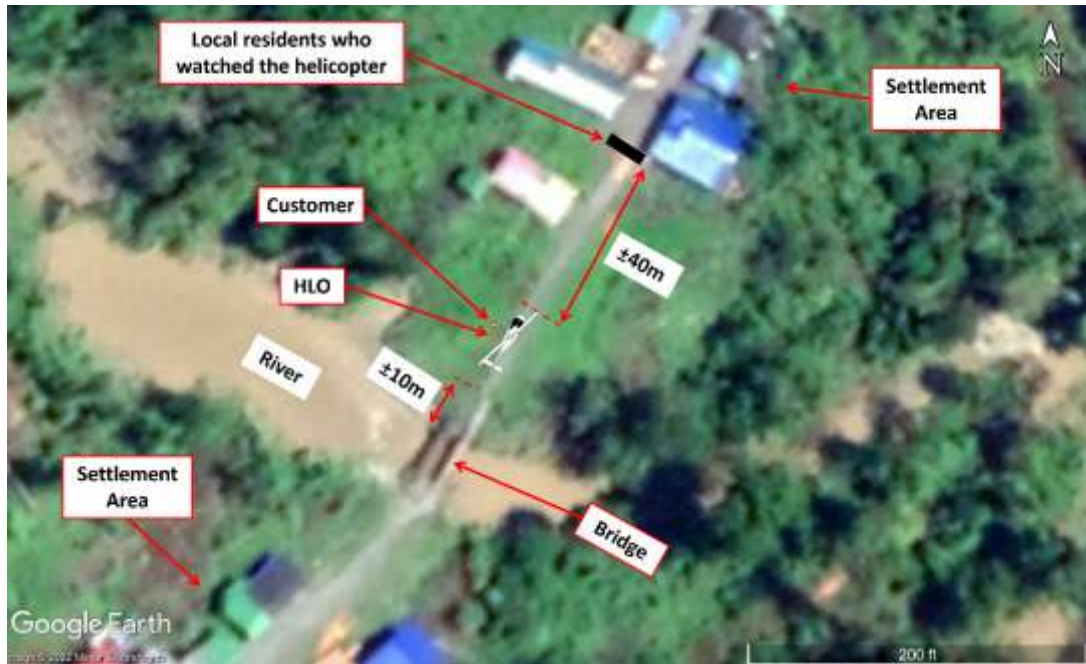
Figure 1: The illustration of the accident site (annotated by KNKT)

The HLO observed that there were no people near the helicopter except the customer who went to the left side of the helicopter to meet the HLO. The HLO then advised the customer to stand on his left side while the HLO unloaded the cargo (see figure 1). The pilot who waited inside the aircraft observed several local residents stood about 40 meters in front of the helicopter, watching the unloading process.

When unloaded the cargo, the HLO heard a loud sound came from the rear section of the helicopter. The HLO looked to the source of the sound and saw a person has laid on the ground. About the same time, the HLO noticed that the customer ran away from the helicopter followed by several people who stood in front of the helicopter. The HLO thought that a danger situation was happening as several people ran away from the helicopter. Thereafter, the HLO went to the helicopter and advised the pilot to take off immediately. The pilot who also aware of several people ran away from the helicopter decided to take off as he assumed that there was security issue.

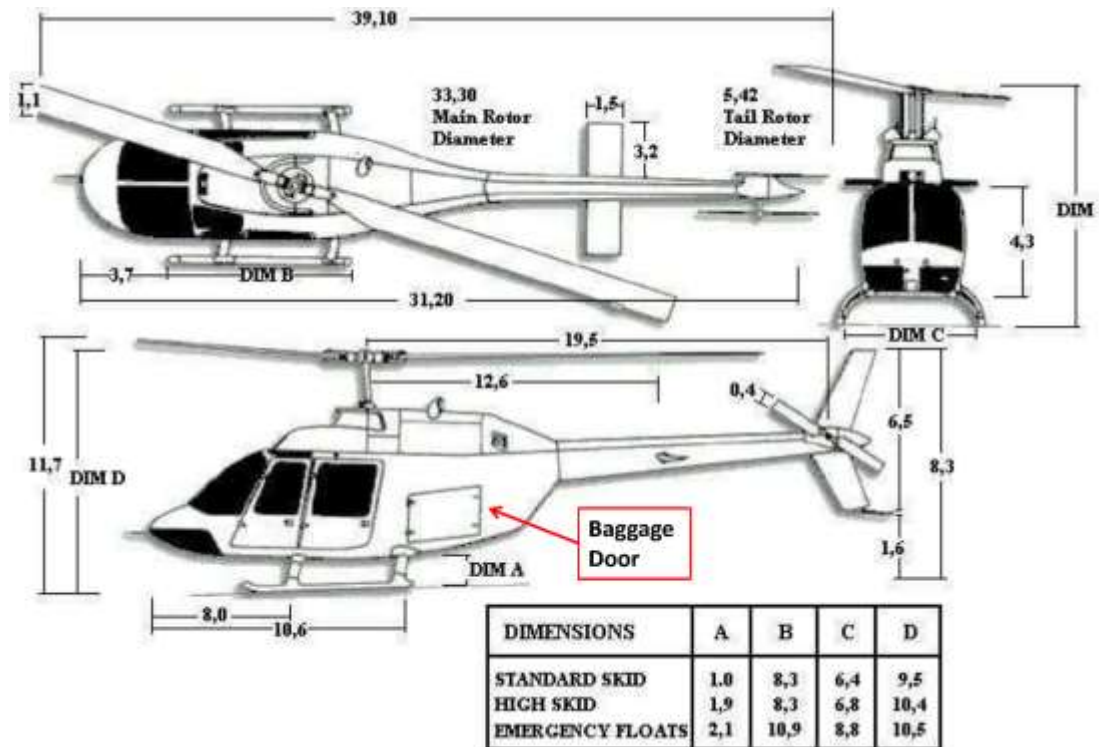
Figure 2: Helicopter dimension and baggage door location (annotate by KNKT)

During the takeoff, the pilot noticed that the BAGGAGE DOOR caution light illuminated as the HLO has not closed the baggage door. Afterward, the HLO advised the pilot that he saw a person laid on the ground and concerned about their security. The pilot then decided to return to Iwot Helipad as there was no other abnormal indication of the helicopter system.

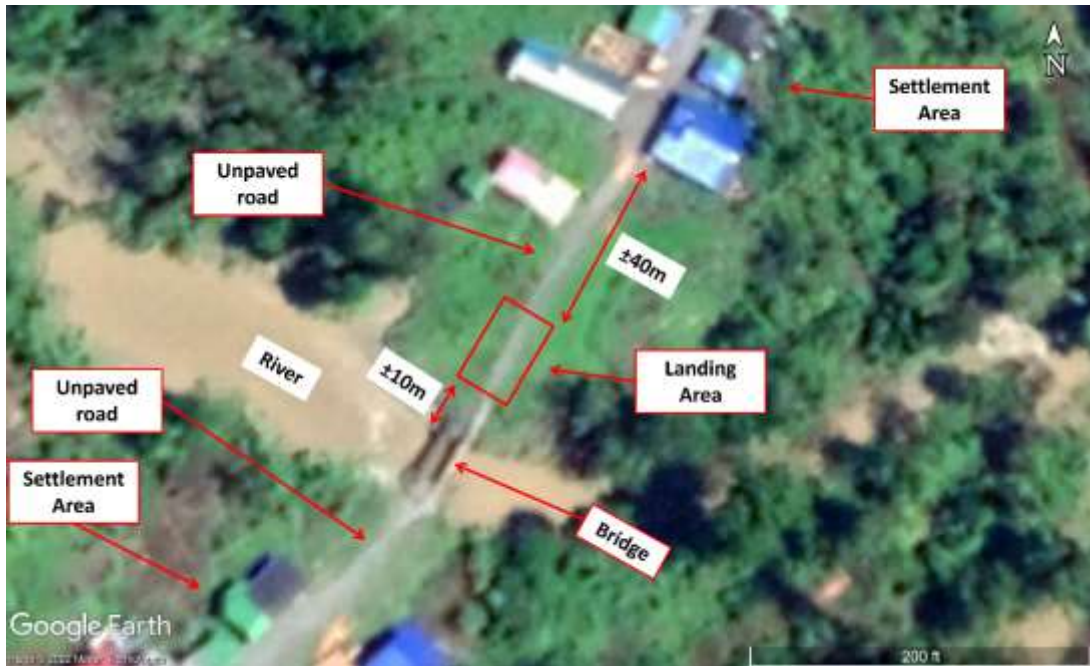
Figure 3: Mining 1 landing spot

The landing spot at Mining 1 (M1) was unprepared heliport which located near mining area on coordinate 5° 0'29.26"S 140° 9'5.70"E. The landing spot situated at unpaved road which connected houses in the settlement area.

The landing spot at Mining 1 was unpaved road which connected houses in the settlement area at M1 which potentially generates people movement from behind and front of the helicopter. The people movement behind the helicopter is considered hazard as the movement was outside pilot's sight. In addition, there was no ground personnel available at M1 except the HLO on board the helicopter to ensure all people movement were within pilot's sight. Based on those conditions, the mitigations for the identified hazard for helicopter operation in Papua area was not sufficient to mitigate the hazard at M1.

Therefore, KNKT recommends the Carpediem Air to conduct hazard identification and risk assessment (HIRA) for specific route of flight operation for ensuring the hazard can be identified and mitigated properly.

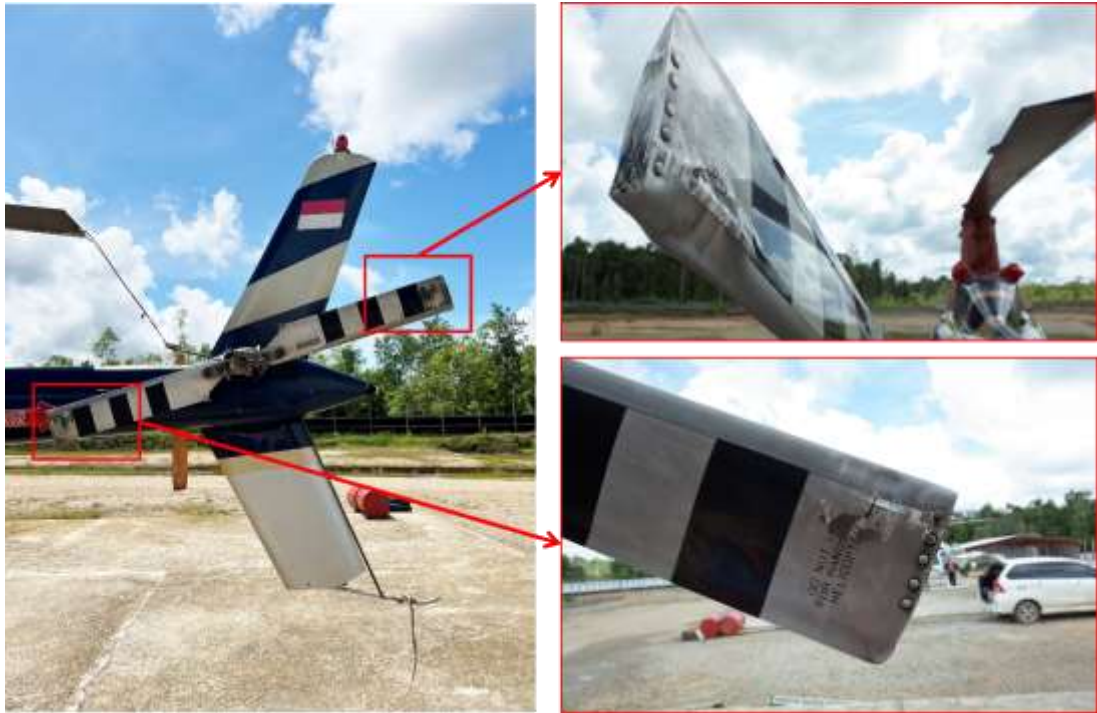
Figure 4: The tail rotor blades damaged

The helicopter was substantially damaged. The damaged of the helicopter limited on the tail rotor blades.

Both tail rotor blades were damaged, and the damages were as follows:

The visual inspection after the accident identified that the tail rotor driveshaft and flexible coupling discs were normal. The inspection also did not find any debris on the magnetic chip detector.
