**KOMITE NASIONAL KESELAMATAN TRANSPORTASI
REPUBLIC OF INDONESIA**

Aircraft Accident Investigation Report

DHC-6-300 Twin Otter; PK-OTY

Moanamani Airport, Papua

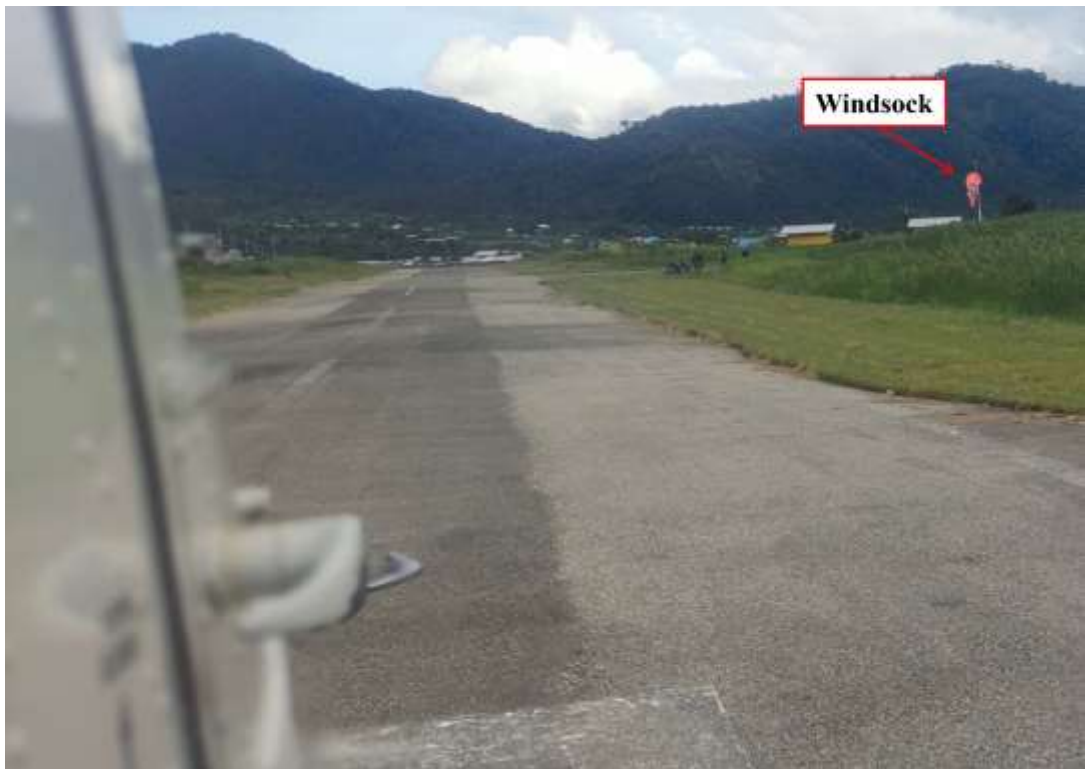
Figure 1: Photo taken by the engineer during aircraft touchdown (windsock annotation by KNKT)

The engineer who was on board the aircraft took several pictures during the approach until the aircraft landed. The weather and wind condition depicted the same information described by the air force personnel.

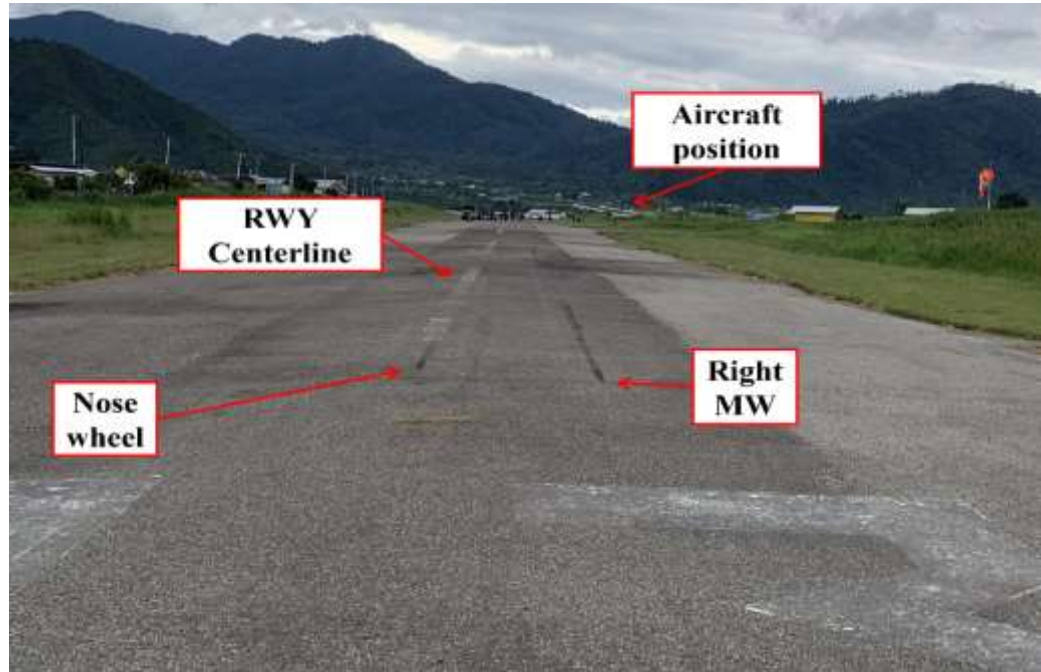
Figure 2: The touchdown marks on the runway

The first tire marks on the runway were found about 80 meters from the beginning of Runway 03, and they were identified from the nose and right main wheels. The nose wheel mark was found at the centerline of the runway. The right main wheels mark was found along 30 meters and then disappeared.

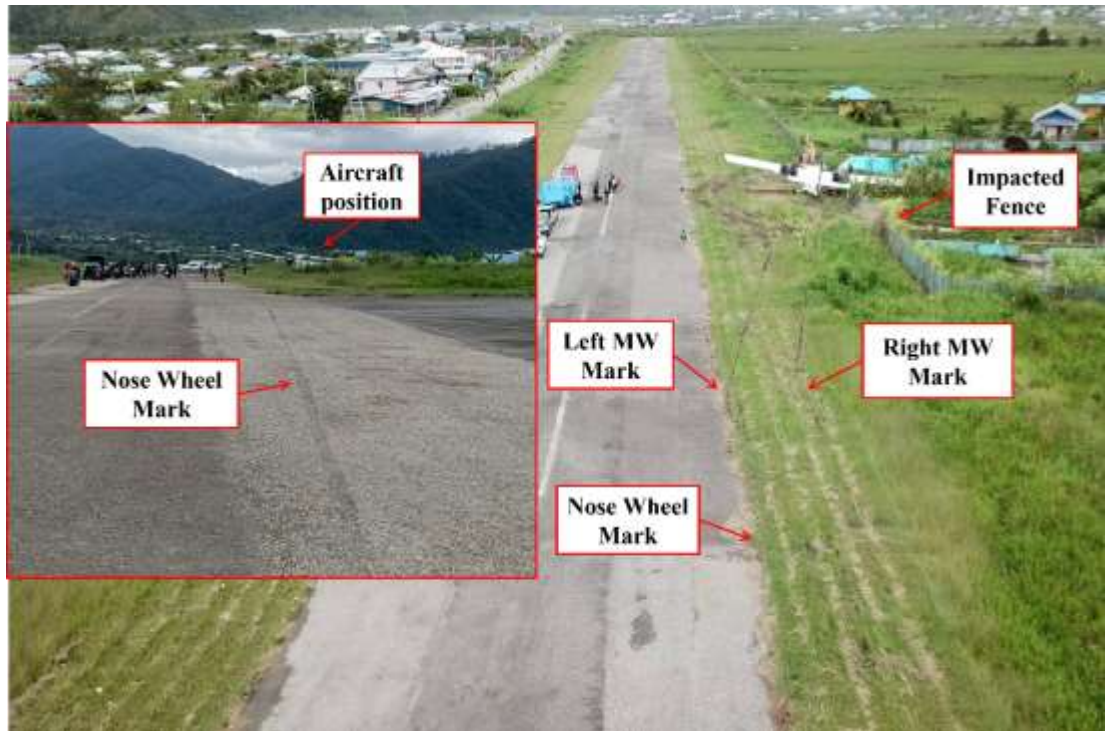
Figure 3: The accident site

About 380 meters from the beginning of Runway 03, the right wing impacted airport fence. The right nose wheel slipped into ditch, and the aircraft stopped about 400 meters from the beginning of Runway 03 on heading about 040°.

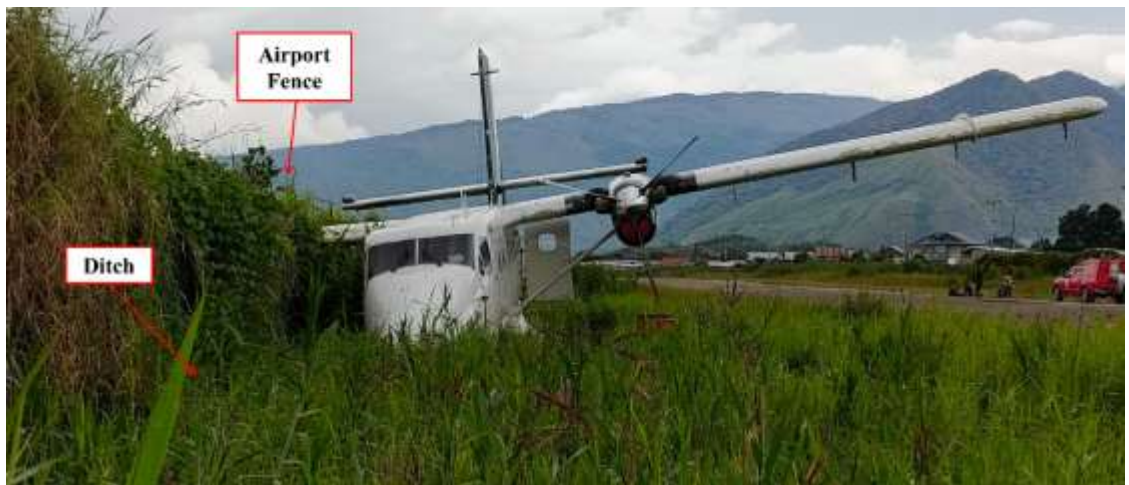
Figure 4: The aircraft condition after stopped

The visual examination of the aircraft indicated that the damage on the aircraft mostly on the right section of the aircraft. The details of the damage were as follows:

- Bottom section of the radome was broken.
- Nose cargo compartment skin was punctured.
- Nose wheel fork was broken, and the nose wheel detached. The detached nose wheel was found behind the left main wheel in front of the passenger door.
- Some of fuselage skin on the right section of the aircraft were punctured (between station 111 and 125, and on station 143).
- Blades of the right propeller were damaged.
- Right flaps were dent.
