**KOMITE NASIONAL KESELAMATAN TRANSPORTASI  
REPUBLIC OF INDONESIA**

**Aircraft Accident Investigation Report**

**PT Sinar Mas Super Air**

**Thrush S2R-T34; PK-PND**

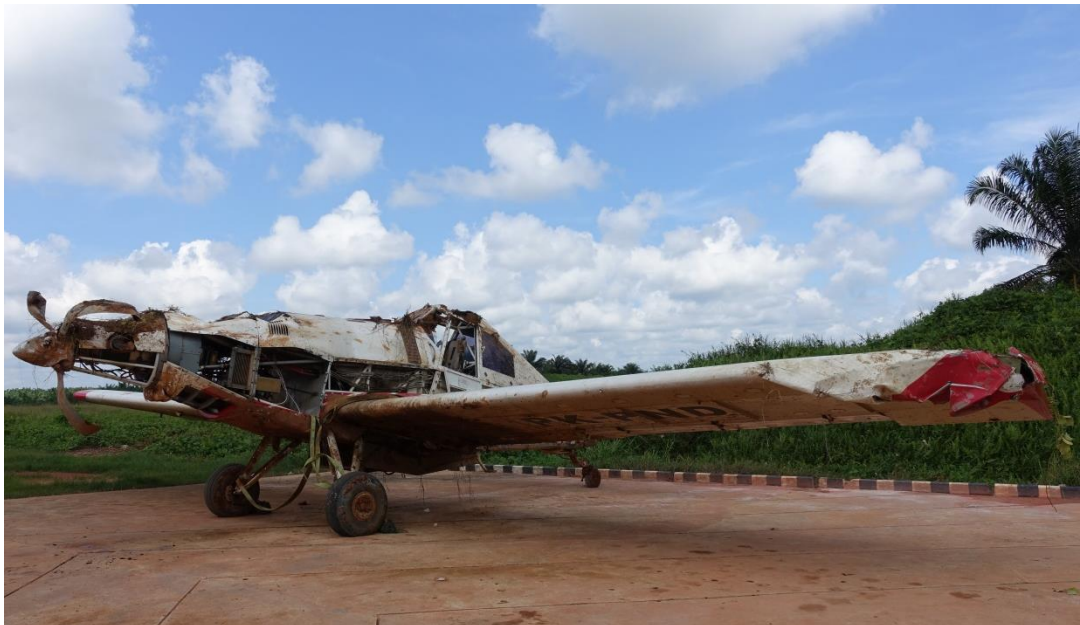
**Figure 1: Damage to the aircraft**

The left wing tip was dented and torn. The upper fuselage suffered major damaged. The cockpit canopy and front windshield were ruptured.

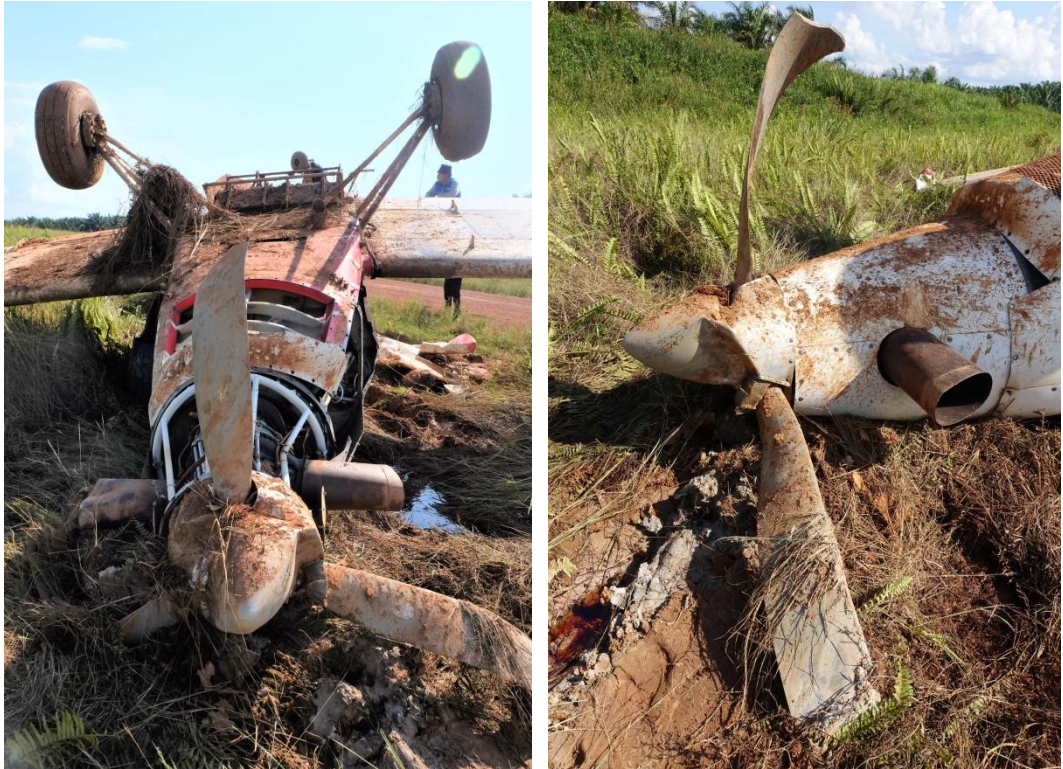
**Figure 2: Damage to the aircraft nose and propellers**

The aircraft nose and tubing structure to the engine attachment were bent to the right. The propellers were fractured and bent.

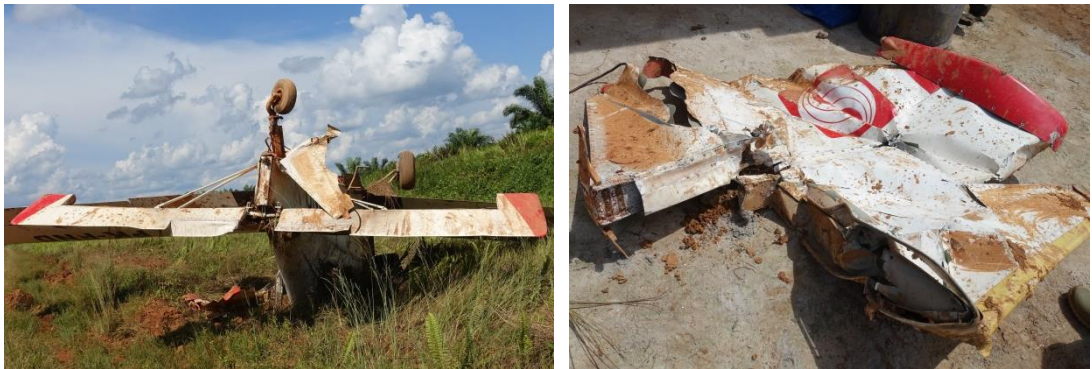
**Figure 3: Damage to the empennage**

The horizontal tail and elevators were crumpled. The vertical tail was detached from the fuselage and severely damaged.

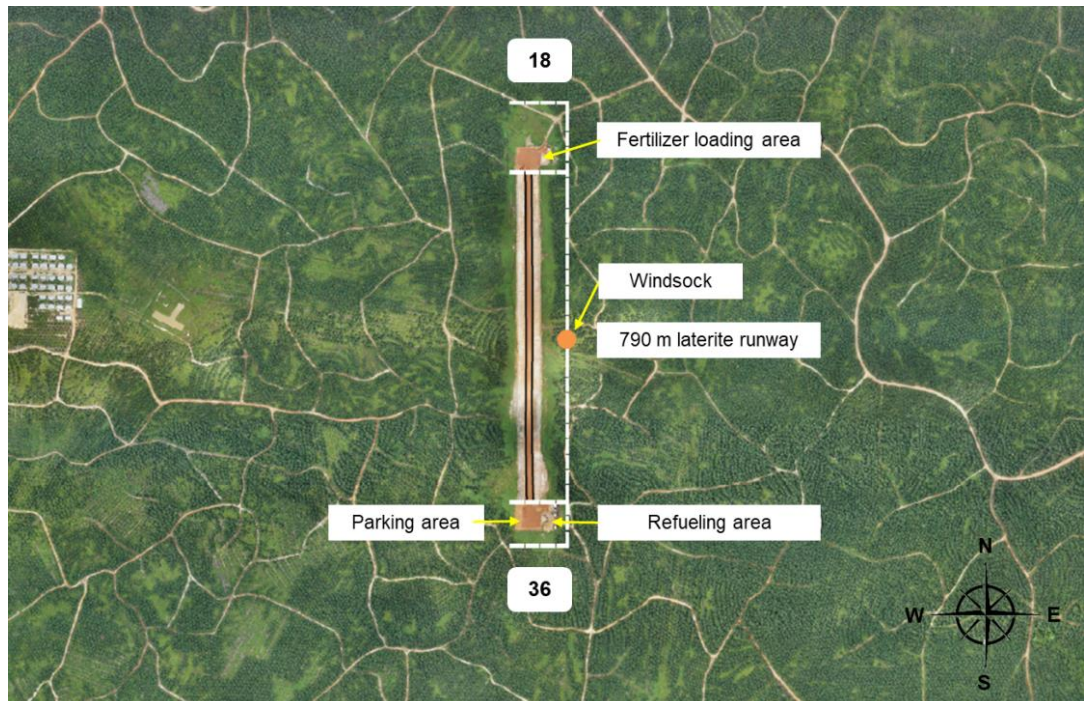
Figure 4: Kajui airstrip aerial photograph

The left and right side of the Runway 18 had different condition and color caused by constant and repetitive rolling in the left area near the runway shoulder after fertilizer loading.

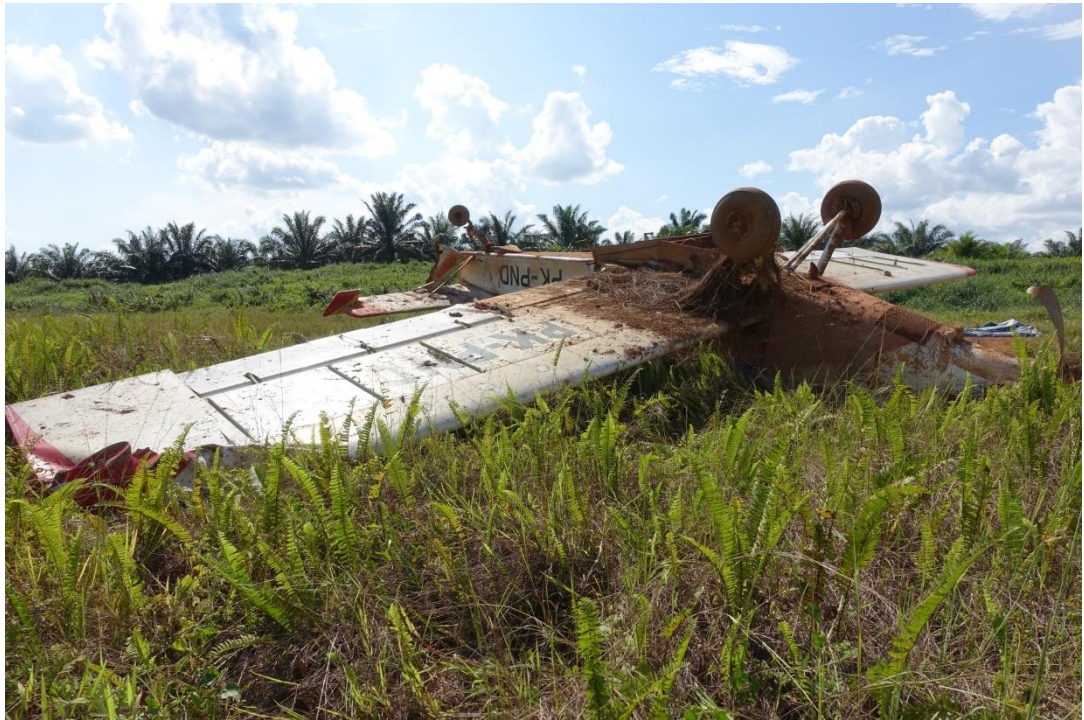
**Figure 5: The wreckage position**

The aircraft was stopped in upside down position at 620 meters from the initial point as shown by Figure 5.

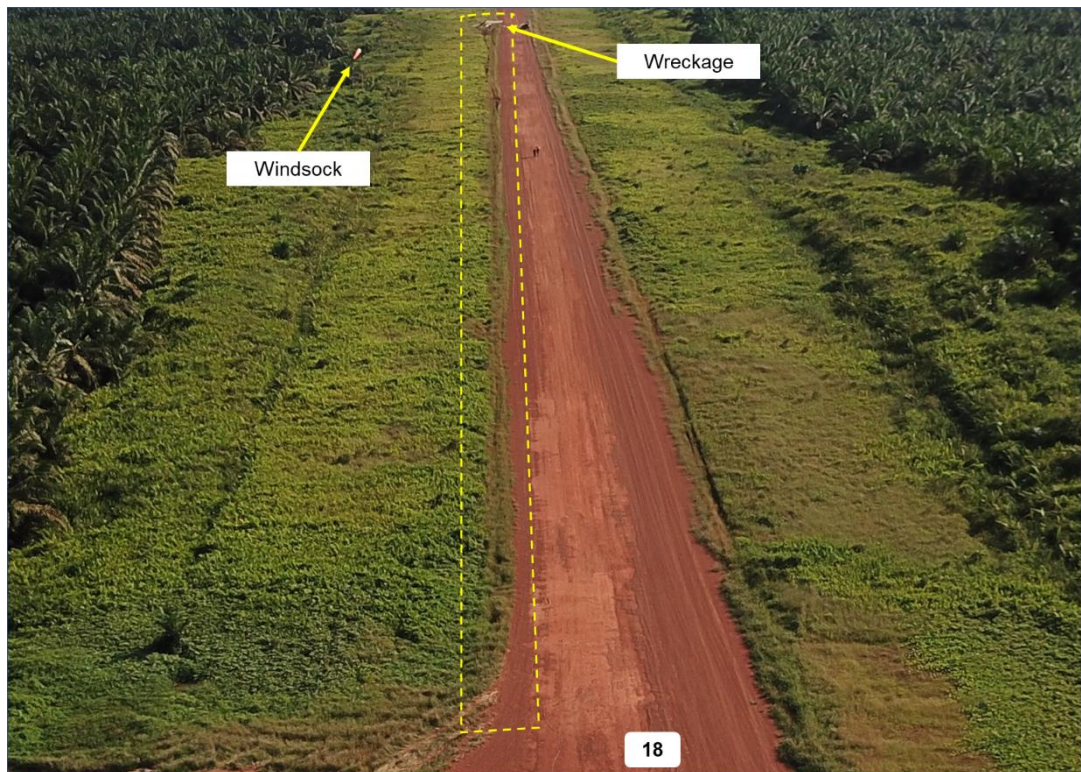
**Figure 6: The aircraft wheels trail**

As shown by Figure 6, the left and right side of the Runway 18 had different condition and color. Near the intersection with fertilizer loading area, initial trace of the left wheel was found on the runway edge touching the grass in the runway shoulder. The trail continued up to 350 meters from the initial point, before it shifted more to the left around 2.7 meters from the runway edge.

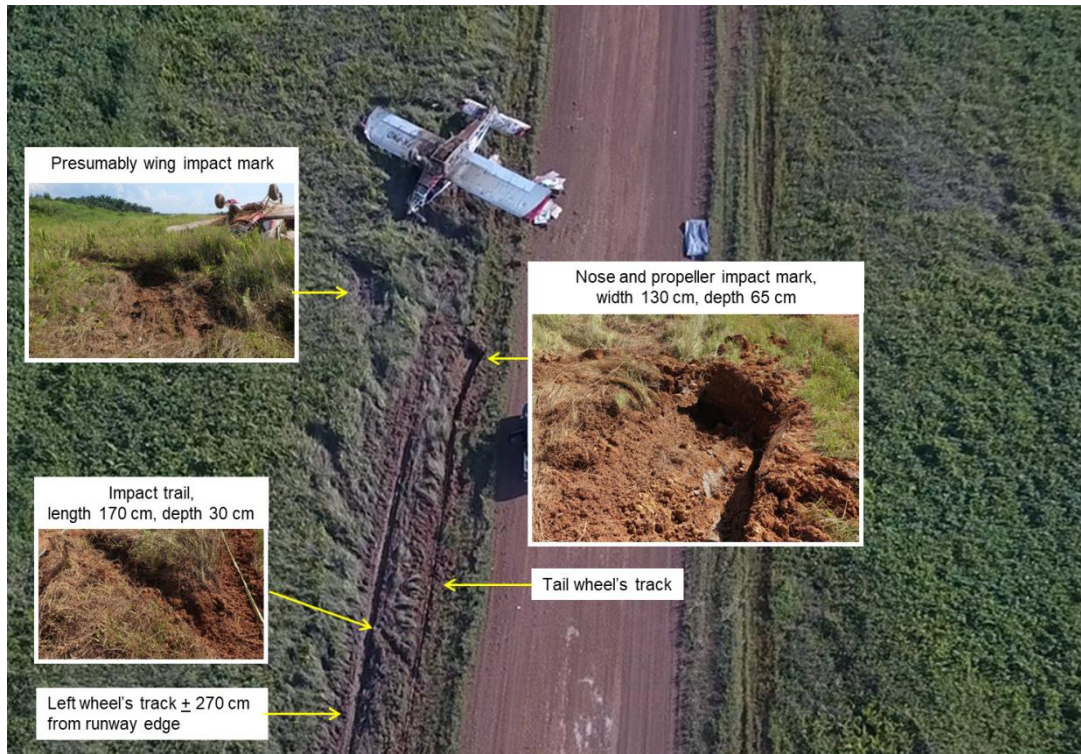
**Figure 7: Wreckage and impact information**

Figure 7 shows the area around the occurrence where the left wheel had entered the runway shoulder. The tail wheel track was found at approximately one meter parallel to the left wheel trail. A diagonal impact mark, around 1.7 meters long and 0.3 meters deep, was found in between left wheel and tail wheel trail at 590 meters from the initial point. End of impact point along the trail was found at 610 meters from the initial point. Sharp hoe marks suspected to have come from aircraft propellers made a large hole with a depth of 0.65 meters and width of 1.3 meters. Presumably wing impact mark was found on the left of the hole, parallel to the landed wing position.
