**KOMITE NASIONAL KESELAMATAN TRANSPORTASI
REPUBLIC OF INDONESIA**

Aircraft Serious Incident Investigation Report

Cessna 208B; PK-BVE

Yuvai Semaring Airport, Long Bawan, North Kalimantan

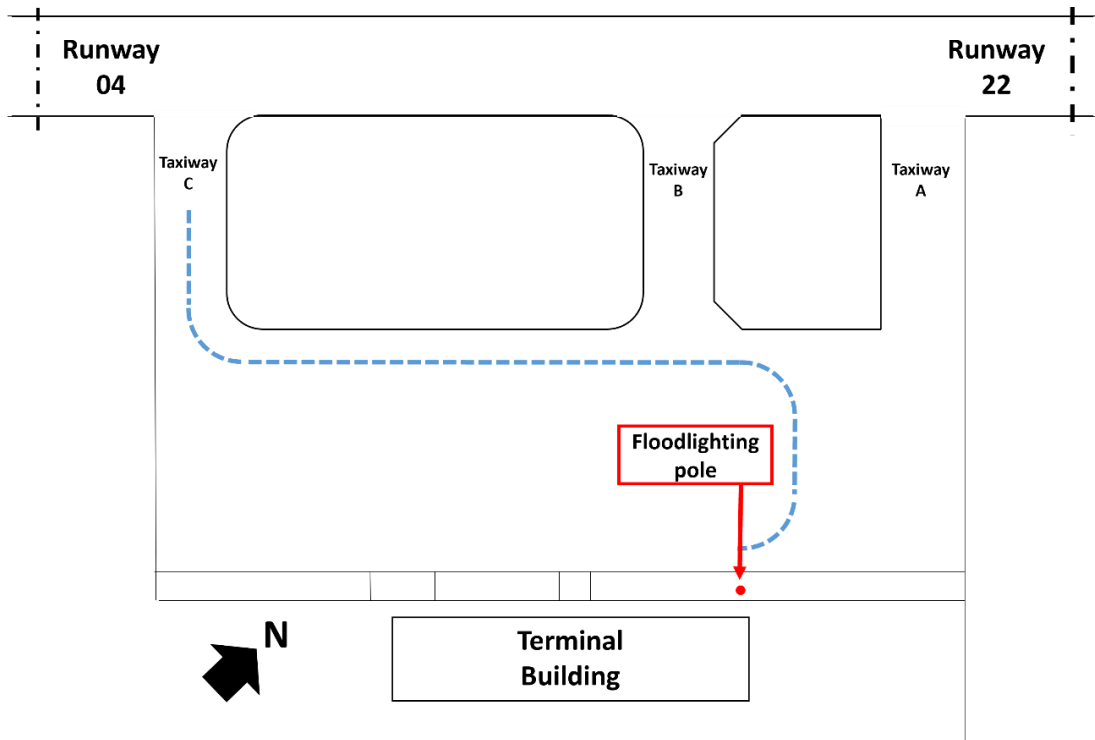
Figure 1: The illustration of the aircraft maneuver – not to be scaled

The aircraft maneuver is illustrated by blue dotted line in Figure 1. At the intersection of Taxiway C and the apron, the aircraft turned left and taxied along the northwest side of the apron. As the aircraft passed taxiway B and about to reach the intersection of apron and Taxiway A, it executed a 90° right turn. Thereafter, the aircraft made another 90° right turn to the southeast of the apron with intention of positioning the aircraft facing northwest direction on the south side of the apron. During the second 90° right turn, the left-wing leading edge impacted an apron floodlighting pole. The aircraft stopped, and the PF shut down the engine. The passengers then disembarked.

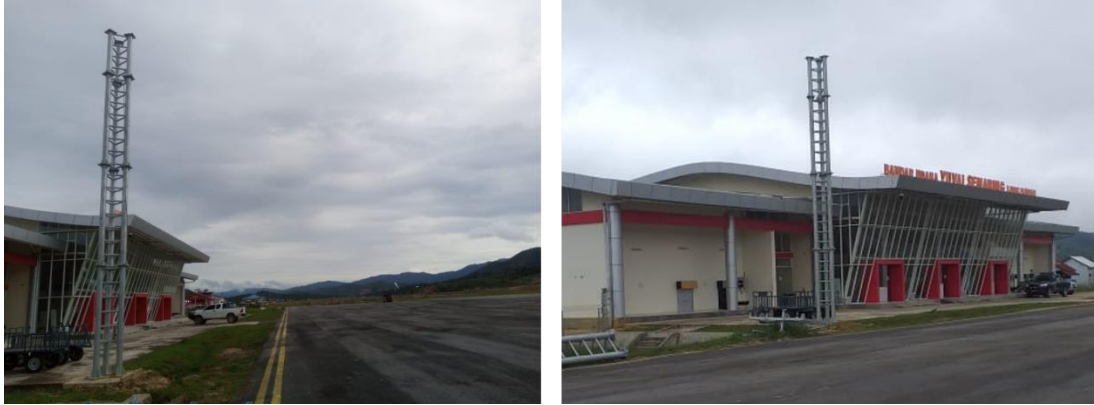
Figure 2: The floodlighting pole

The apron was equipped with an apron floodlighting as shown in Figure 2, which was built on 23 September 2021. The floodlighting pole was situated near the terminal building at coordinates 3°54'7.32"N 115°41'35.94"E. The distance between the floodlighting pole and the apron edge line was about 4.5 meters, with a height of 15 meters. The pole's color was similar with the color of the terminal building.

The AIP Volume III chapter WAQJ AD 2 - 10 (Aerodrome Obstacles) provided obstacles information for the airport and the information in Area 3⁷ was stated NIL. The information of floodlighting pole was not included in the AIP.

Despite the regulation stated on MOS 139 that all fixed objects should be marked whenever practicable, the apron floodlighting pole was not marked with a distinctive color, making it less conspicuous. Its color blended with the building behind it, creating a visual hazard, especially for pilots unfamiliar with its presence. The absence of information regarding the apron floodlighting pole and the lack of visual cue meant the PIC was unaware of the new obstacle.

Therefore, KNKT recommends the Yuvai Semaring Airport Operator to ensure obstacles in the Area 3 are published in aeronautical information publication in accordance with the CASR Part 175.

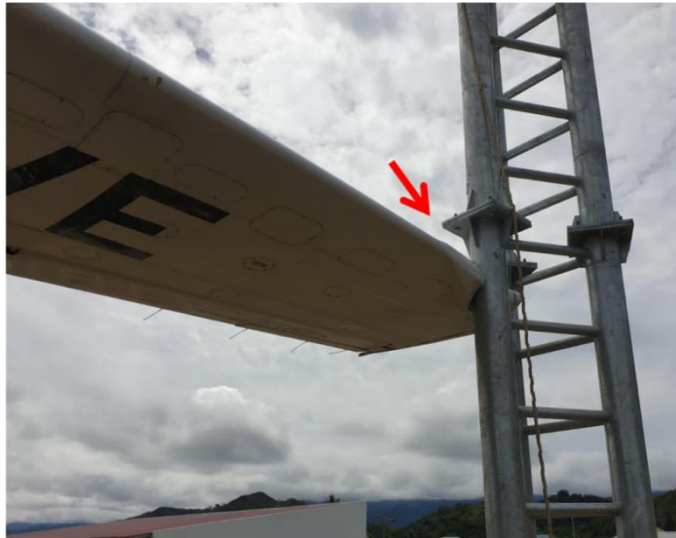
Figure 3: The left-wing leading edge impacted floodlighting pole

The impact of the left-wing leading edge with the floodlighting pole is shown in Figure 3.

12. The unawareness of the obstacle's location and the intention to park close to the terminal building, caused the final right turn towards the intended parking position to be too close to the apron floodlighting pole, resulting in the aircraft's left-wing leading edge colliding with the pole.

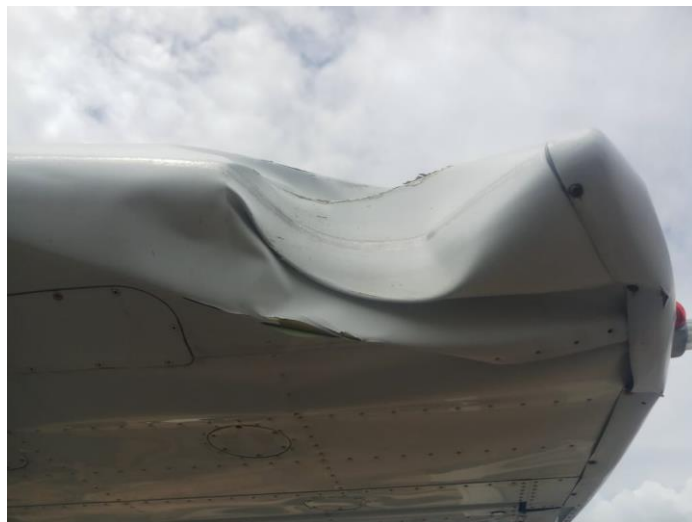
Figure 4: The damaged of the left-wing leading edge

The outer surface of the left-wing leading edge was dented, as shown by Figure 4, between the wing sections 276.24 to 308.00.

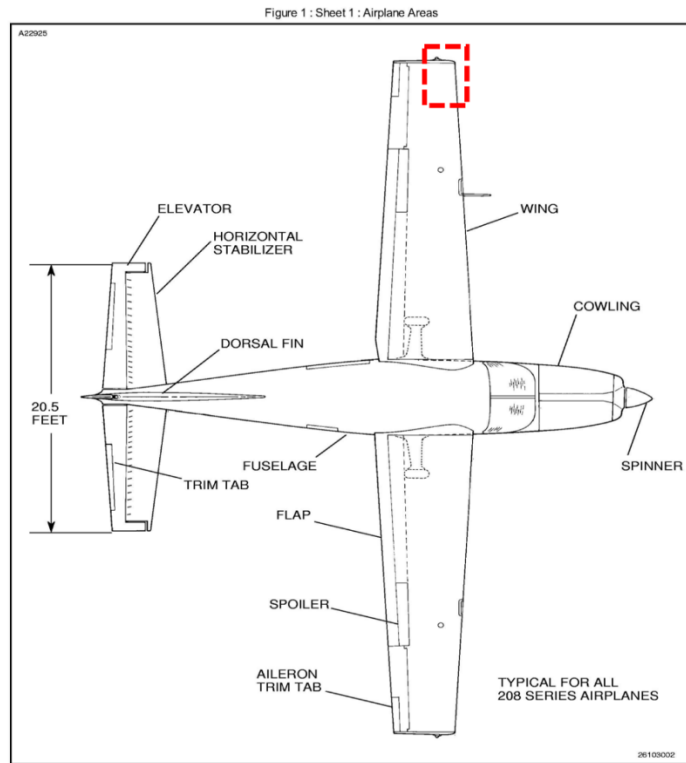
Figure 5: The damaged location of the left-wing leading edge

The following damage location, as shown by Figure 5, was illustrated by KNKT using a typical drawing of Cessna 208 Series taken from the Cessna Model 208 Series Maintenance Manual.

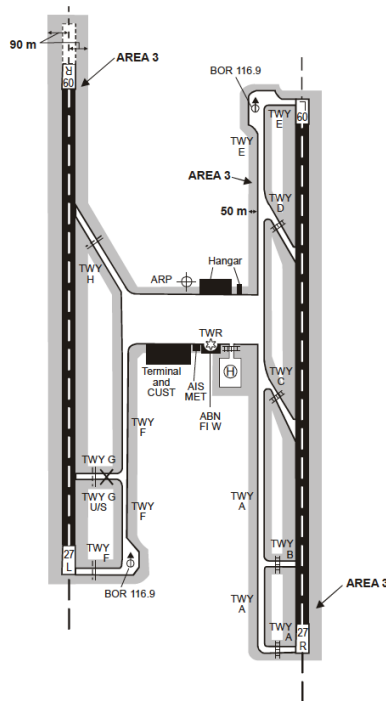
Figure 6: The typical of Area 3 of an aerodrome

CASR Part 175 Appendix A-3 point 3 describes that all terrain and obstacles within the horizontal spatial extent of Area 3 that extend more than 0.5 meters above the horizontal plane passing through the nearest point on the aerodrome surface movement area may be hazardous for surface movement and must be surveyed and stored on the aerodrome mapping database.

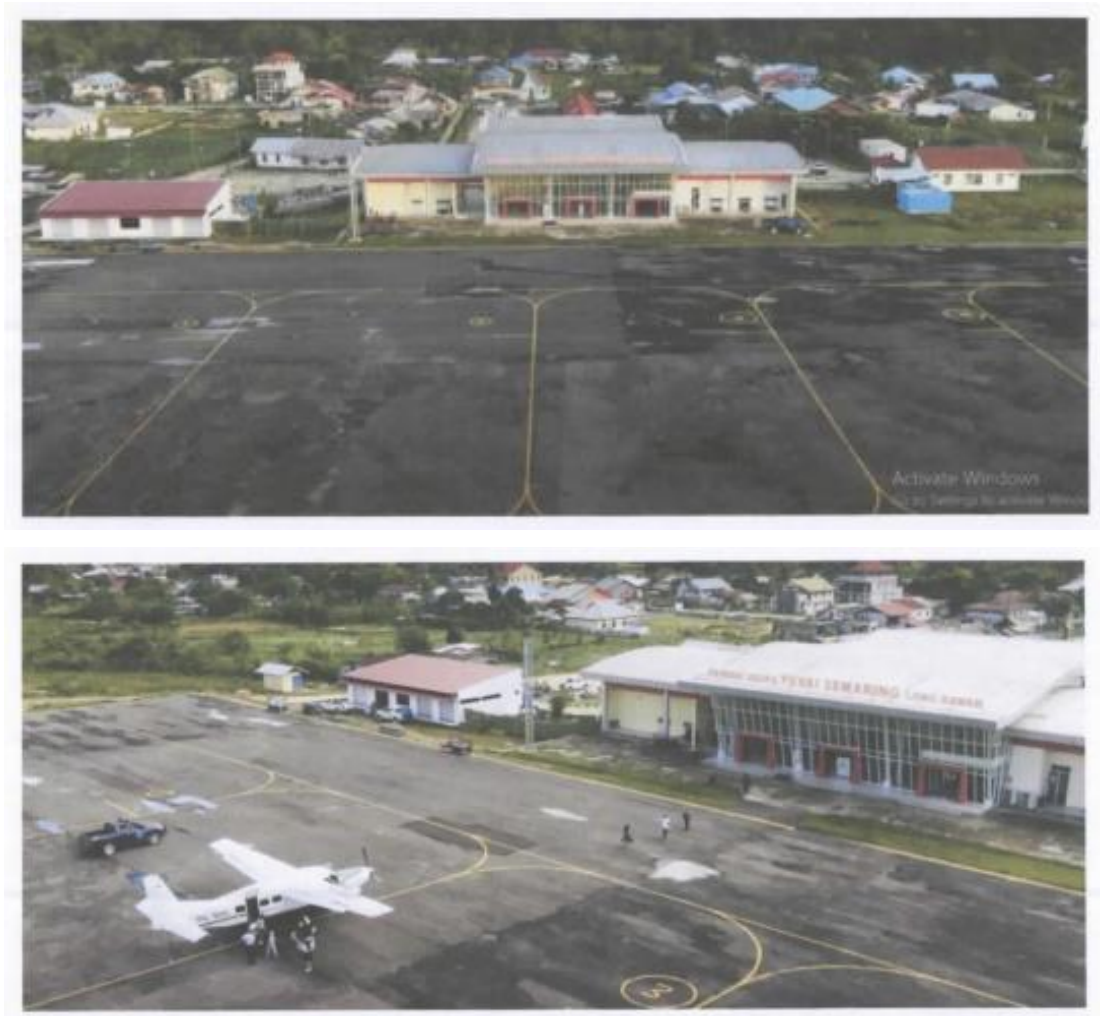
Figure 7: The painted taxiway centerline markings

Manual of Standard CASR Part 139 Volume I (MOS 139) subchapter 5.2.8 requires paved taxiway and apron to be provided by taxiway center line marking in such a way as to provide continuous guidance between the runway center line and aircraft stands. The airport has paved apron without taxiway centerline marking that can be used as guidance between runway centerline and aircraft stands. The absence of the taxiway centerline marking is not accordance with the MOS 139 and considered hazard for aircraft operation.

Therefore, KNKT recommends the Yuvai Semaring Airport Operator to provide taxiway centerline marking in accordance with the MOS 139.

Responding to the safety recommendation, the Yuvai Semaring Airport operator painted the taxiway centerline and apron markings in compliance with MOS 139.
