**KOMITE NASIONAL KESELAMATAN TRANSPORTASI
REPUBLIC OF INDONESIA**

Aircraft Serious Incident Investigation Report

PT. ASI Pudjiastuti Aviation (Susi Air)

Cessna 208B; PK-BVE

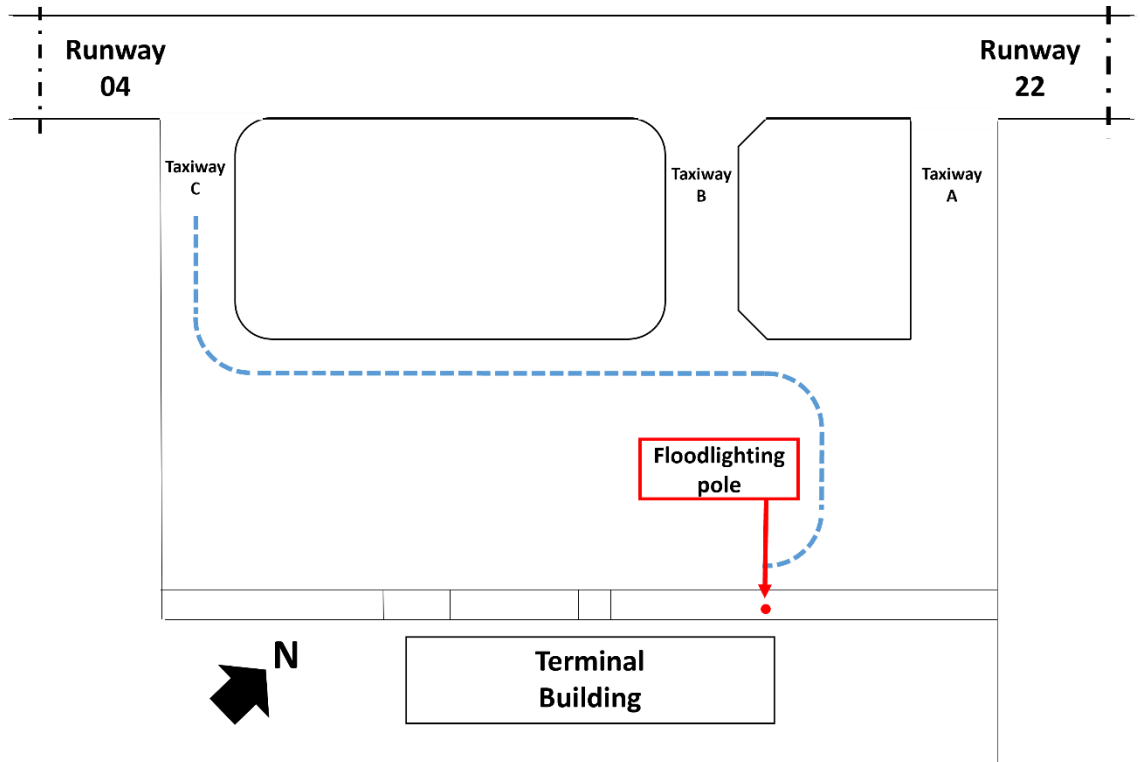
At the intersection Taxiway C and the apron, the aircraft was turned to the left and taxied along the northwest side of the apron. When the aircraft was about on intersection of apron and Taxiway A, the aircraft was maneuvered 090° right turn. Thereafter, the aircraft was maneuvered by another 090° right turn on the southeast of the apron with intention to position the aircraft facing northwest direction on the south side of the apron. When the aircraft on the second 90° right turn, the left-wing leading edge impacted an apron floodlighting pole. The aircraft stopped and the PF shutdown the engine followed by passenger disembarkation.

Figure 1: The illustration of the aircraft maneuver (blue dotted line) – not to be scaled

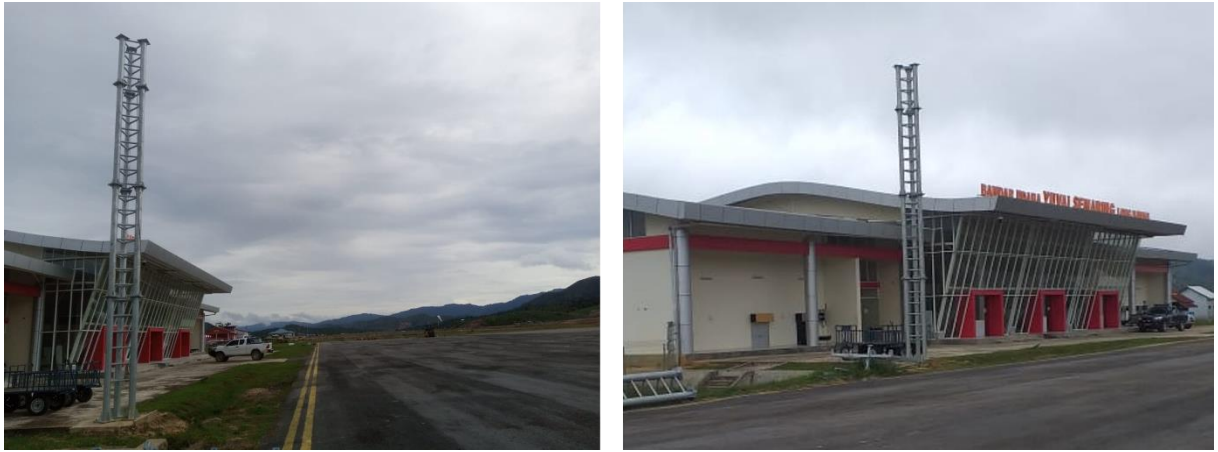
The apron is provided with apron floodlighting which was built on 23 September 2021. The floodlighting pole was located near the terminal building on coordinate 3°54'7.32"N 115°41'35.94"E. The distance of the floodlighting pole and the apron edge line was about 4.5 meters with height of 15 meters. The apron layout illustration can be seen in the figure 1 (illustration of the aircraft maneuver).

Figure 2: The floodlighting pole

The apron floodlighting pole in the Yuvai Semaring Airport was located at 4.5 meters from the apron edge line with height of 15 meters. The AIP Volume III chapter WAQJ AD 2 - 10 provided aerodrome obstacles of the airport which did not include the floodlighting pole information in the Area 3. The absence of floodlighting pole information that located in the region of the Area 3 may be hazardous for surface movement.

Therefore, KNKT recommends the Yuvai Semaring Airport Operator to ensure obstacles in the Area 3 are published in aeronautical information publication in accordance with the CASR Part 175.

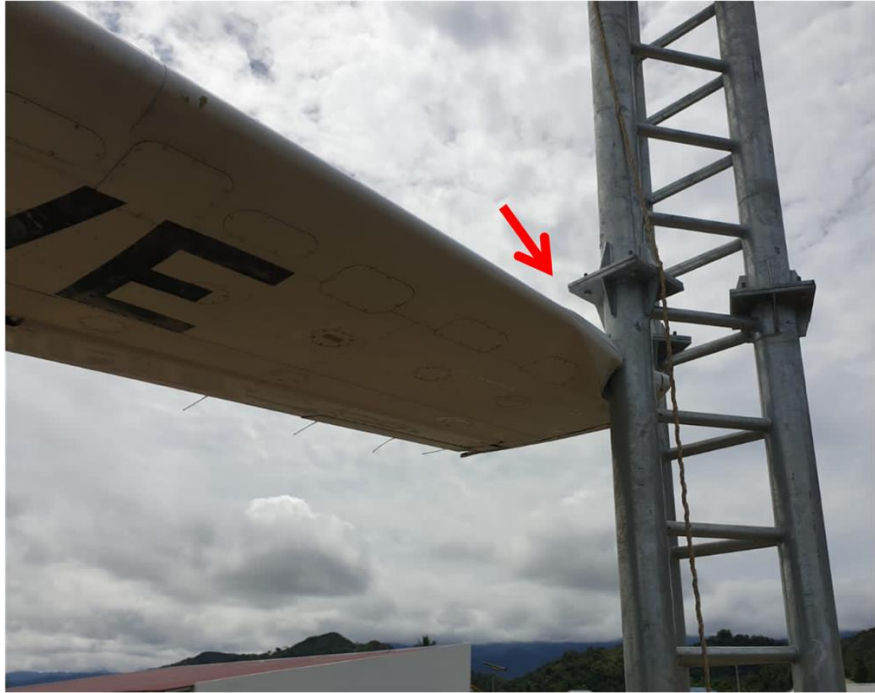
The outer surface of the left-wing leading edge was dent between the wing section 276.24 to 308.00. The following damage location was illustrated by KNKT using typical of Cessna 208 Series taken from the Cessna Model 208 Series Maintenance Manual.

Figure 3: The left-wing leading edge impacted floodlighting pole

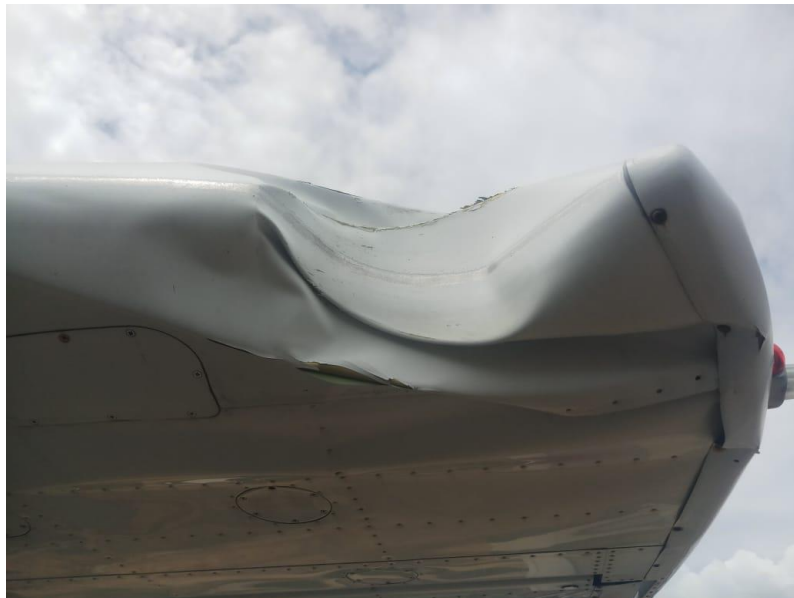
Figure 4: The damaged of the left-wing leading edge

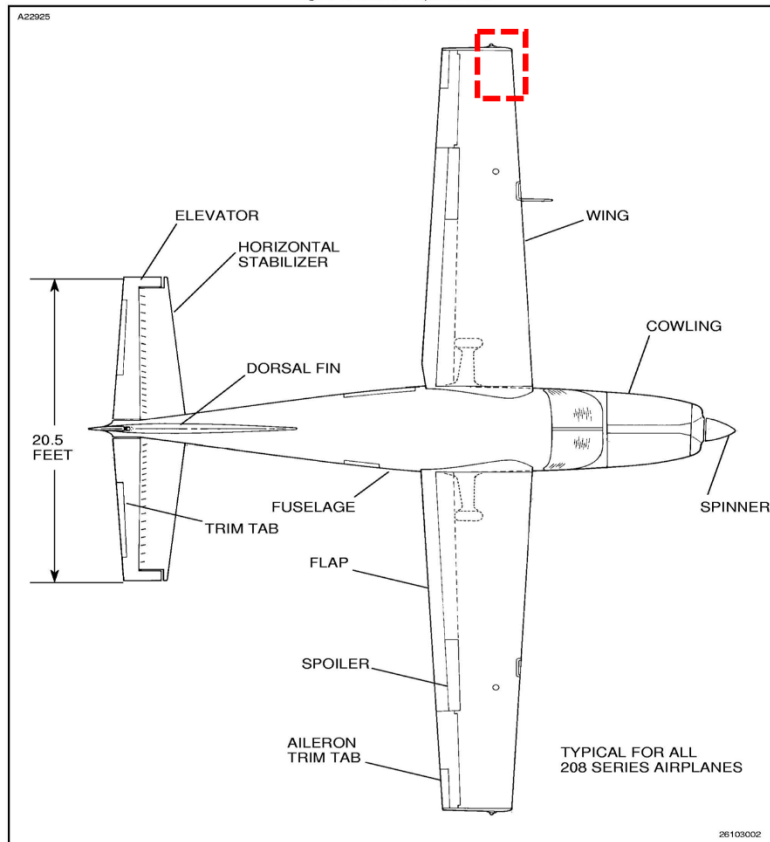
Figure 1 : Sheet 1 : Airplane Areas

Figure 5: The damaged location of the left-wing leading edge (marked by square dotted line)

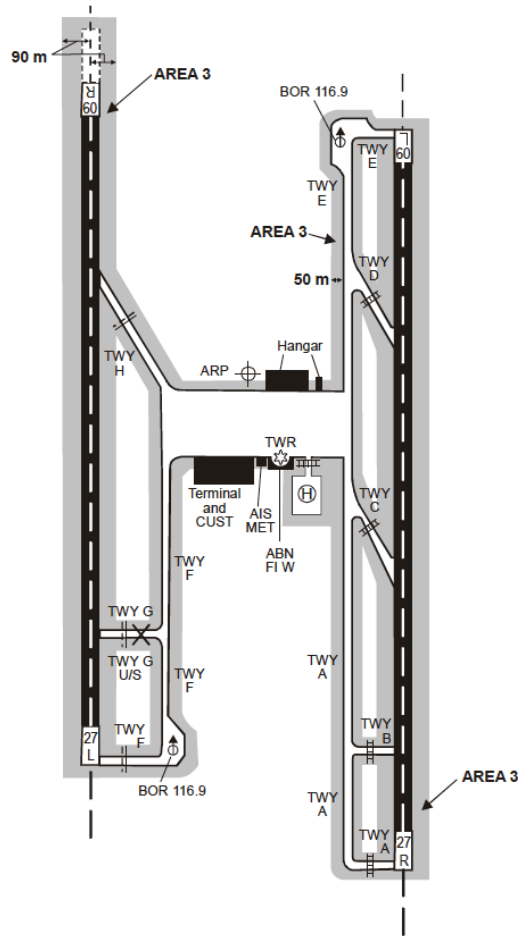
The Area 3 is defined as the area bordering an aerodrome movement area that extends horizontally from the edge of a runway to 90 meters from the runway center line, and 50 meters from the edge of all other parts of the aerodrome movement area including the apron or taxiway.

Figure 6: The typical of Area 3
