**KOMITE NASIONAL KESELAMATAN TRANSPORTASI
REPUBLIC OF INDONESIA**

Aircraft Accident Investigation Report

PT Derazona Air Service

Bell 412; PK-DAR

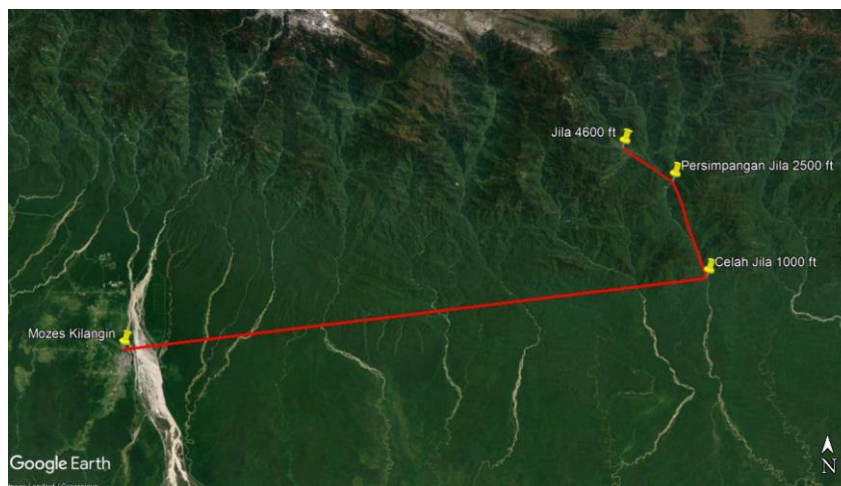
Figure 1: Timika – Jila flight guidance

The merged way point from Timika to Jila on the google earth image is as follow.

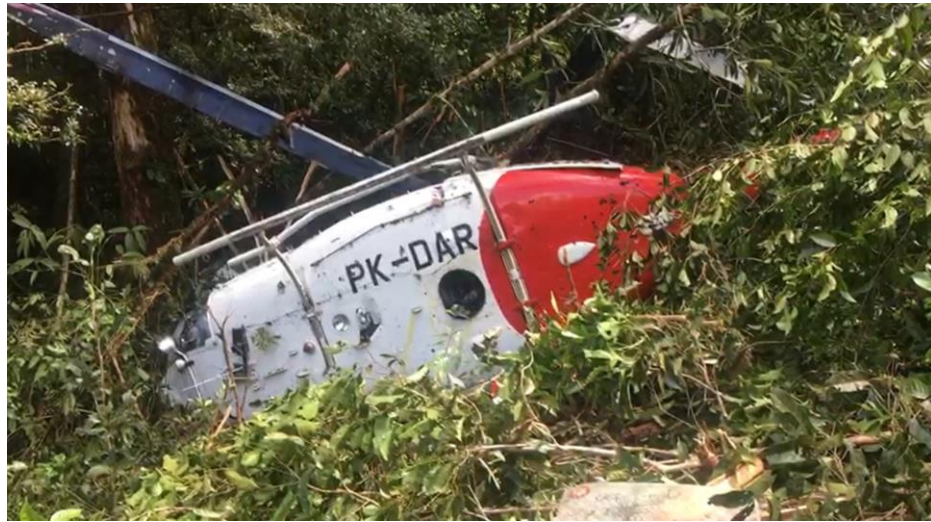
Figure 2: The condition of the helicopter.

The helicopter was substantially damaged.

The accident site was in the high density of rain forest. The helicopter condition was shown in the figure below.

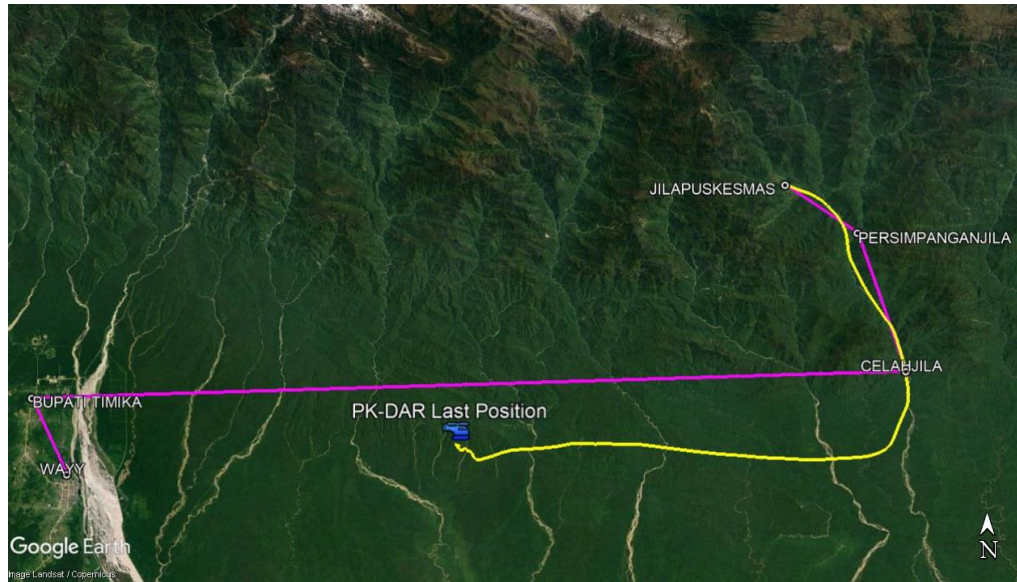
Figure 4: The helicopter flight following

The aircraft operator utilizes the Spidertrack for flight following which could be used for the tracking purposes. The flight following data merged to the google earth image is as follow:
