**KOMITE NASIONAL KESELAMATAN TRANSPORTASI  
REPUBLIC OF INDONESIA**

**Aircraft Serious Incident Investigation Report**

**PT Semuwa Aviasi Mandiri**

**DHC6-300; PK-SMS**

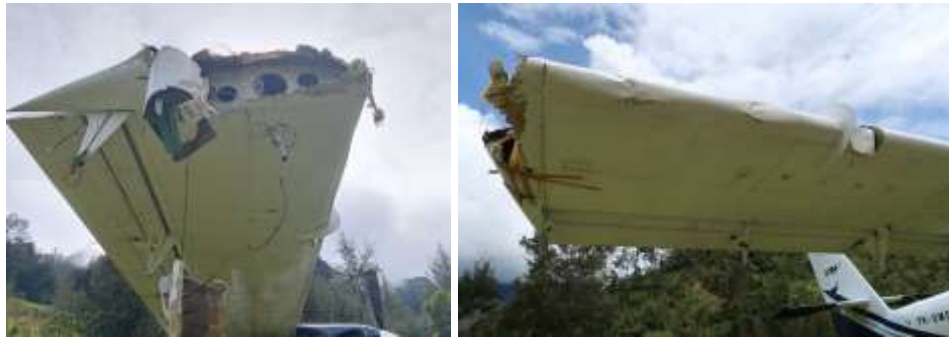
The aircraft has substantially damaged. The right wingtip was broken, the right wing leading edge were bent at several points, and the propeller blades found nicks.

**Figure 1 Damage on the left wingtip and leading edge**

The right wing tip damage and the leading edge dents were caused by impact with the trees near the right runway shoulder, in a position approximately 320 meters from the beginning Runway 16.

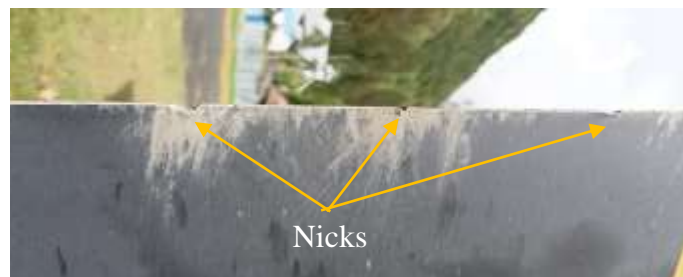
**Figure 2 Nicks on the propeller blade.**

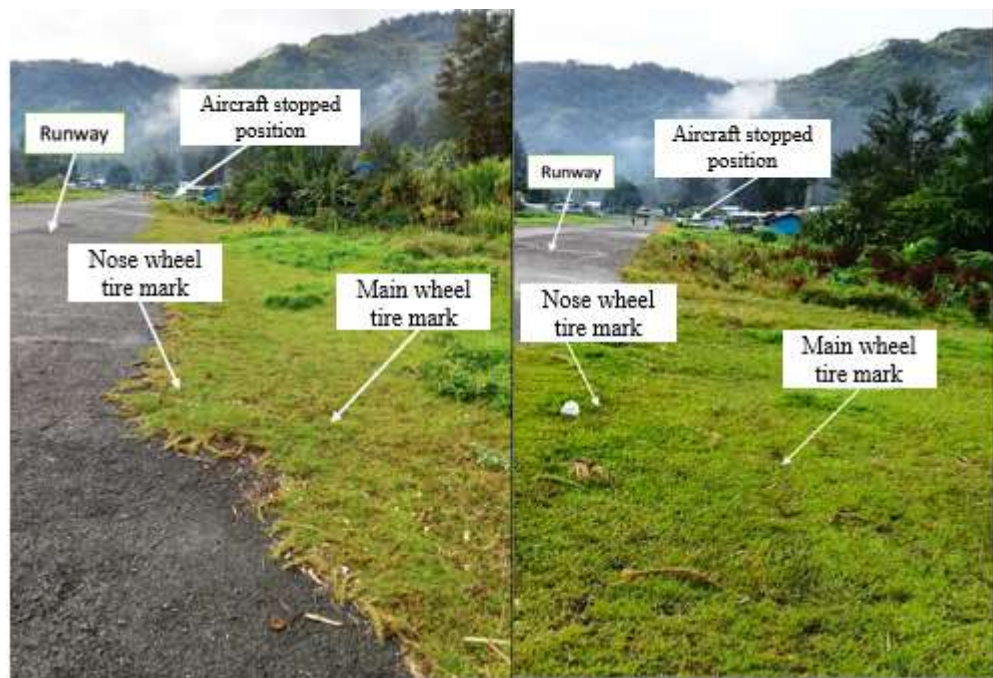
There was no obvious tire mark visible on the runway. The first tire mark was found on the runway edge approximately five meters after the predicted aircraft touched

down position. The mark was identified as the mark of the right main wheel. About three meters from the first tire mark, another tire mark was found in parallel with the first tire mark, which was identified as the nose wheel mark.

The nose wheel and right main wheel marks continued along the runway shoulder to the slightly right direction. Approximately 100 meters, another tire mark was found which was identified as the left main wheel track.

The tire marks continued along the runway shoulder until the aircraft stop position about 400 meters from beginning Runway 16.

**Figure 6 The wheel marks found on the occurrence site**

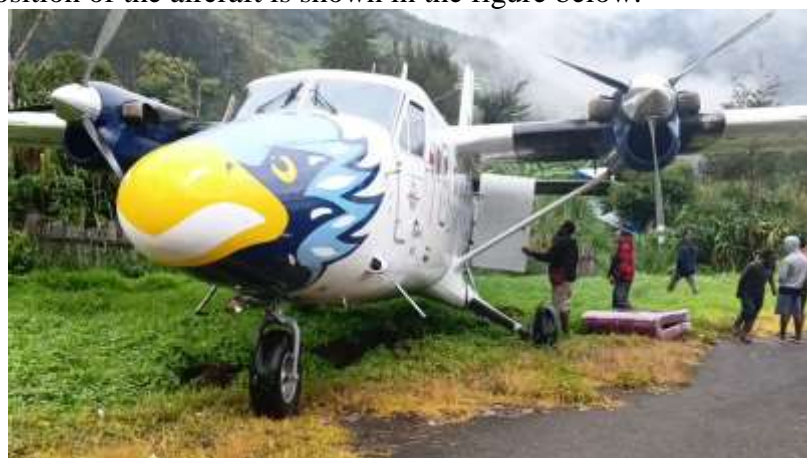
The aircraft exited the runway, and the right wing hit the trees near the runway shoulder during rolling. Afterward, the landing gear travelled on the soft soil and stopped on the right runway shoulder on heading about 114°.

**Figure 7 The aircraft condition after stopped**
