**KOMITE NASIONAL KESELAMATAN TRANSPORTASI  
REPUBLIC OF INDONESIA**

**KNKT.23.01.02.04**

**Aircraft Serious Incident Investigation Report**

**PT Lion Mentari Airlines  
Boeing 737-900 ER; PK-LFO  
Mopah Airport, Merauke  
Republic of Indonesia  
26 January 2023**

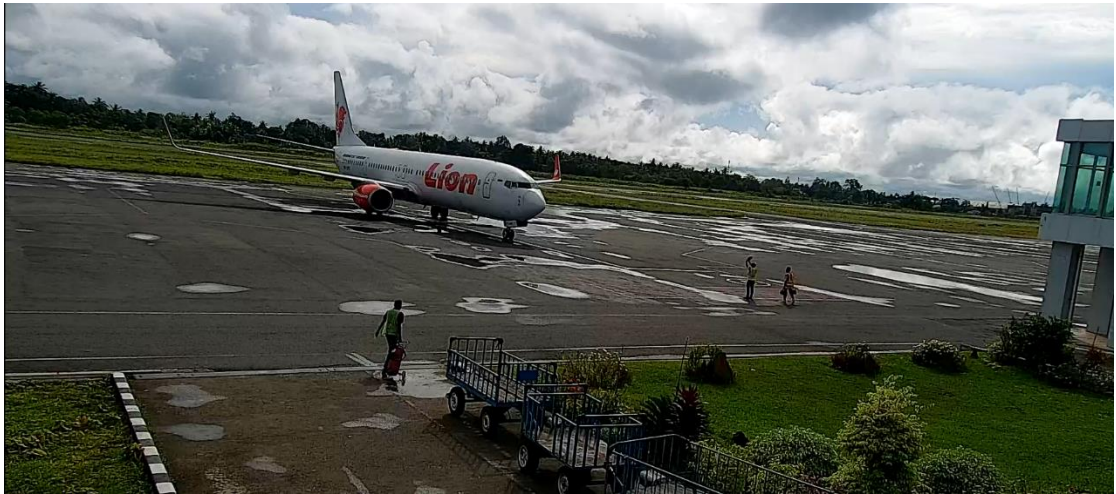
**Figure 1: PK-LFO parking position**

The flight from Jayapura to Merauke were uneventful and landed at 0821 LT which was nine minutes earlier from the flight scheduled. The aircraft landed using Runway 34 and was instructed by Merauke air traffic controller (tower controller) to taxi to Aircraft Stand 5 via Taxiway B. During the parking process, the PIC was assisted by marshaller. The aircraft was stopped about two meters ahead of pilot stop line<sup>5</sup> at Parking Stand 5 by following the marshaller signal. The marshaller intended to make the aircraft parked on flat surface as some of the apron surfaces were wavy.

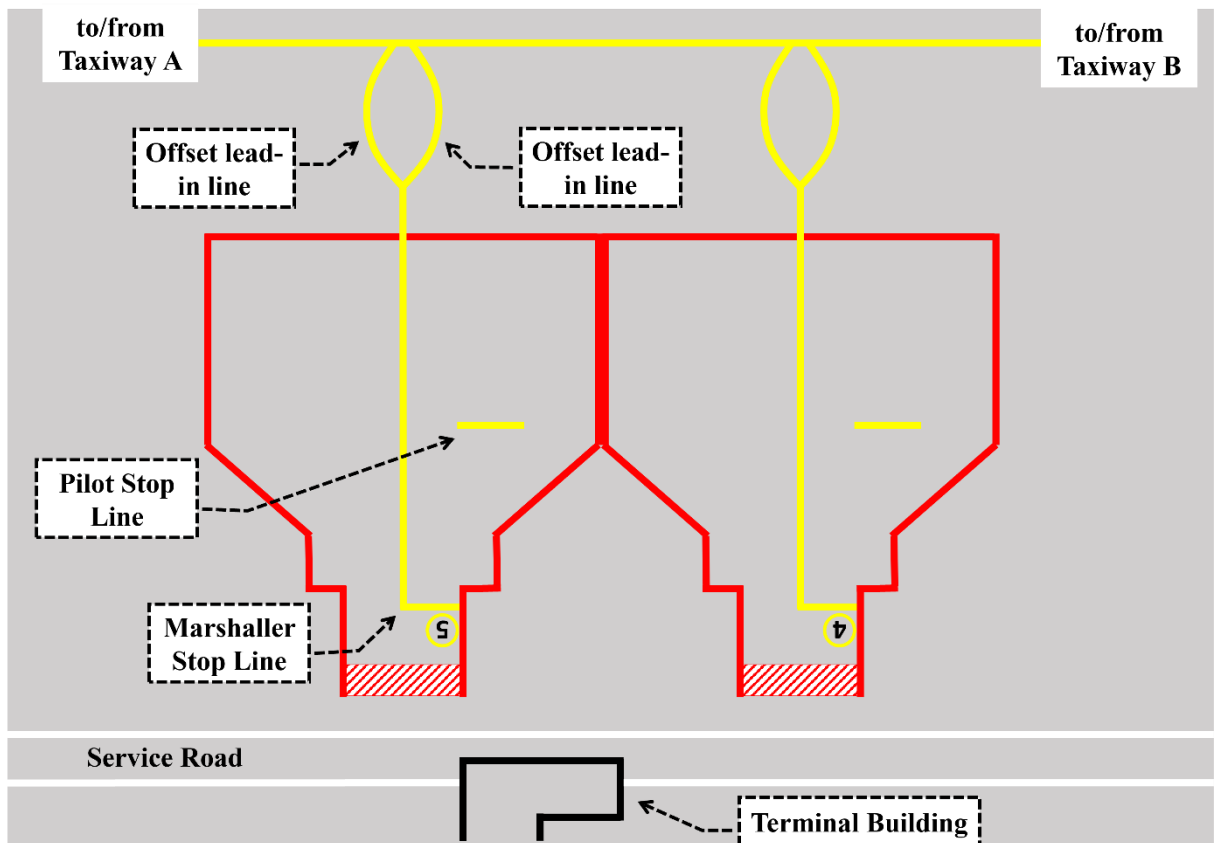
**Figure 5: The Aircraft Stand 5 layout and the location of the terminal building impacted to the aircraft**

The Aircraft Stand 5 had two offset lead-in lines which is used for guidance during taxi in maneuver. The aircraft stand also utilized with two different stop lines – Marshaller Stop Line<sup>6</sup> and Pilot Stop Line.

All available markings/guidelines on the apron were suitable for aircraft to leave the aircraft stand utilizing towing tractor. There was no turn bar, turning line, lead-out line nor alignment bar available in the apron which can be used for self-maneuvering parking<sup>7</sup>. All aircraft parked in the apron did not utilize towing tractor and the parking maneuver was conducted by self-maneuvering using aircraft own power.

Therefore, KNKT recommends the Airport Operation Unit of Mopah Airport in cooperation with aircraft operators to review the parking configuration to ensure safe maneuver when aircraft leave the aircraft stand.

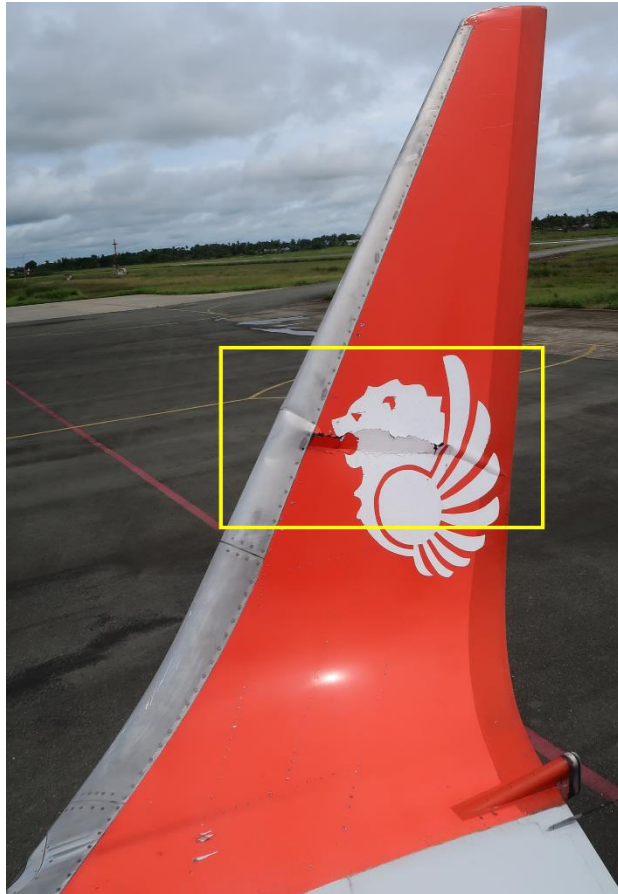
The wingtip of the right wing impacted terminal building. The wingtip and the terminal building were damaged.

**Figure 6: The damaged wingtip (inside yellow square)**

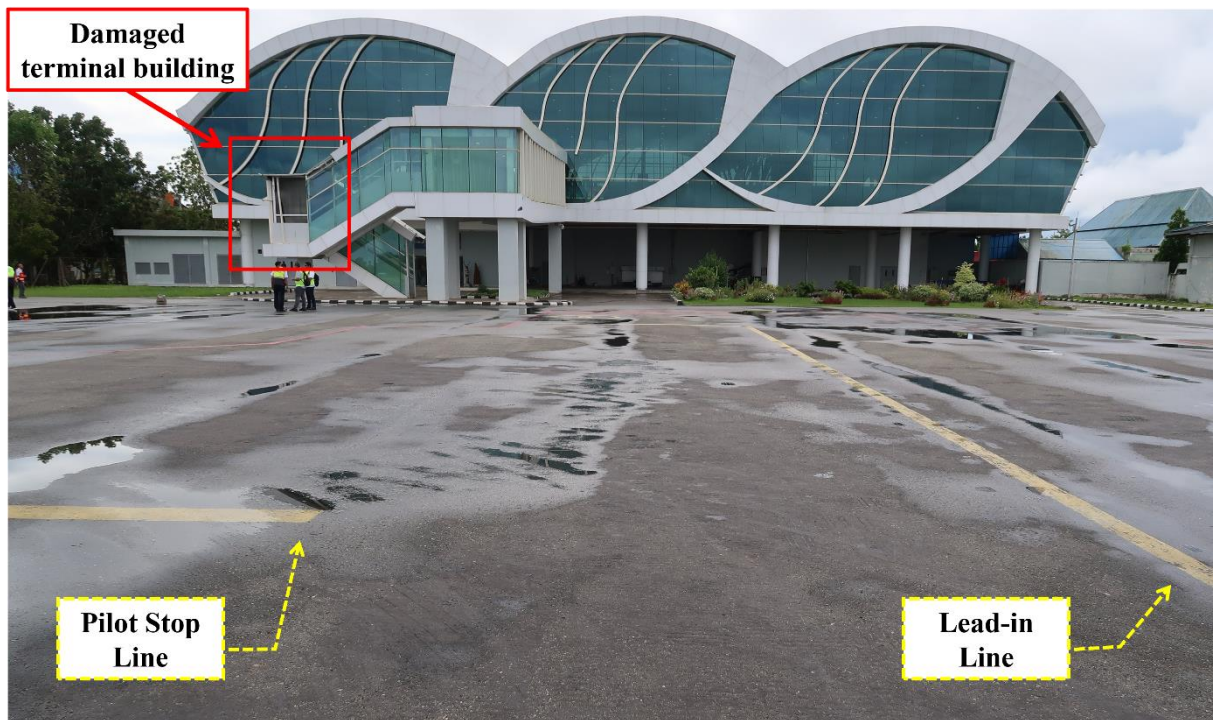
**Figure 7: The damaged airport terminal building from the apron**

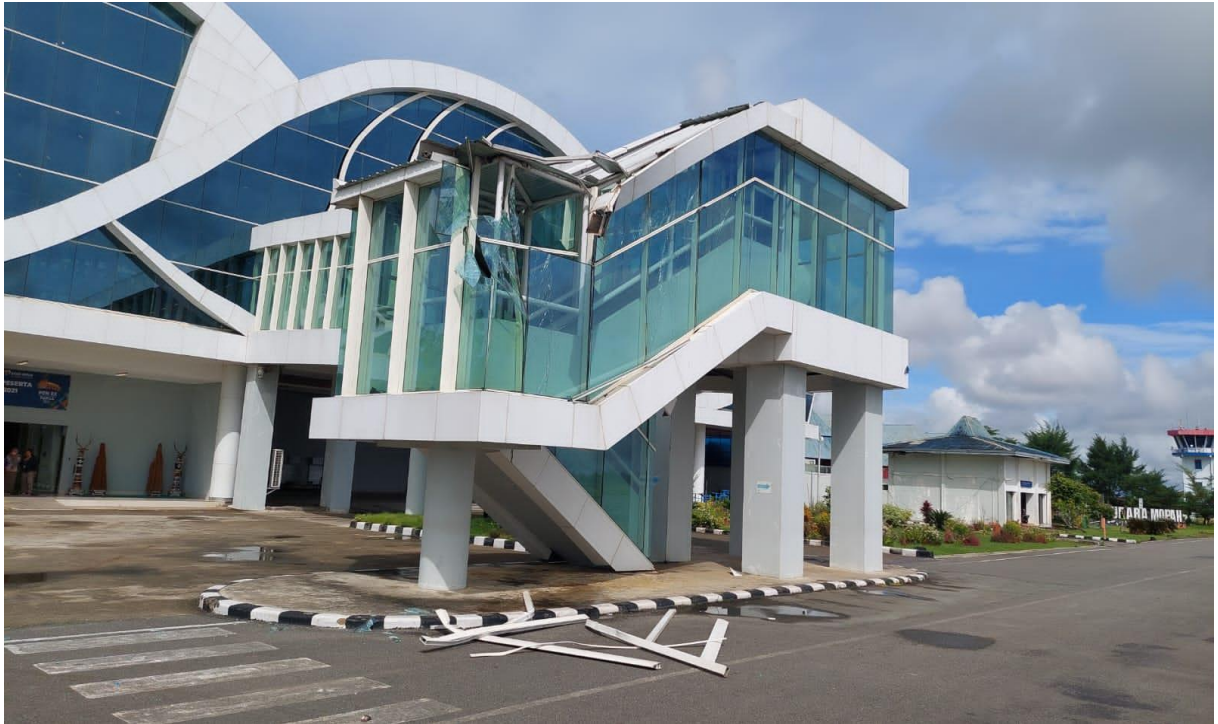
**Figure 8: The damaged airport terminal building**

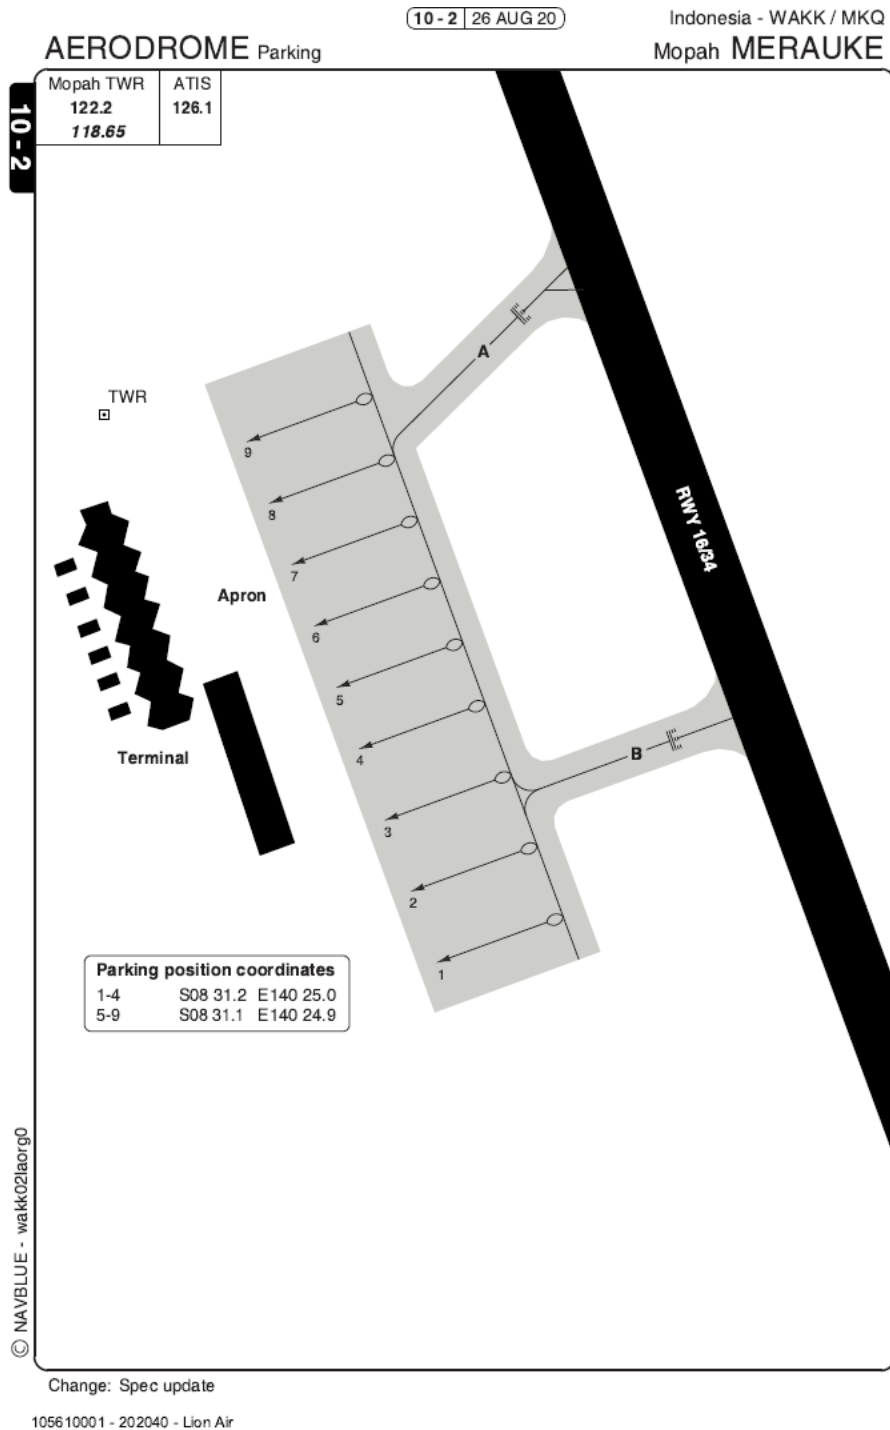
**Figure 9: The Aerodrome Parking chart for Merauke**

The Navblue Document for Merauke did not provide any specific procedure for pilot when maneuvering aircraft from aircraft stand. The Aerodrome Parking chart in the Navblue Document was as follows:
