**KOMITE NASIONAL KESELAMATAN TRANSPORTASI
REPUBLIC OF INDONESIA**

KNKT.23.03.04.04

Aircraft Serious Incident Investigation Report

Boeing 737-800; PK-GMC

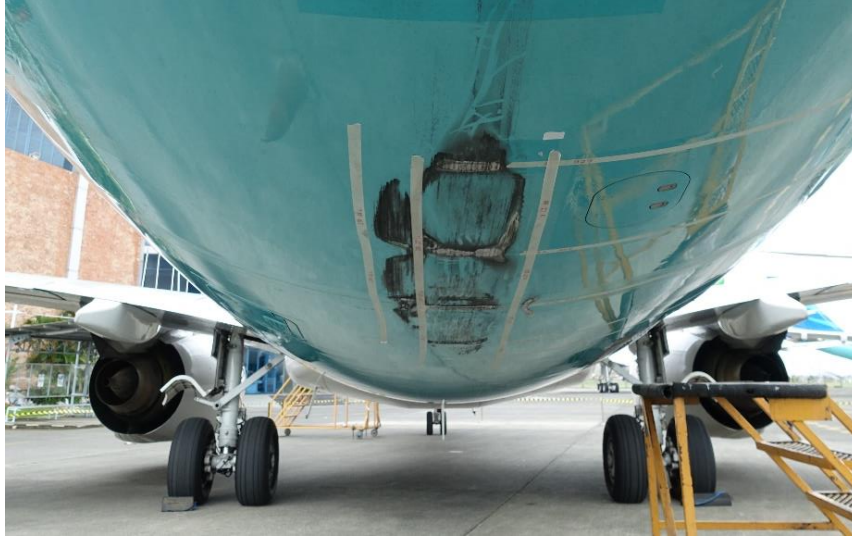
The aircraft was slightly damaged as illustrated by Figure 1 to Figure 3. There were scratches on lower surface of the aft fuselage skin (section 46 – 47, from station 847 to 927).

Figure 1. Scratches on lower surface of the aft fuselage skin (view looking forward)

9. The aircraft was experiencing bouncing during touch down.
10. The lower surface on the aft fuselage skin and tailskid damper were scratched and deflected respectively.

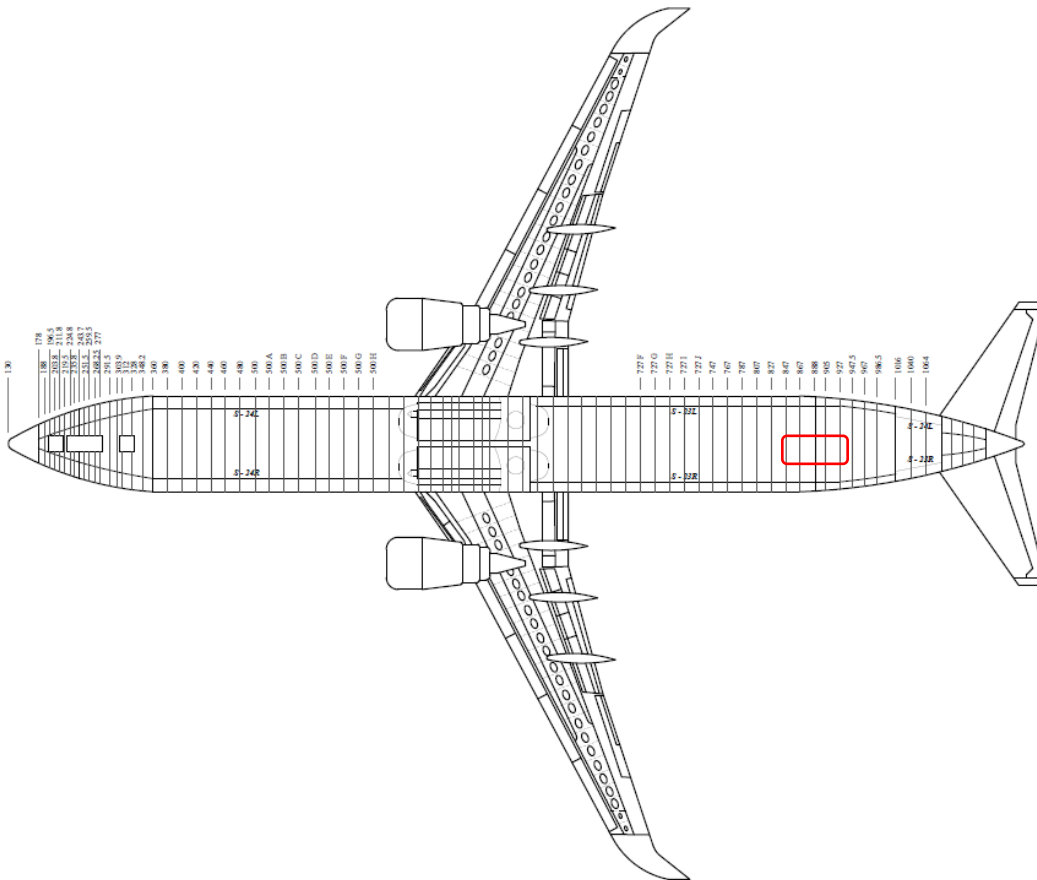
Figure 2. Damage location on lower surface drawing global view (red-highlighted)

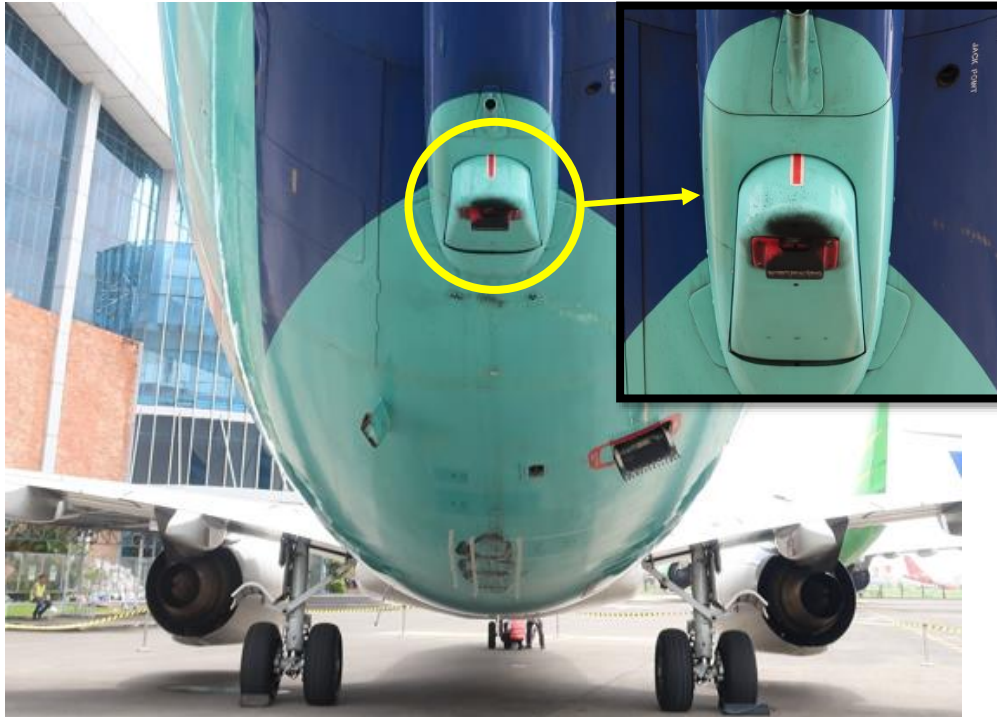
Figure 3. Deflected tailskid damper

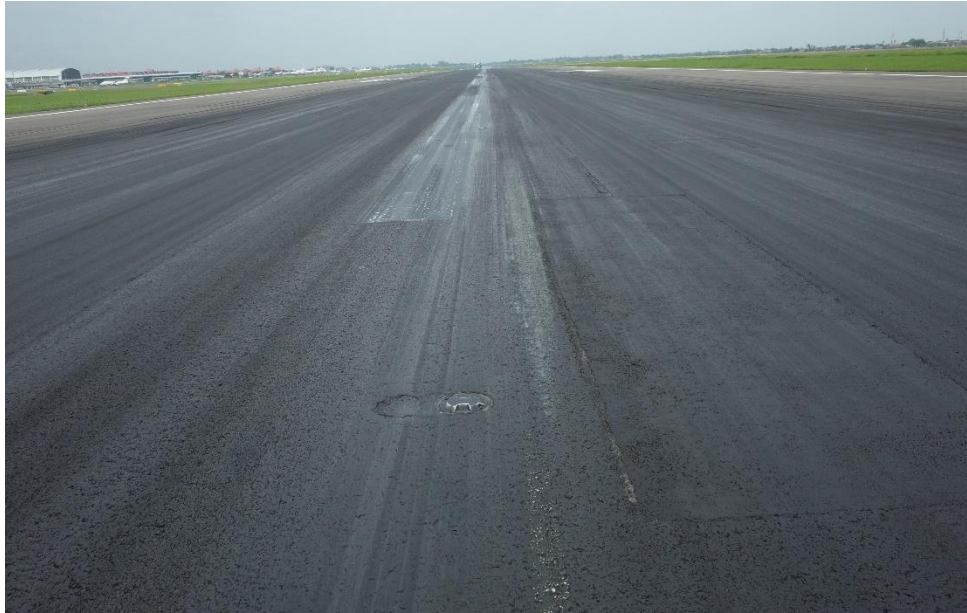
A 13 meters long scratch mark with yellowish green and white-blue paint was found on the right side of the runway centerline.

The scratch mark was found about 500 meters from the threshold of Runway 25R approximately one meter from the runway centerline, as shown in Figure 4.

Figure 4. Thirteen meters long scratch mark on the runway
