**KOMITE NASIONAL KESELAMATAN TRANSPORTASI
REPUBLIC OF INDONESIA**

KNKT.23.05.05.04

Aircraft Accident Investigation Report

Cessna C208; PK-HVG

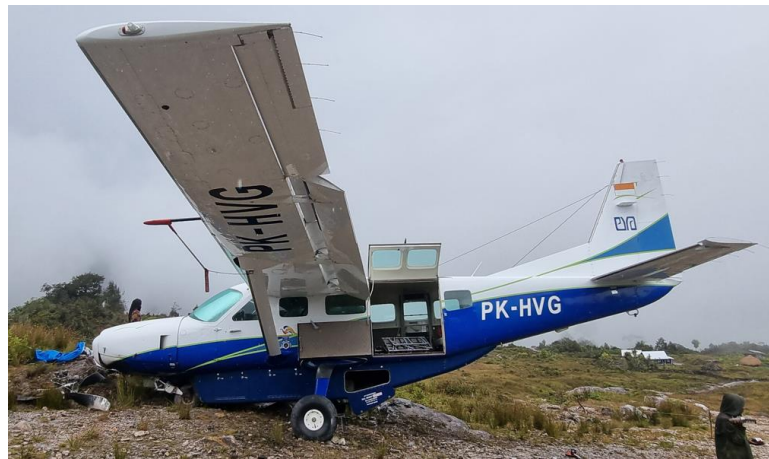
Figure 1: Damage to the aircraft

No one was injured in this occurrence. However, the sustained substantial damage, including bent propeller blades, a collapsed nose landing gear, and damage to the forward cargo door, engine cowling, and exhaust.

The aircraft was substantially damaged as shown by Figure 1 to Figure 5.

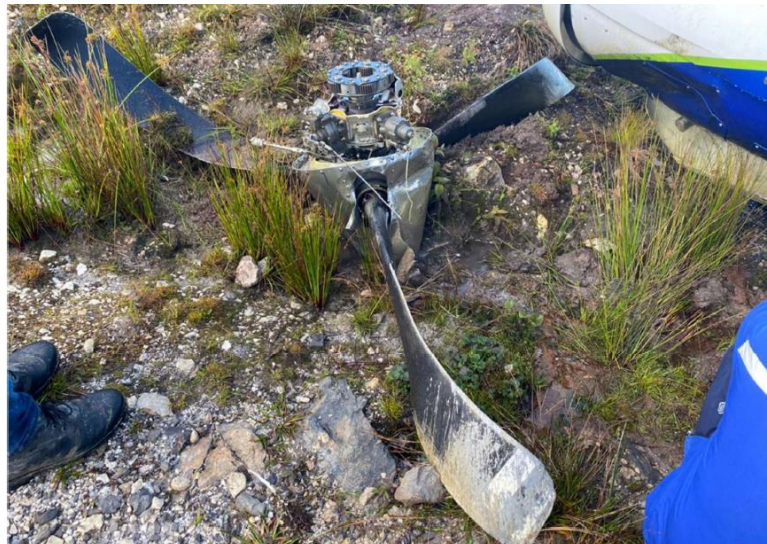
Figure 2: Damage to the propeller

As the aircraft kept going right, the pilot reduced the power and cut off the fuel by closing the fuel valve. The aircraft collided with a large rock led to the detachment of the propeller from the engine power drive and caused the aircraft to stop.

The propeller disassembled from the engine power drive and its blades were bent as shown by Figure 2.

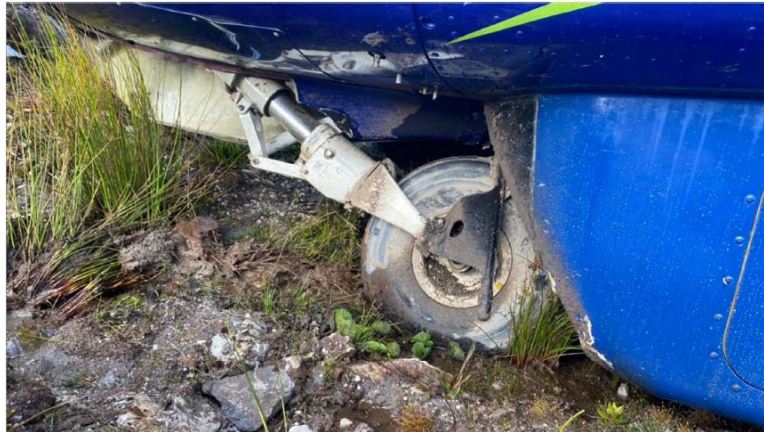
Figure 3: Damage to the forward cargo door

The nose landing gear collapsed and folded back causing damaged to the forward cargo door as shown by Figure 3.

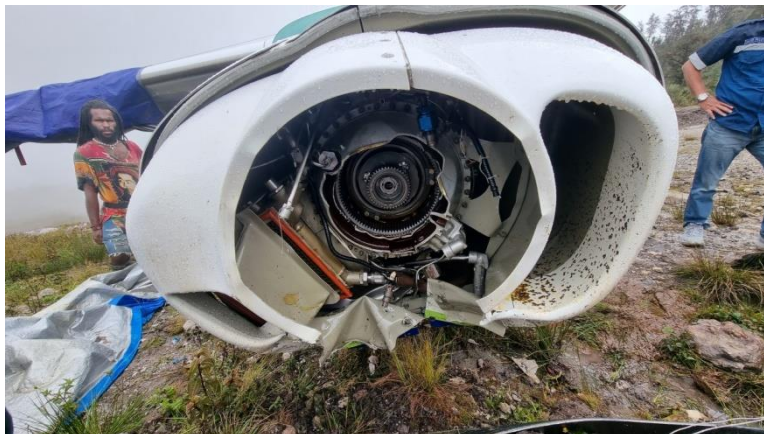
Figure 4: Damage to the engine and its cowling

The engine, its cowling, and the exhaust were wrinkled as shown by Figure 4 and Figure 5 respectively.

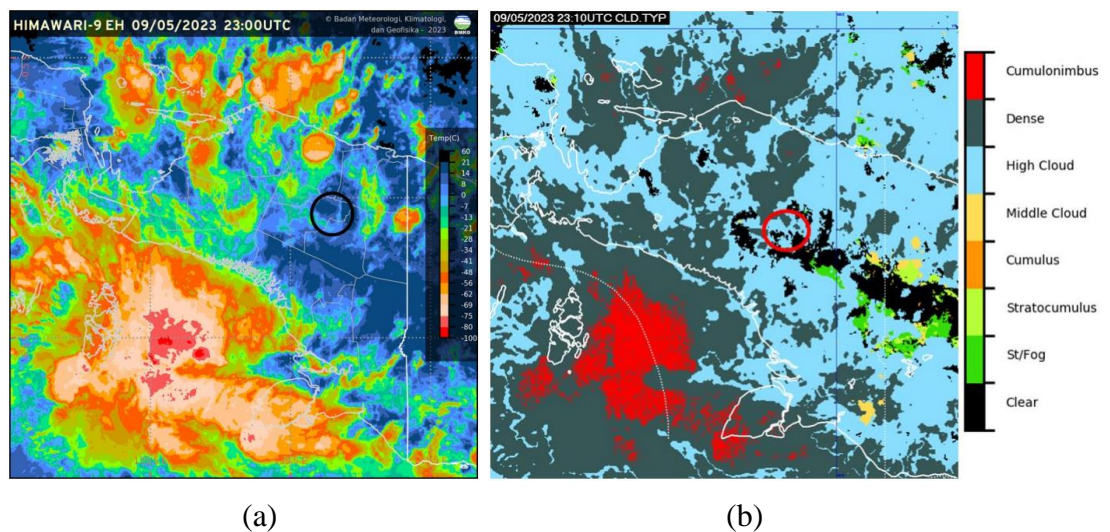
Figure 6: The satellite image around the accident site

The IR Enhanced satellite imagery on May 9, 2023 at 2300 UTC around the accident area showed that the cloud top temperature ranged from 0°C – 14°C as shown in Figure 1(a).

Meanwhile, the cloud type satellite imagery (HCAI Cloud Type) on May 9 2023 around the time of accident showed the presence of high clouds, and it was dominated by clear clouds as illustrated in Figure 1(b).

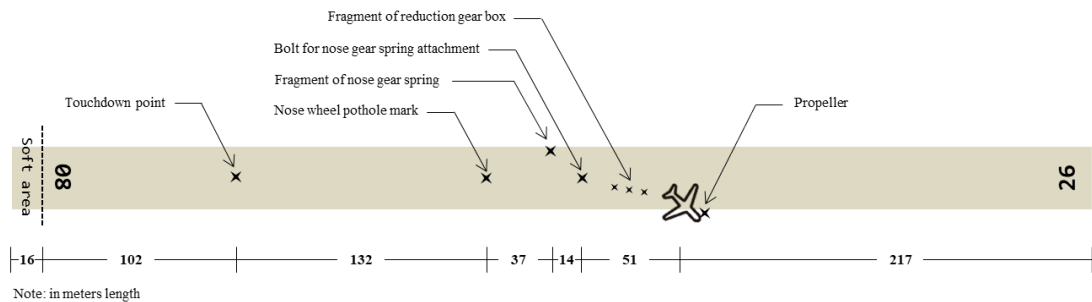
Figure 8: Impact sequence and wreckage trail

Figure 5 depicts landing sequence of the aircraft. Touch down mark was found 102 meters from the runway threshold, approximately 130 meters after that, the mark indicating the nose wheel pothole was identified.

A fragment of the nose landing gear spring was discovered about 270 meters from the runway threshold, and the bolt used for the nose gear spring attachment was found about 14 meters further along from that point. Scattered fragments of the reduction gear box were found along the trail as the aircraft made a right turn before stopped. The propeller detached from the engine power drive rested around 0.5 meters from on the left side of the aircraft nose.

7. Touch down mark was found 102 meters from the runway threshold, and the nose wheel pothole mark was identified at a distance of 234 meters. The aircraft came to a stop approximately 330 meters from the threshold, at the right side of the runway, after executing a right turn, colliding with a large rock which led to the disassembly of the propeller from the engine power drive.

10. The nose landing gear collapsed. A fragment of the nose landing gear spring was discovered 271 meters from the runway threshold, and the bolt used for the nose gear spring attachment was found 14 meters further along from that point. Scattered fragments of the reduction gear box were found along the trail as the aircraft made a right turn before stopped.
