**KOMITE NASIONAL KESELAMATAN TRANSPORTASI
REPUBLIC OF INDONESIA**

KNKT.23.05.06.04

Aircraft Accident Investigation Report

Cessna 208B; PK-NGA

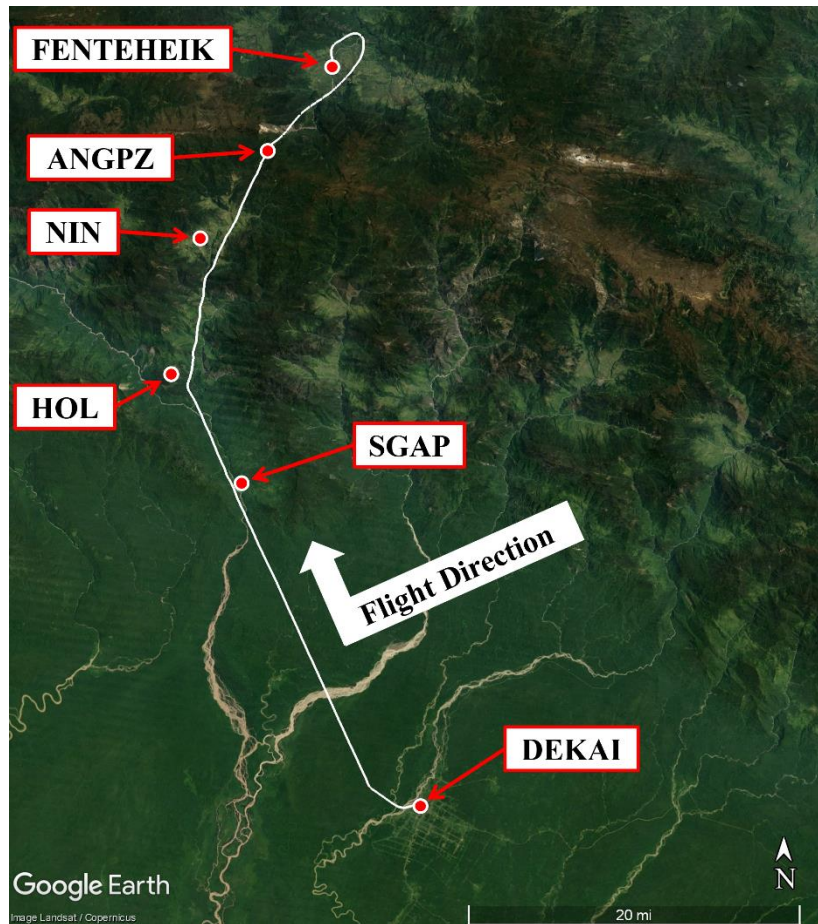
Figure 1: The occurrence flight track (white line) based on the GPS flight data logging

At 1039 LT, on daylight condition, the aircraft departed from Dekai to Fenteheik following a flight plan route stored in the aircraft Global Positioning System (GPS)². The stored flight plan route to Fenteheik following the GPS waypoints of Dekai – SGAP – HOL – NIN – ANGPZ – Fenteheik (see figure 1).

According to the flight data logging recorded in the aircraft GPS, at 1103 LT, the aircraft turned to the base leg of Runway 17 and passed an altitude of 6,700 feet (about 1,100 feet above the airstrip elevation). At this time, the Indicated Airspeed (IAS) of the aircraft recorded 116 knots and the value continued reducing. The SIC advised the PIC that the aircraft altitude was too high and was acknowledged.

About 30 seconds later, the aircraft turned to the final Runway 17 and passed altitude of 6,500 feet (about 900 feet above the airstrip elevation). At this time the IAS reduced to 87 knots. The SIC readvised the PIC that the aircraft altitude was too high and was acknowledged. The rate of descend of the aircraft then recorded an increased value.. The pilots recalled that when the aircraft on final, the visibility was good and the wind was calm.

At 11:04:06 LT, about 0.5 Nm from the airstrip, the aircraft passed altitude of 5,900 feet (about 300 feet above the airstrip elevation) with the IAS of 85 knots and rate of descent was about 1,600 fpm. This recorded rate of descend was the highest value prior to the touchdown.

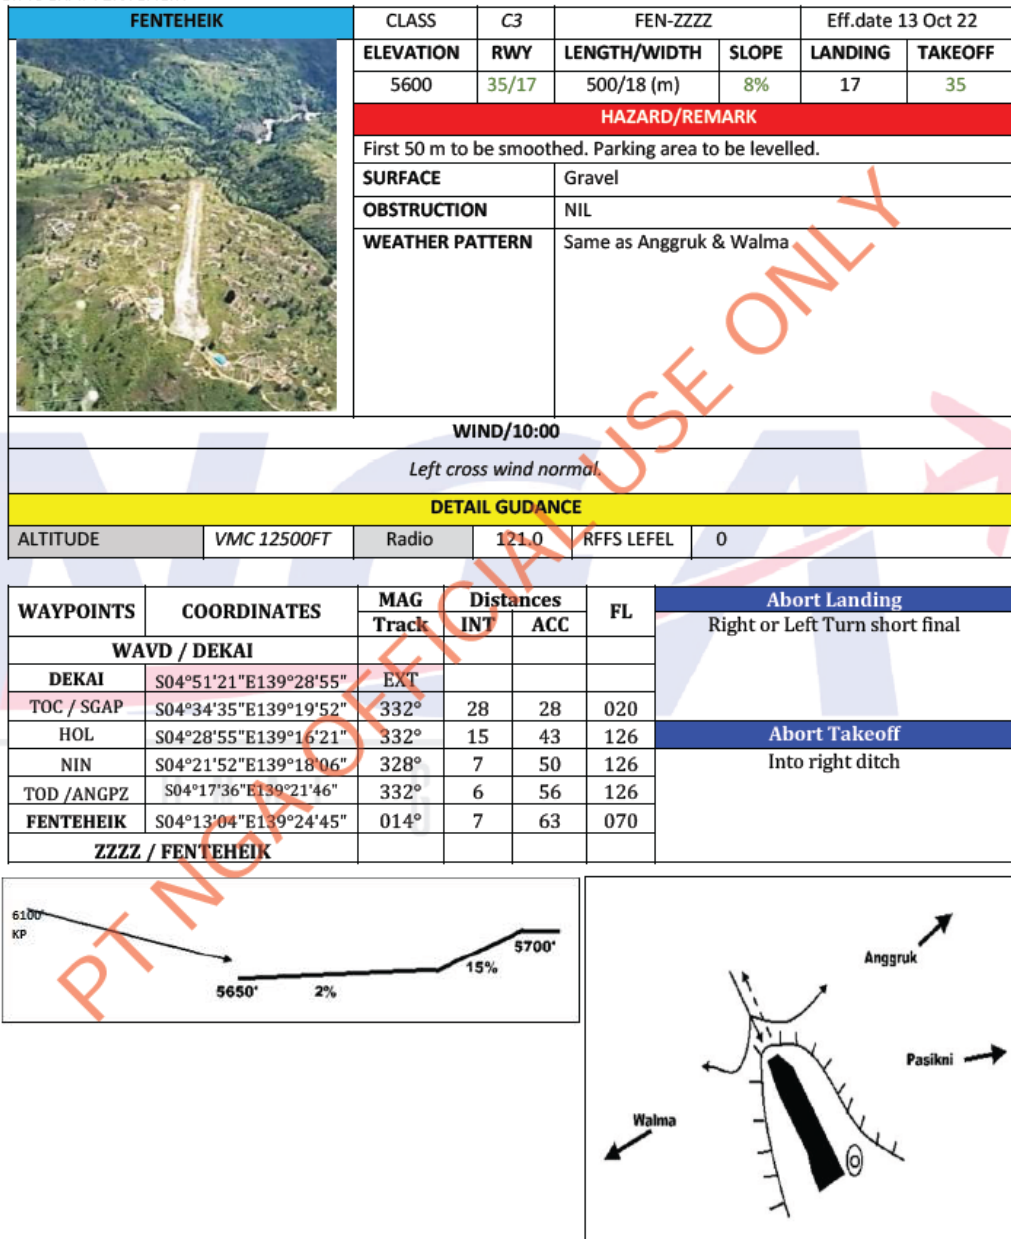
Figure 2: Route guidance document for Fenteheik

Both pilots were aware that the aircraft was still too high as the route guidance published by the company requires pilots to pass the Key Point at an altitude of 6,100 feet. The PIC considered that it was not possible to abort the landing approach after passed the Key Point due to the high terrain surrounding the airstrip.

The aircraft operator developed Operation Manual Part C (OM-C) which contained route and airport information for internal use. The document included a route guidance to fly to Fenteheik as follow:

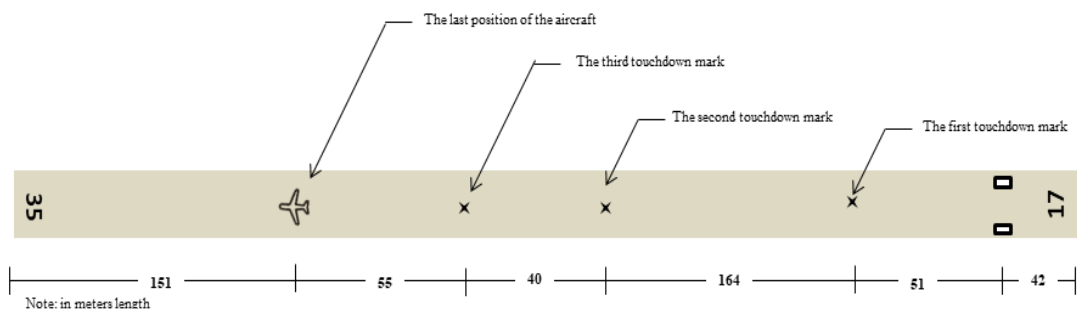
Figure 3: The illustration of the touchdown marks on the runway

At 11:04:22 LT, the aircraft touched down Runway 17. During the touchdown, rate of descend recorded about 1,200 fpm, the IAS was recorded 85 knots, and the aircraft pitch was 0.57° . The aircraft bounced two times and during the third touchdown the nose gear was collapsed.

Several touchdown marks were found on the runway. The first touchdown mark was found about 90 meters from beginning of Runway 17. The second touchdown mark was found about 165 meters ahead of the first touchdown mark, followed by the third touchdown mark that found about 40 meters ahead of the second touchdown mark. The final position of the aircraft was about 55 meters from the last touchdown mark or approximately 350 meters from the beginning of Runway 17.

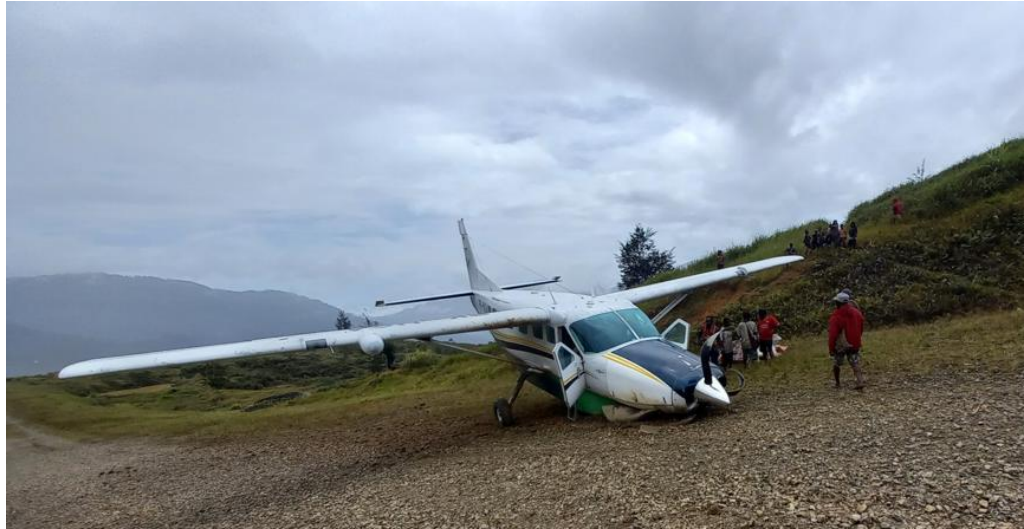
Figure 4: The aircraft condition after stopped

Based on the visual examination of the aircraft, the damage on the aircraft were as follows:

- The propeller hub was cracked.
- Three propeller blades bent and displaced from the hub.

- The nose landing gear was collapsed, nose gear drag link spring was broken.
- The cargo pods were torn and broken.
