**KOMITE NASIONAL KESELAMATAN TRANSPORTASI
REPUBLIC OF INDONESIA**

Aircraft Serious Incident Investigation Report

Cessna 208B; PK-BVU

Sipora Airport, Rokot, West Sumatera

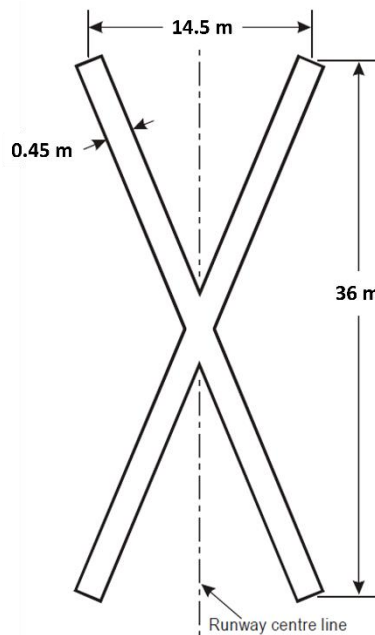
Figure 2: Runway 14-43 closed marking dimension

On 25 April 2023, the Rokot Airport operator which managed the implementation of the new airport construction plan issued instructions to the construction provider to paint two closed runway markings on the Runway 14-32 which located near the touchdown zone marking.

The closed runway marking painted in yellow color with specification as follows:

The painted closed runway marking color and dimension remained the same until the day of the occurrence.

Therefore, KNKT recommends the DGCA to review the regulation of closed runway markings to minimise the risk of pilot landing on undesignated runway.

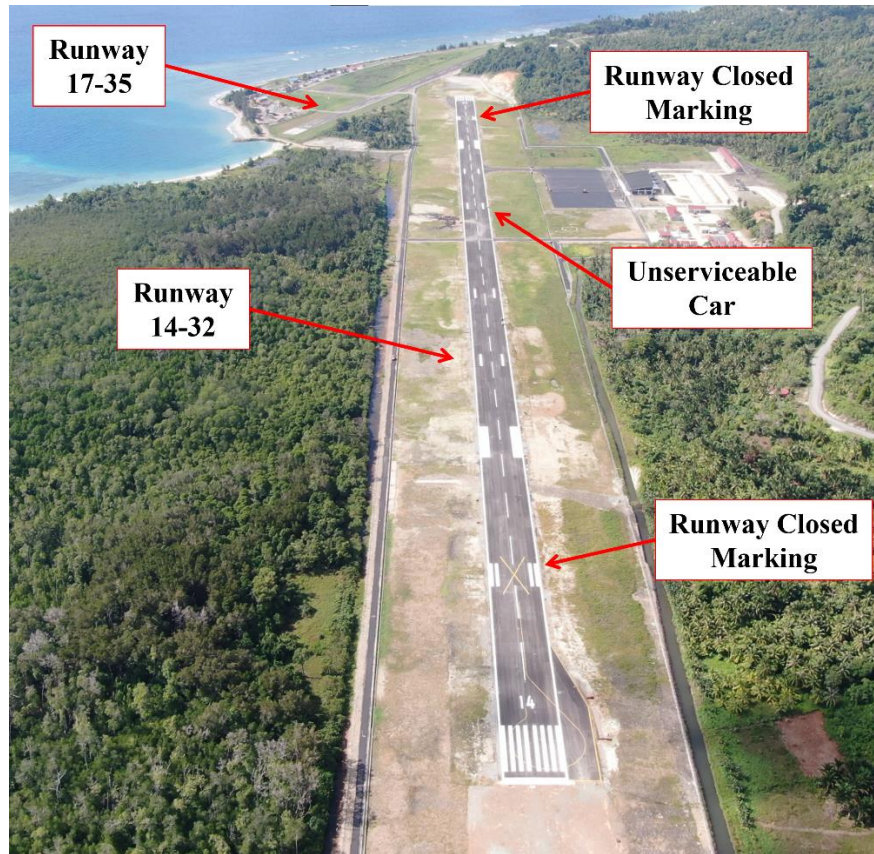
Figure 4: Runway 14-32 from aerial view (taken on 25 May 2023)

Until the day of the occurrence, the airport certification for the new airport had not been conducted as the construction of the new airport near Rokot Airport had not been completed.

Therefore, KNKT recommends the Rokot Airport to review the NOTAM content and its duration to ensure that the notice could provide pilot awareness of an undesignated Runway 14-32 at Rokot.

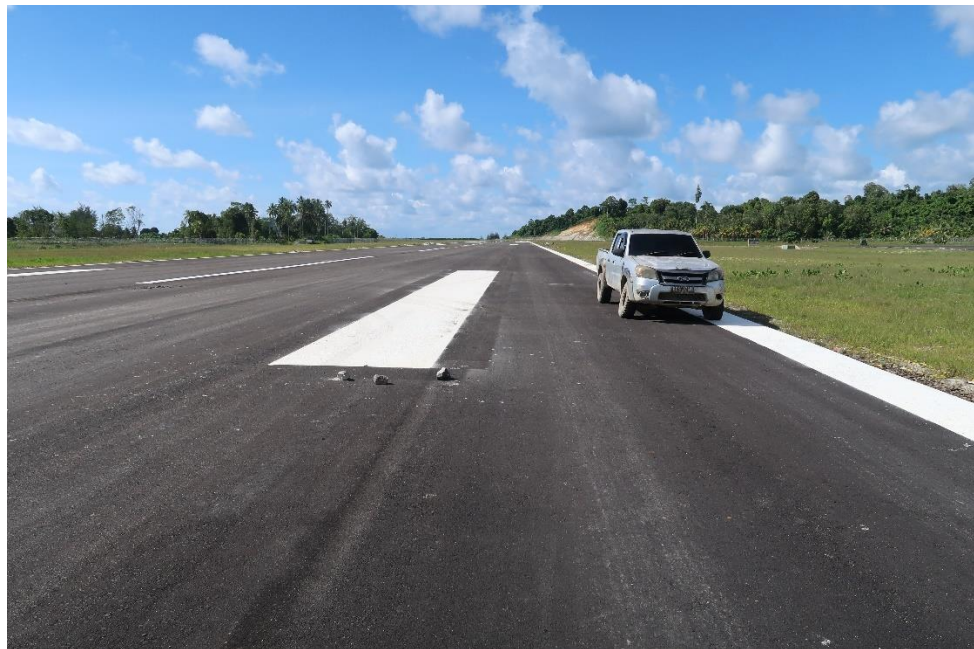
Figure 5: The unserviceable car on Runway 14-32 (taken on 25 May 2023)

In April 2023, one of the airport operational cars was unserviceable and left on Runway 14-32. The car was parked on the runway pavement near the runway edge marking and which was located about 800 meters from the beginning of Runway 14. The unserviceable car remained in the same location until the day of the occurrence.

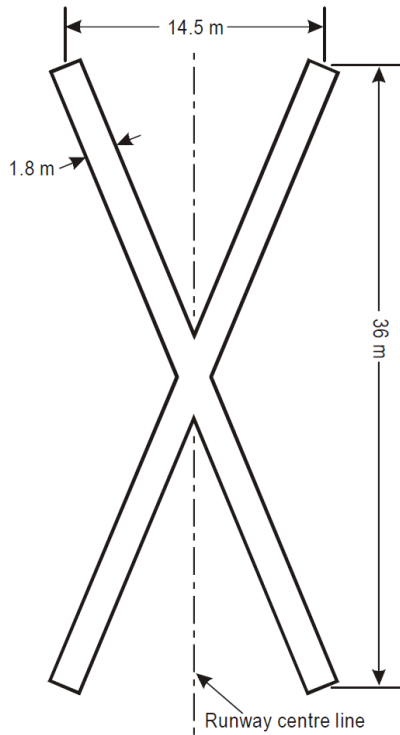
Figure 6: Illustration of closed runway marking

A closed runway marking shall be displayed on a runway or portion thereof which is permanently closed to the use of all aircraft. The closed runway marking may also be displayed on a temporary closed runway or portion thereof, except that such marking may be omitted when the closing is of short duration and adequate warning by air traffic services is provided.

The closed runway marking shall be placed at each end of the runway, or portion thereof, declared closed, and additional markings shall be so placed that the maximum interval between markings does not exceed 300 meters. The closed marking for runway shall be painted in white color with form and proportions as follows:

The regulation of closed runway markings described in the MOS CASR Part 139 was not applicable for a runway which had not been certified for airport operation by the DGCA.
