**KOMITE NASIONAL KESELAMATAN TRANSPORTASI
REPUBLIC OF INDONESIA**

Aircraft Accident Investigation Report

PAC 750 XL; PK-TET

Duma Airstrip

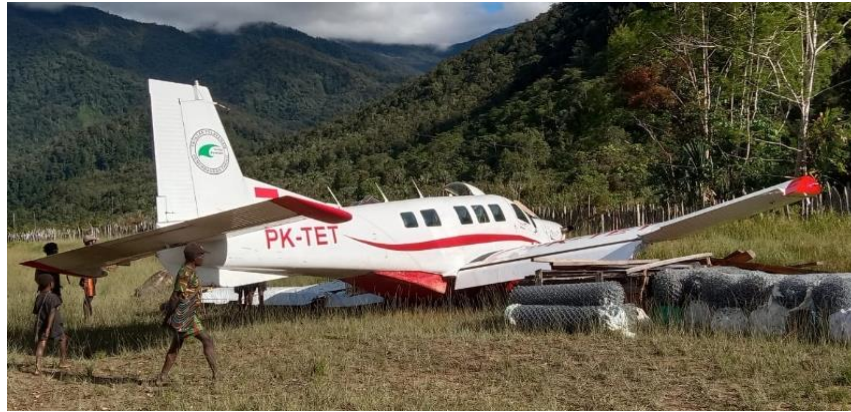
After evacuated the aircraft, the pilot observed a dead boar on the runway. No injuries were reported, and the aircraft was substantially damaged.

Figure 1: The condition of the aircraft when it had stopped completely.

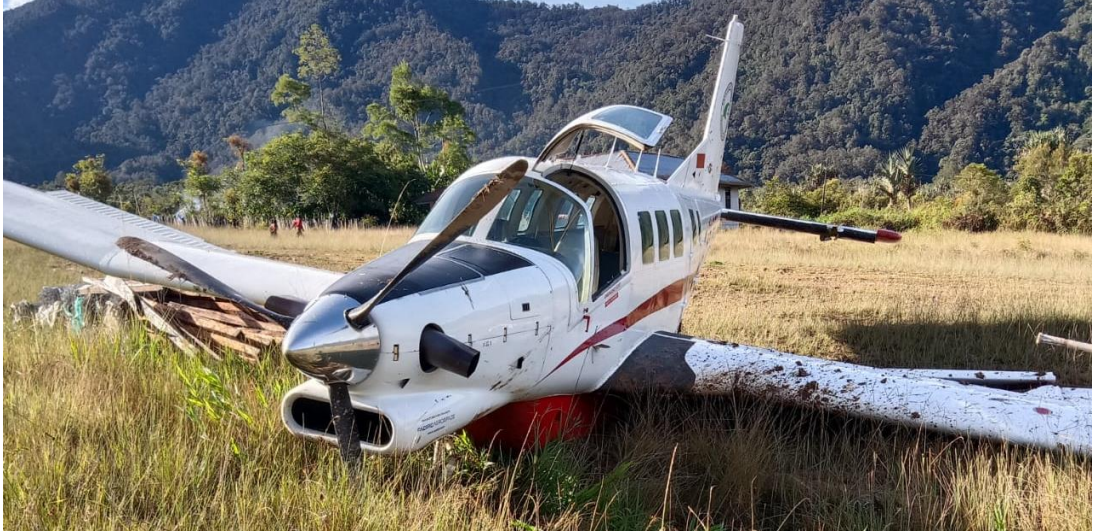
The aircraft was substantially damaged, as illustrated in Figures 3 to 7. Both wings and the left horizontal stabilizer were damaged, the nose landing gear was deformed, and the left main landing gear was detached.

Figure 3: Aircraft condition from the front view

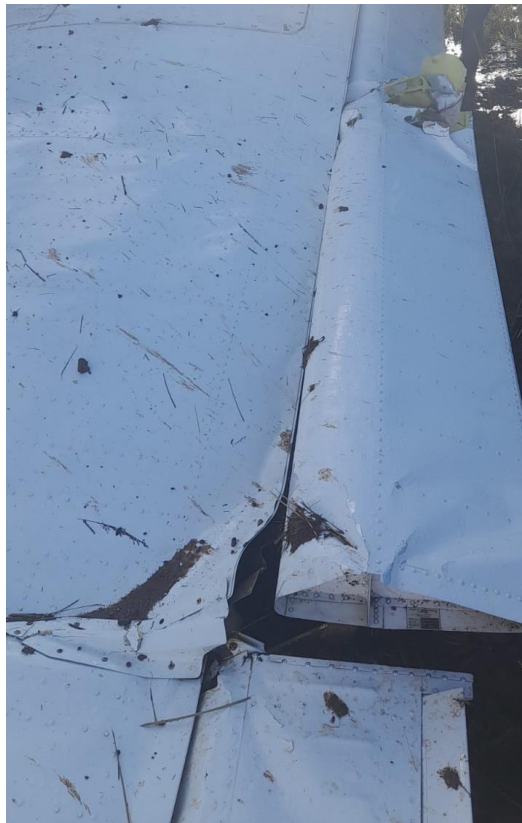
Figure 4: Damaged left wing (view looking inboard)

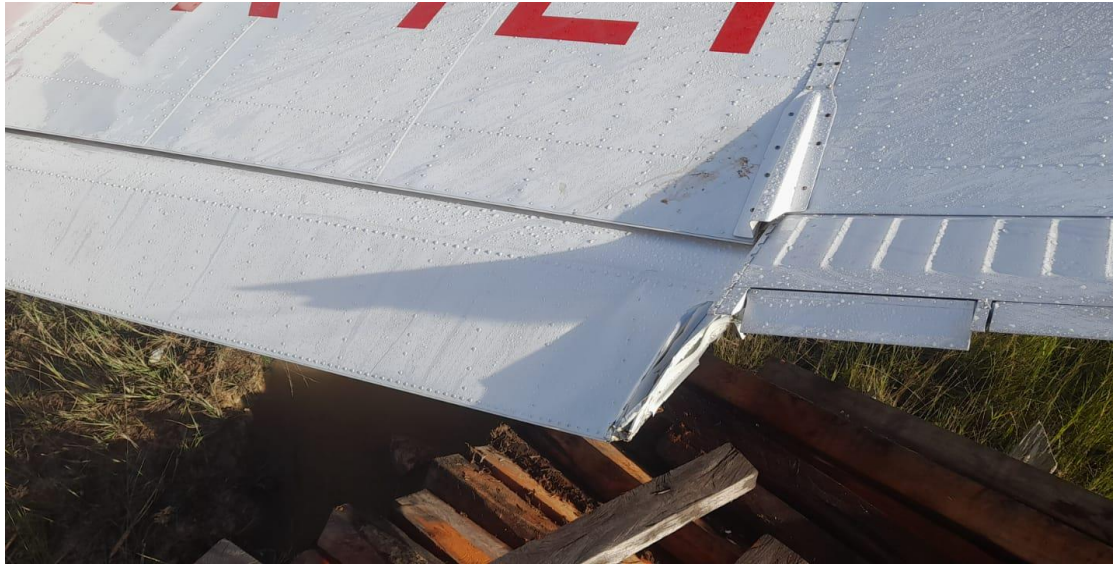
Figure 5: Damaged right wing (view looking forward)

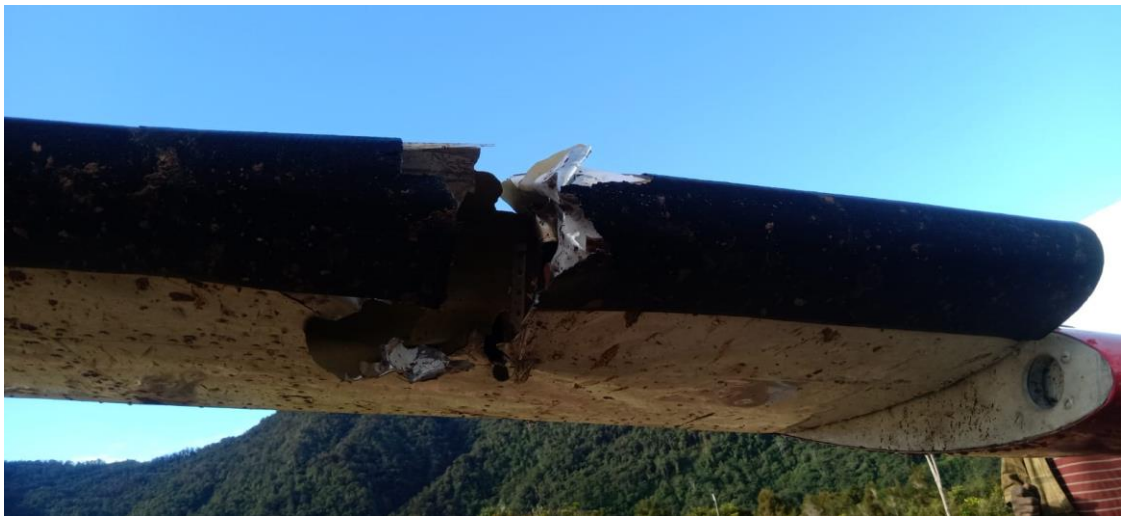
Figure 6: Damaged leading edge of left horizontal stabilizers

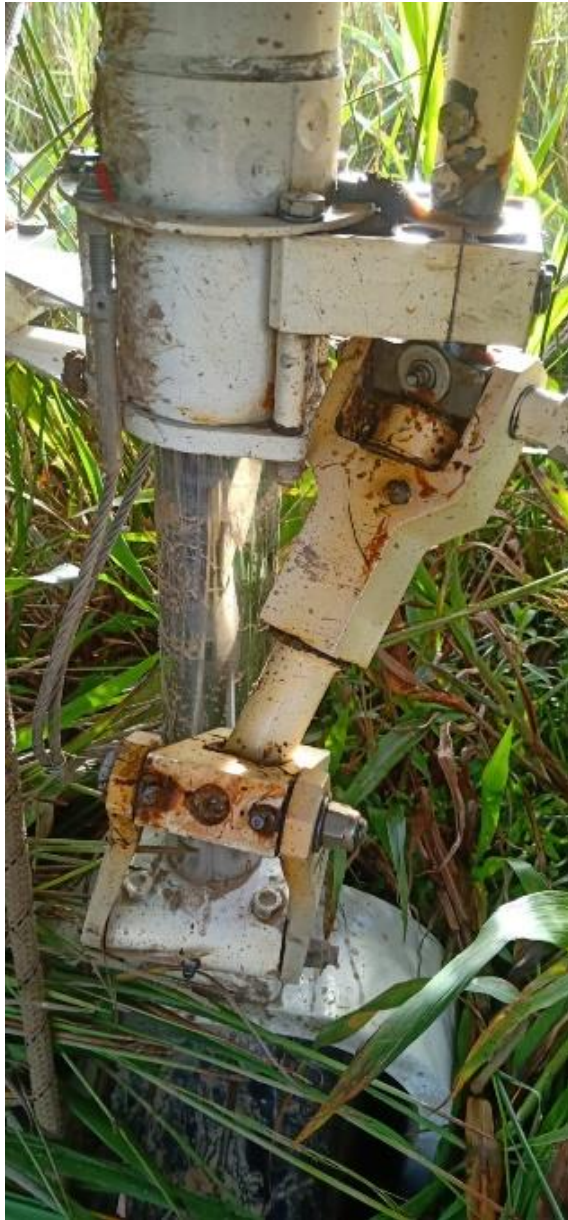
Figure 7: Broken nose landing gear torque link

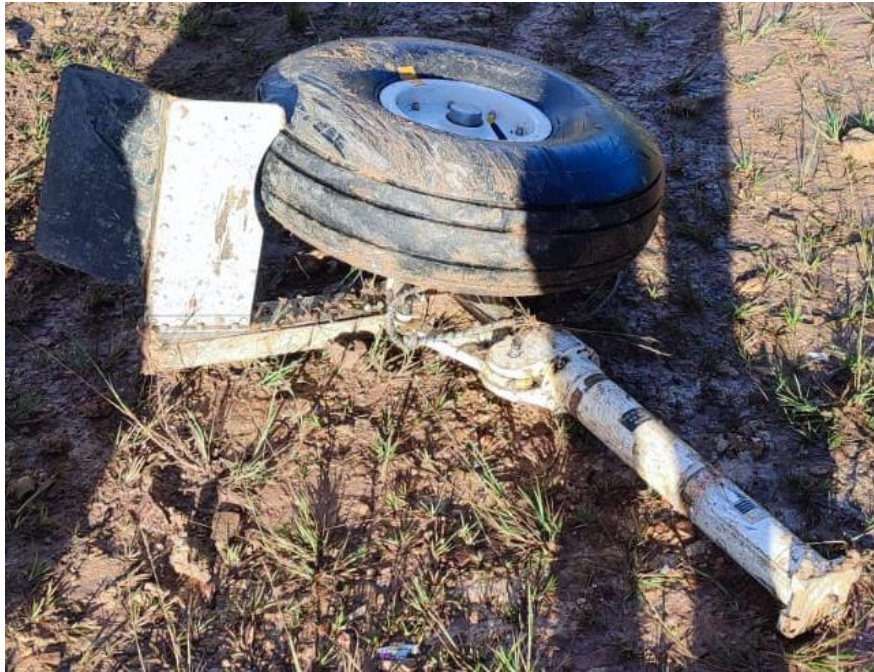
The wreckage of the detached left main landing gear (illustrated in Figure 8) was found approximately 165 meters from the suspected touchdown position and about 60 meters from the position of the aircraft stopped. Additionally, a dead boar was found on the runway, approximately 40 meters from the suspected touchdown position.

Figure 8: The detached left main landing gear

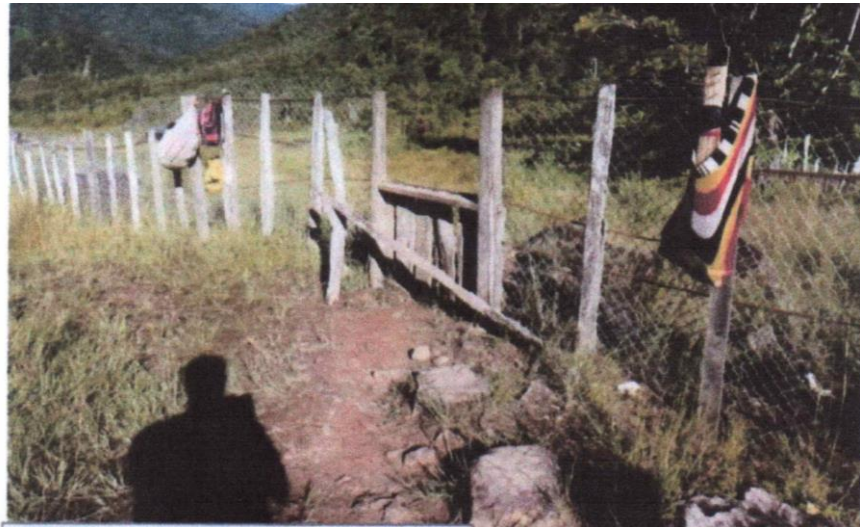
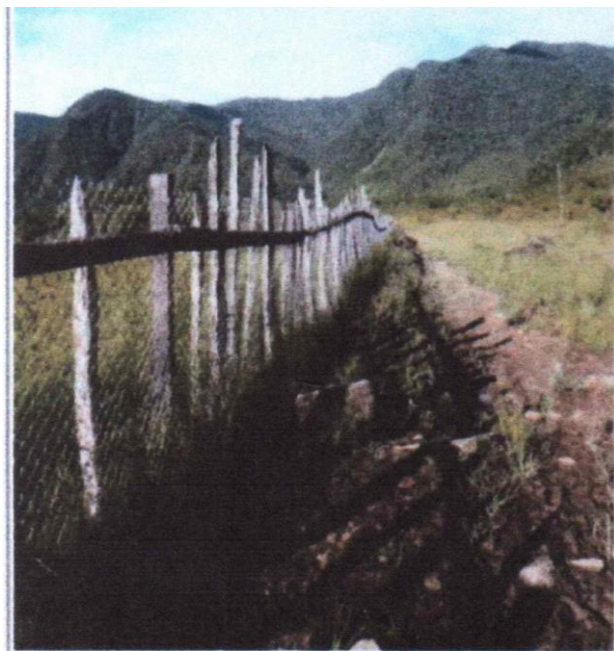
Figure 10: The fences that have been built surrounding Dumadama

The fences at Dumadama were not in a good condition, with several gaps that allowed animals, including the boar involved in the accident, to access the runway area.

1. YPPT conducted outreach to the villagers in Dumadama, who committed to maintaining and preserving the Duma airstrip.
2. The villagers constructed fences around the airstrip to control and prevent animals from entering the runway area (shown in Figure 10).
