**KOMITE NASIONAL KESELAMATAN TRANSPORTASI  
REPUBLIC OF INDONESIA**

**KNKT.23.05.09.04**

**Aircraft Accident Investigation Report**

**PAC 750 XL; PK-TET**

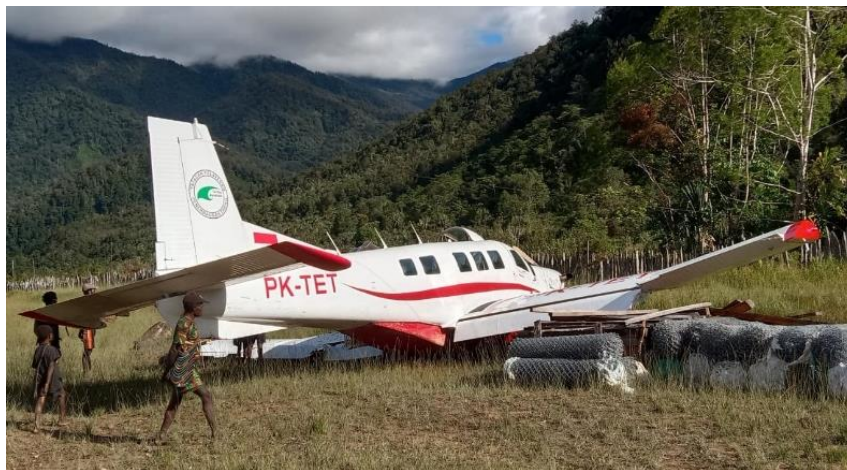
During landing, the pilot felt that the aircraft hit a bumpy surface. The pilot observed a boar was crossing from the left to the right side of the runway. The aircraft then started to veer off to the left side of the runway. The lower part of the left wing contacted the ground, hit the woodpiles and building materials near the runway, and then stopped with the nose wheel resting in the drainage ditch of the airstrip.

**Figure 1. The condition of the aircraft when it had stopped completely.**

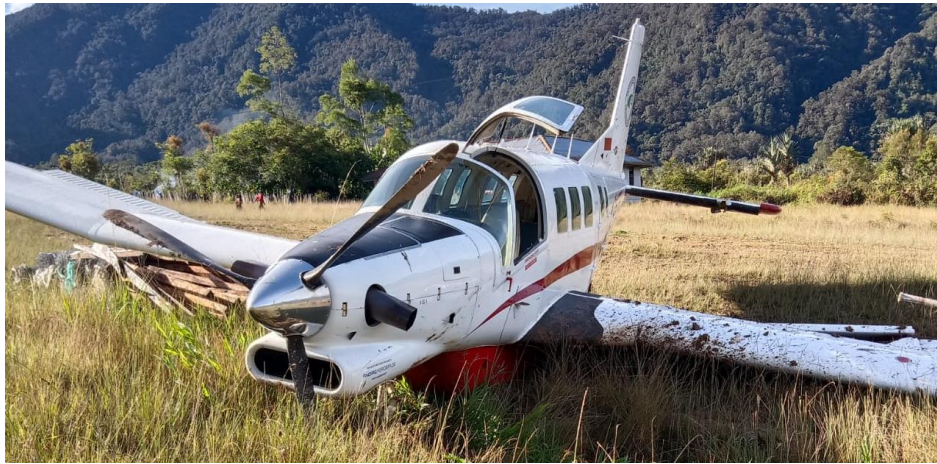
The aircraft was substantially damaged, as illustrated in Figures 2 to 6. The left main landing gear collapsed and detached. The nose landing gear was broken, wings and the left horizontal stabilizer were damaged.

**Figure 2. Aircraft condition from the front view**

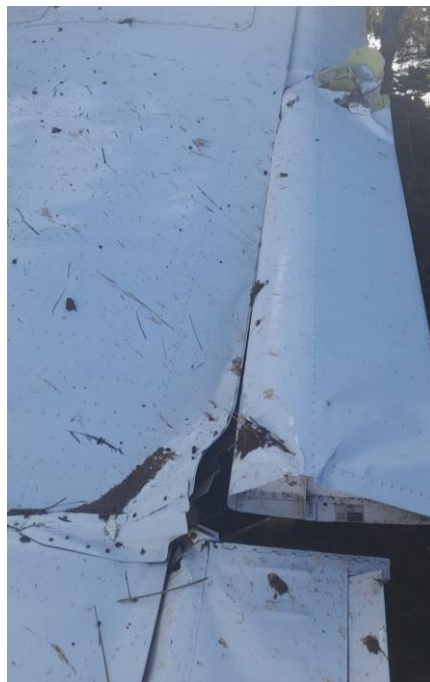
**Figure 3. Damaged left wing (view looking inboard)**

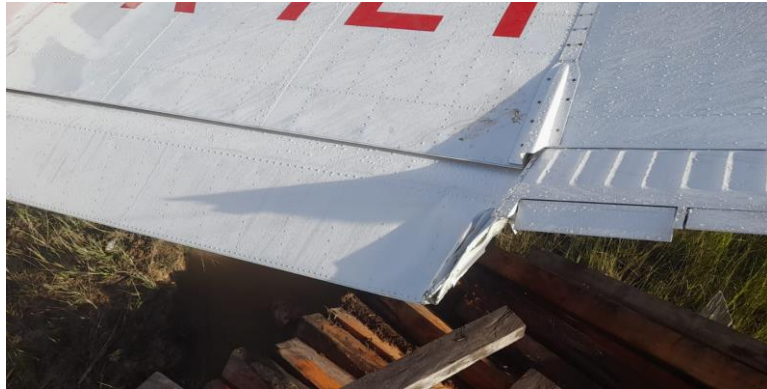
**Figure 4. Damaged right wing (view looking forward)**

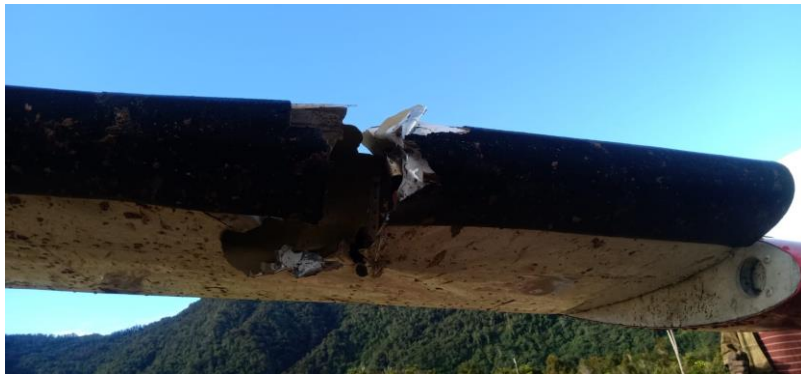
**Figure 5. Damaged leading edge of left horizontal stabilizers**

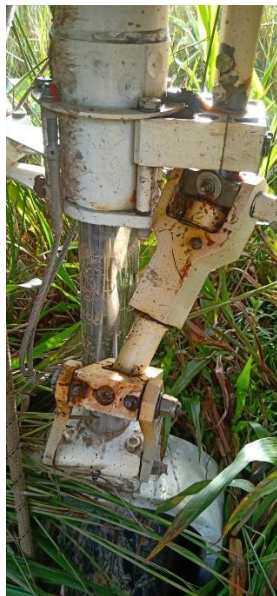
**Figure 6. Broken nose landing gear torque link**

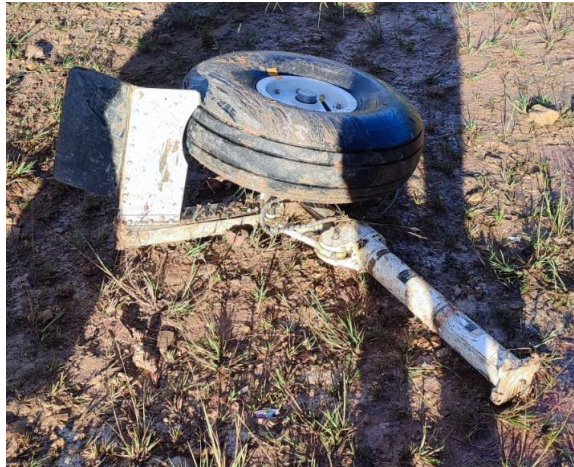
The wreckage of the detached left main landing gear (illustrated in Figure 9) was found about 165 m from the suspected touchdown position, or about 60 m from the position of the aircraft after it stopped. The boar, which was hit by the left main landing gear, was found dead at a distance of about 40 m from the suspected touchdown position.

**Figure 9. The detached left main landing gear**
