KNKT.23.05.07.04

Aircraft Accident Investigation Report

Hawker 900 XP; PK-LRU

Morowali Airport, Central Sulawesi

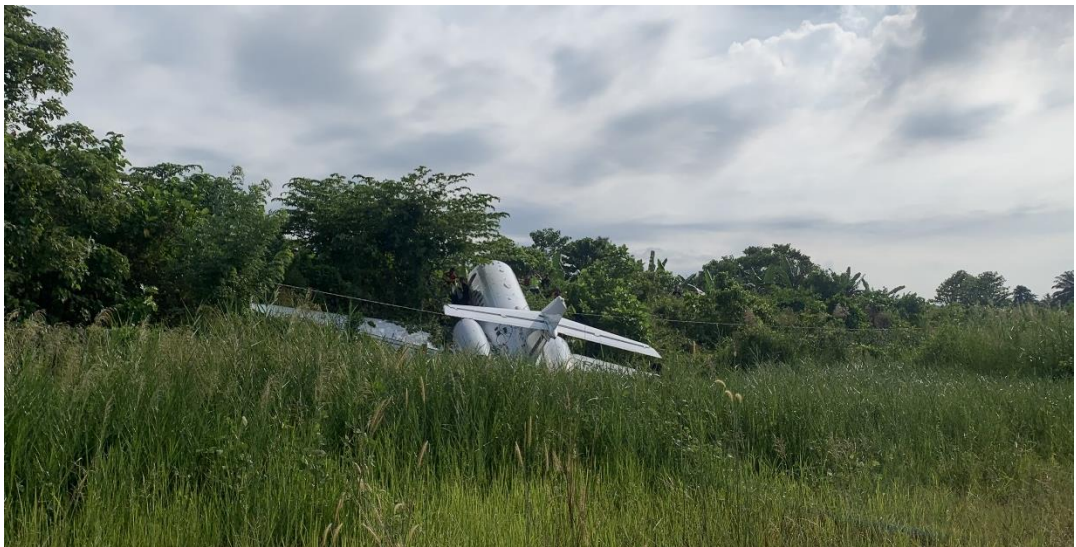
Both pilots felt that the aircraft was not decelerating. The aircraft out off the runway and stopped about 210 meters from the end of Runway 23 after impacted to the embankment.

Figure 1: The aircraft condition after stop

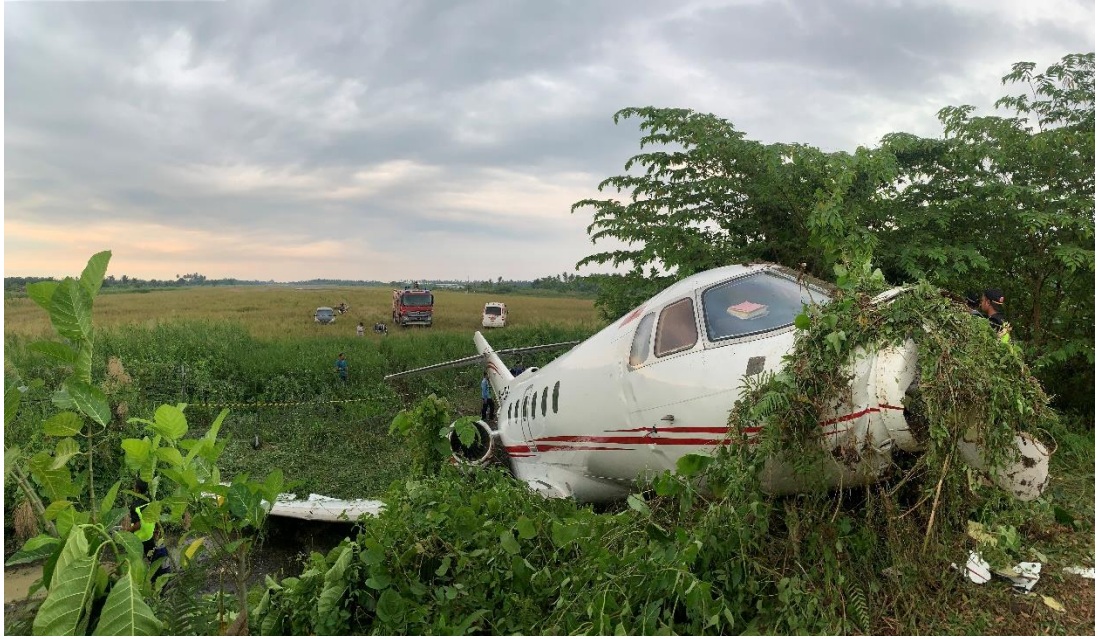
The nose landing gear was collapse. The nose radome was damage and the fuselage skin on the aft of cockpit section wrinkle.

Figure 2: The damage of nose section and the wrinkle on the fuselage

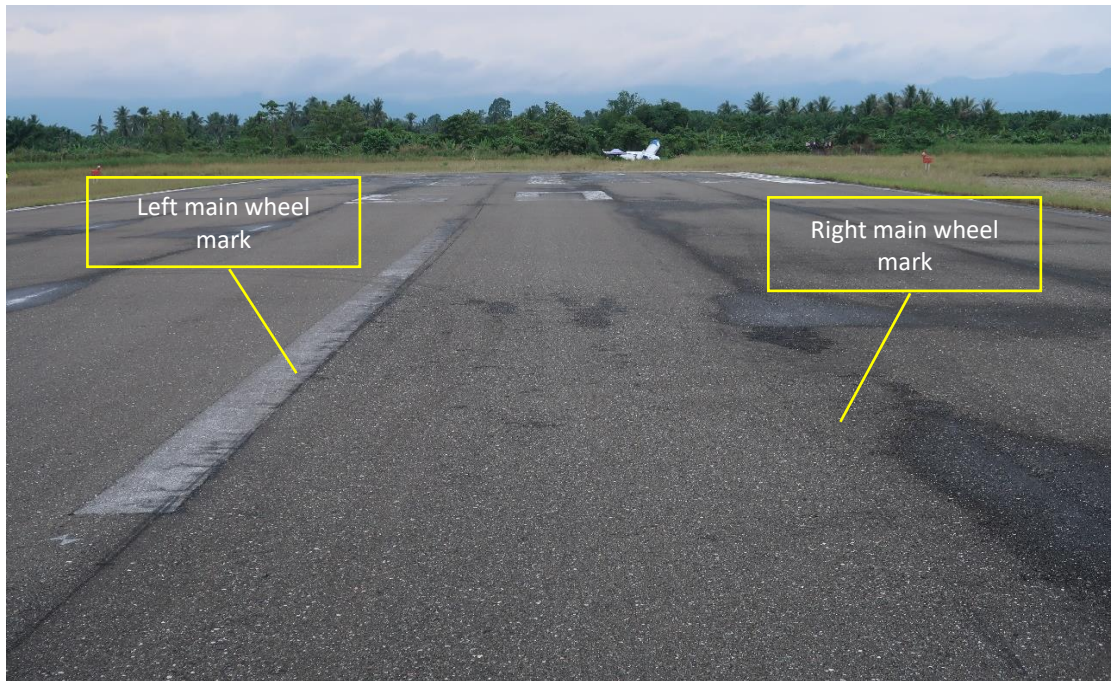
The aircraft tire marks found on the runway and able to be clearly identified about 500 meters to the end of Runway 23. The marks of the aircraft exited the runway were found on the end of Runway 23, around the runway centerline and continued to the aircraft stop position.

Figure 6: Tire marks found on the runway

11. The aircraft tire marks found on the runway and able to be clearly identified about 500 meters to the end of Runway 23. The marks of the aircraft exited the runway were found on the end of Runway 23, around the runway centerline and continued to the aircraft stop position.

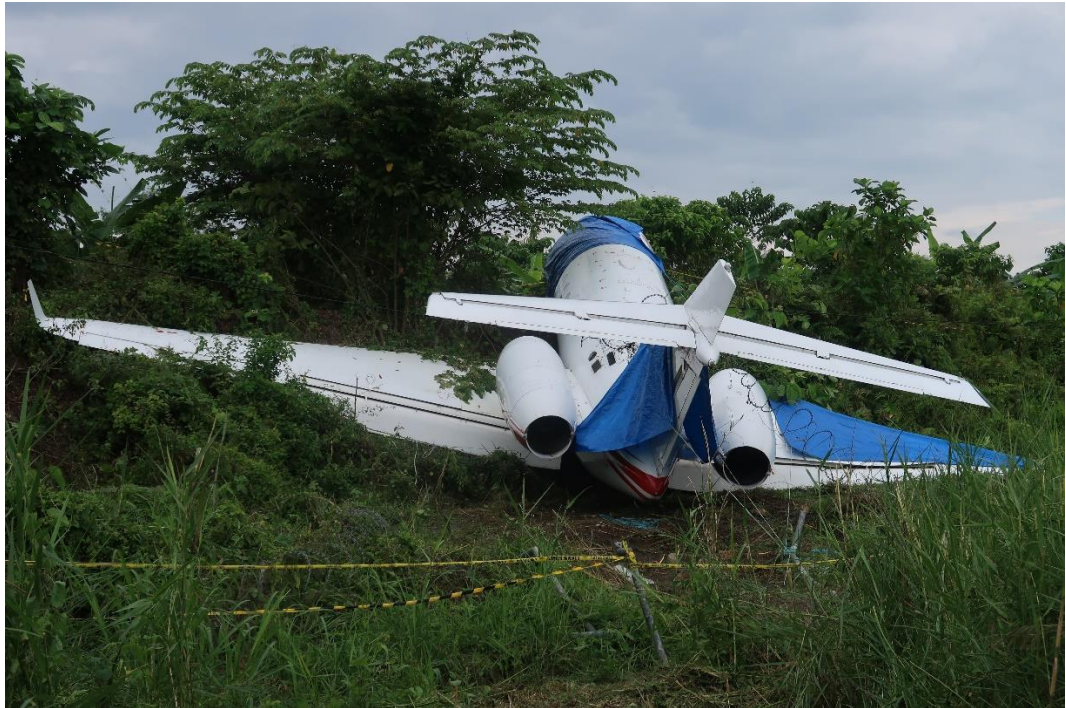
The engine thrust reverser doors were found closed and the air brake in flush position. The flaps were found on 45 position.

Figure 7: The engine thrust reversers dan air brake position

12. The aircraft out off the runway and stopped about 210 meters from the end of Runway 23 after impacting the embankment.
13. At the accident site, the engine thrust reverser doors were found closed and the air brake in flush position. The flaps were found on 45 position.
