**KOMITE NASIONAL KESELAMATAN TRANSPORTASI
REPUBLIC OF INDONESIA**

KNKT 23.06.11.04

Aircraft Accident Investigation Report

Cessna 208 Caravan; PK-SMW

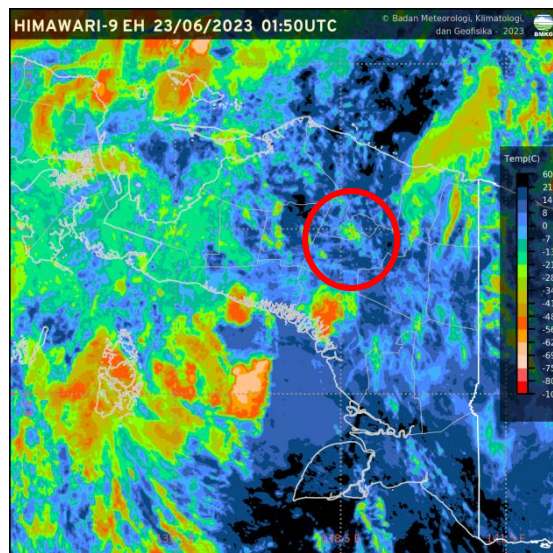
Figure 1: The enhance infrared to show the cloud top temperature on 0150 UTC

Based on the satellite images below, it was shown that the weather around Poik Airstrip was considered clear.

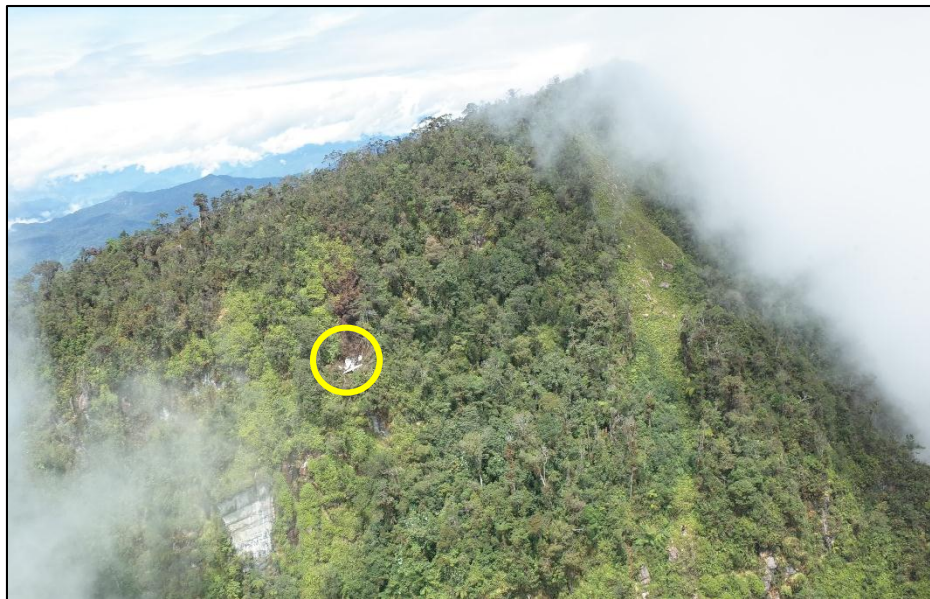
Figure 8: The location of the wreckage on the ridge

The aircraft wreckage was found at about 7.8 NM from Elelim Airport on a bearing of 158° with an elevation of about 5,600 feet (yellow-highlighted).

7. The aircraft was found impacted into the ridge of the mountain with an elevation of about 5,600 feet on coordinates of 3° 54' 26.35" S and 139° 25' 53.08" E. The crash site location is about 9.5 NM from Poik Airstrip on bearing 030° or about 7.5 NM from Elelim Airport on bearing 158°.

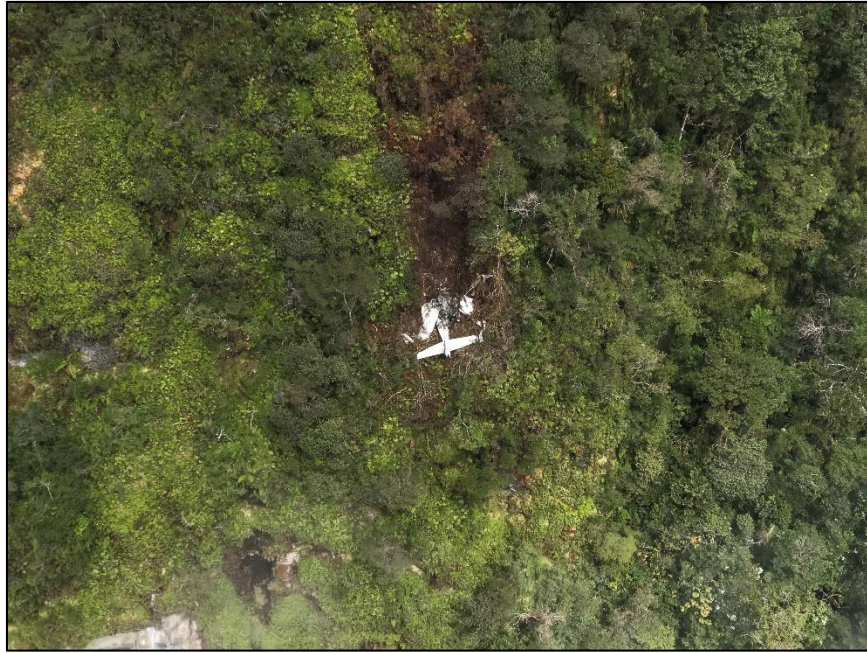
Figure 9: The accident site

The aircraft was destroyed.

The evidence of in-flight fire was unknown. There was evidence of burnt vegetation in surrounding the impact area.

On 25 June 2023, the search and rescue team found the location of the crash site. The accident was unsurvivable. Due to the weather, the evacuation could not be conducted, and the team stayed overnight near the crash site.
