**KOMITE NASIONAL KESELAMATAN TRANSPORTASI
REPUBLIC OF INDONESIA**

Aircraft Serious Incident Investigation Report

Pilatus PC-6/B2-H4; PK-VVU

12 July 2023

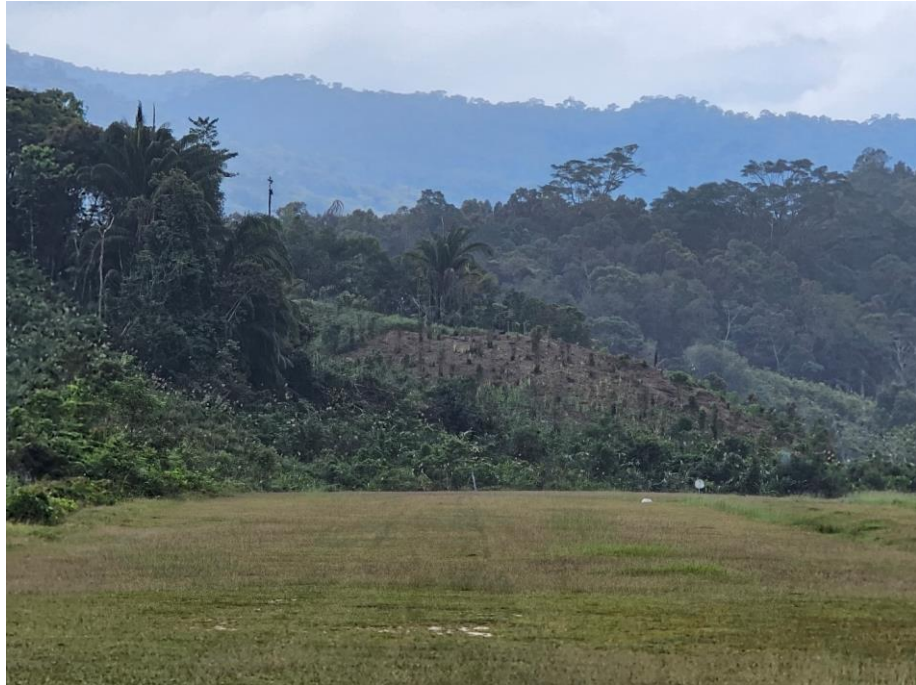
There is a hill with some vegetation on the short final path of Runway 19, presenting hazards for the approach to Runway 19.

Figure 1: The hill with vegetation on the short final path of Runway 19.

Therefore, KNKT recommends that Susi Air develop and implement detailed approach procedures that address obstacle avoidance for Runway 19 of Long Layu Airstrip.

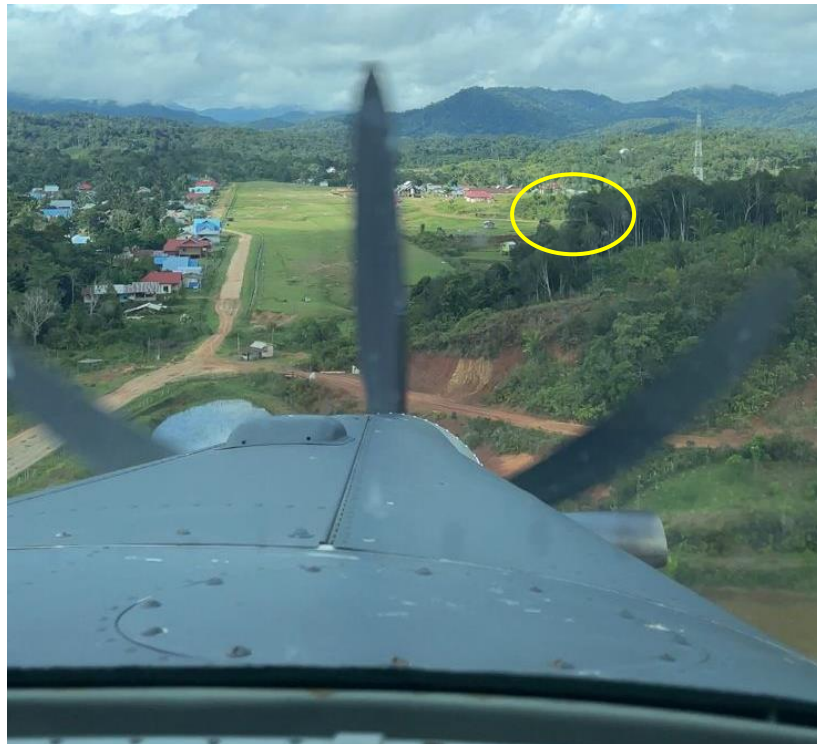
Figure 2: Predicted impact location (highlighted in yellow). The picture was taken on a different flight after the occurrence, before the tree was cut down.

The aircraft operator had never received any documented report regarding the tree as a hazard since it has been included in the ARB. It was only after the incident, the tree was subsequently cut down as requested by the aircraft operator. This indicates that the airstrip operator was unaware of the tree posing a hazard to flight operations.

Therefore, KNKT recommends that Susi Air work closely with airstrip operator to regularly assess and mitigate the risk of all hazards to ensure safe flight operations.

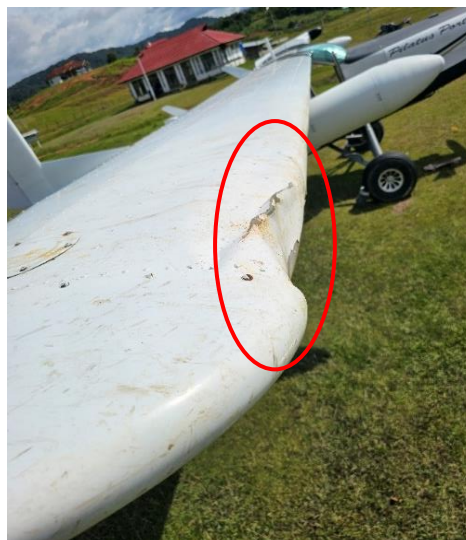
After the aircraft came to a complete stop, the pilot performed a walk-around inspection with an engineer and discovered a dent on the leading edge of the right wing. The dent indicated that the aircraft's right wing striking tree branches. No injuries were reported, and the aircraft sustained minor damage.

The outer surface of the right wing leading edge was dented, as shown in Figure 3.

Figure 3: Dent on the leading edge of right wing (red-highlighted). View from right hand side of the aircraft (looking inboard).

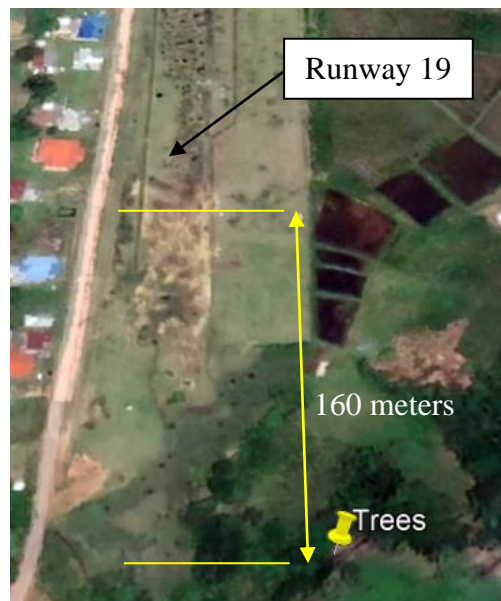
The predicted impact location was the trees on final approach, approximately 160 meters from the beginning of Runway 19, as shown in Figure 4.

Figure 4: Predicted location of the tree relative to the beginning of Runway 19
