**KNKT 23.10.15.04**

**Aircraft Serious Incident Investigation Report**

**PT Smart Cakrawala Aviation**

**Cessna 208B EX; PK-SNI**

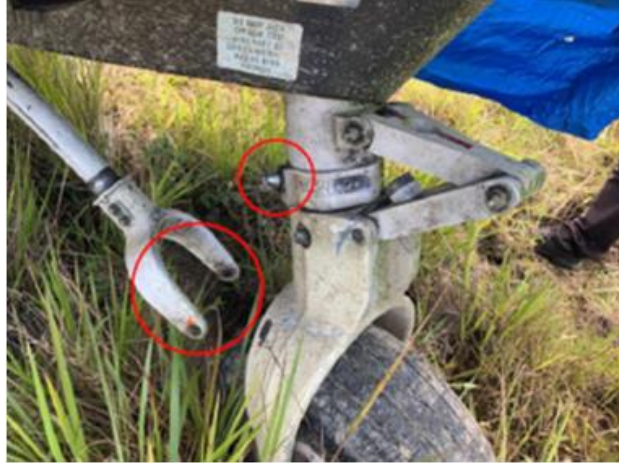
The aircraft was substantially damaged. The fork draglink spring bearing comes out, bolt fork draglink spring shear cut off, left main tire burst and the fairing damage and cargo pod C, D damage. The damages are shown in the figure below.

**Figure 1: Bolt AN6-52A shear cutoff and fork draglink spring bearing come out**

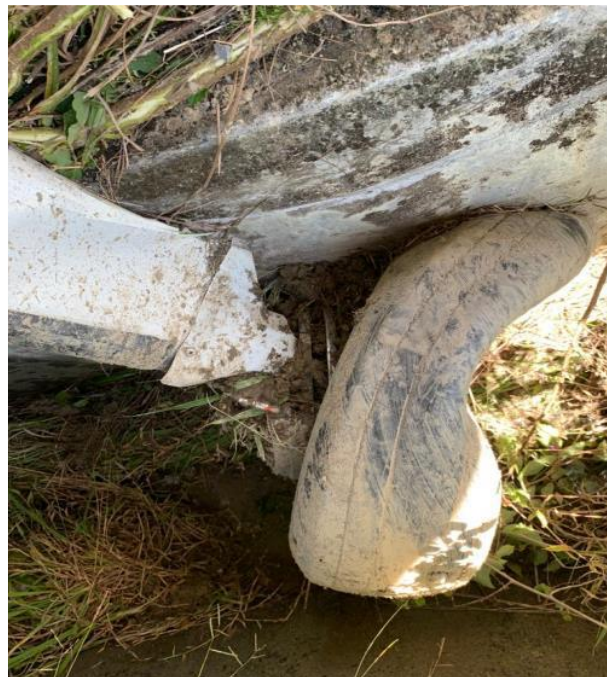
**Figure 2: Left main landing gear tire burst and fairing damage**

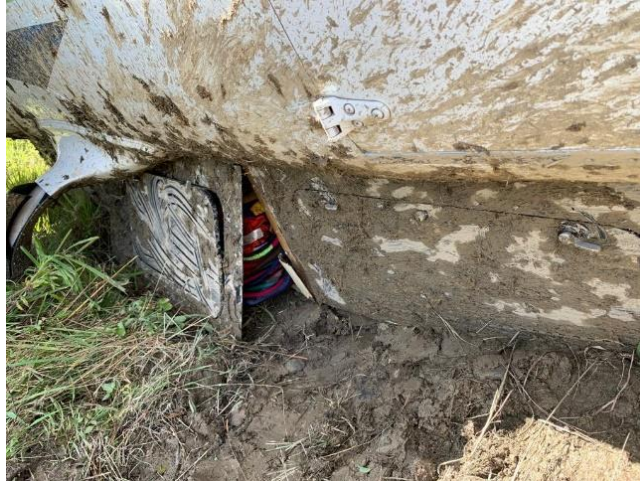
**Figure 3: Cargo pod C and D damage**

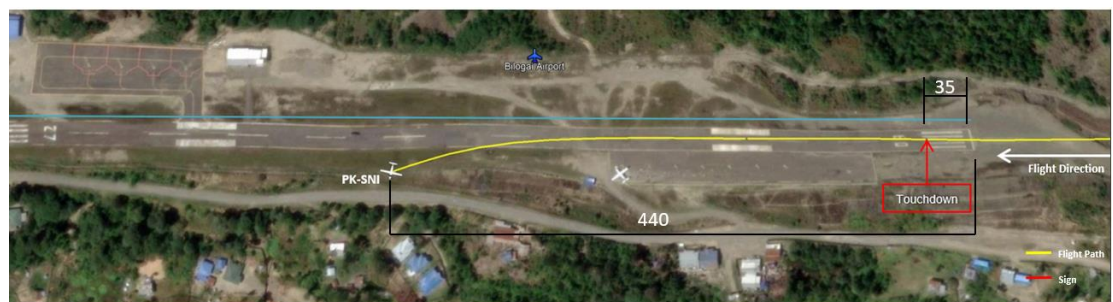
Based on video and photograph, the aircraft touchdown point was about 35 meters from the beginning of Runway 09. The marks of the aircraft exiting the runway were found on the left side of the runway and then continued until the aircraft stopped about 440 meters from the beginning of Runway 09.

**Figure 7: Illustration of the aircraft's runway excursion**

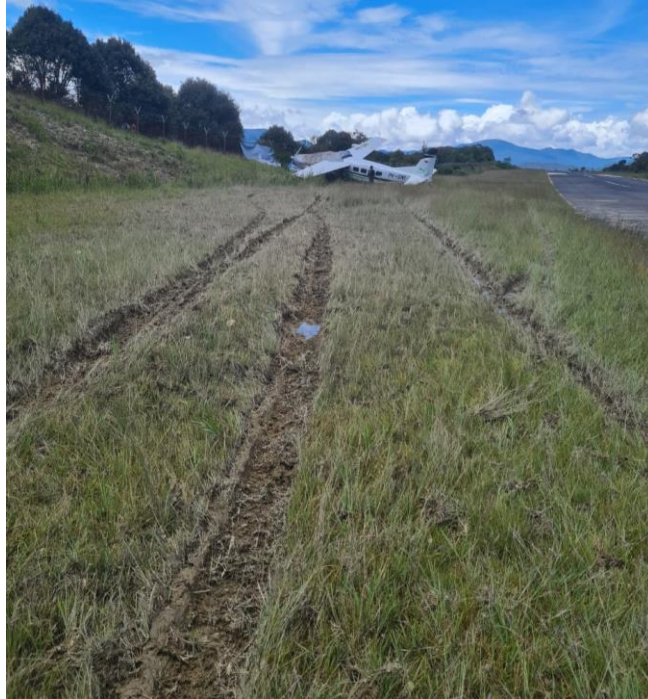
**Figure 8: The aircraft tire marks outside the runway**

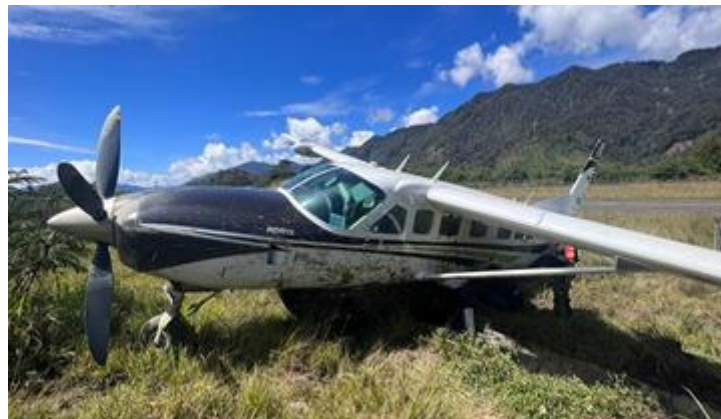
**Figure 9: The aircraft position at the rest condition**

11. The aircraft rest position was about 440 meters from the beginning of Runway 09.
12. No one was injured in this occurrence.
