**Aircraft Accident Investigation Report**

**PT. Garuda Indonesia**

**B737-800; PK-GNM**

**7 August 2023**

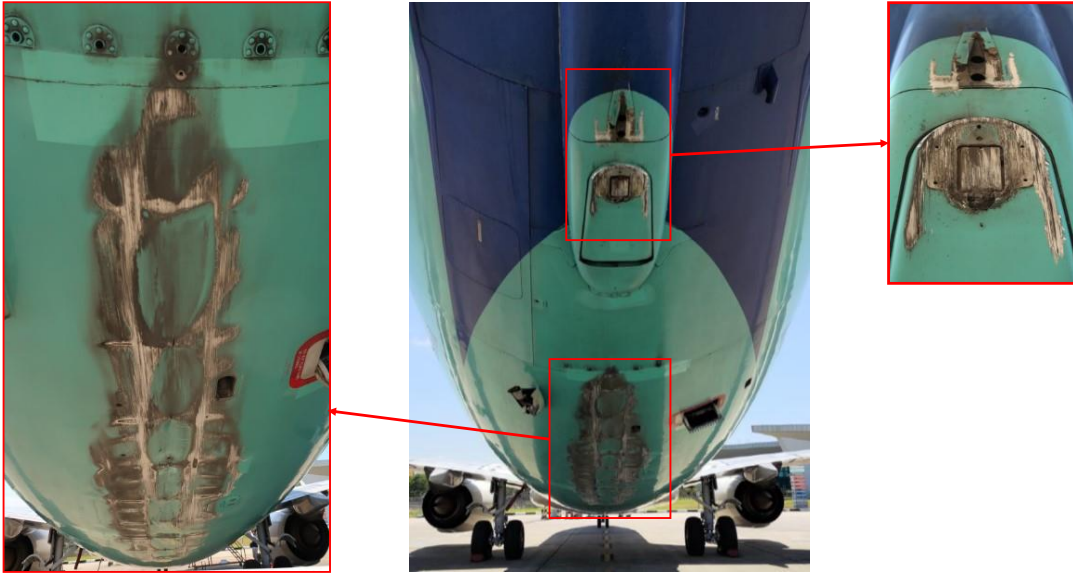
**Figure 1. External damage on lower surface of the aft fuselage**

The damage was found on the lower surface of the aft fuselage and the tailskid damper on the section 46 to 48, from station 827 to 1088. The damages were scratches, cracks, and punctures on lower surface of the aft fuselage skin. The widest scratch marks dimension found on the lower aft fuselage skin was 78 cm. The tailskid damper was detached. The details of the damage are shown in Figure 1.

10. The flight returned and safely landing using Runway 10.
11. The aircraft was substantially damage with some scratches, deformations, cracks, punctures, and holes on lower surface of the aft fuselage skin and its structures.

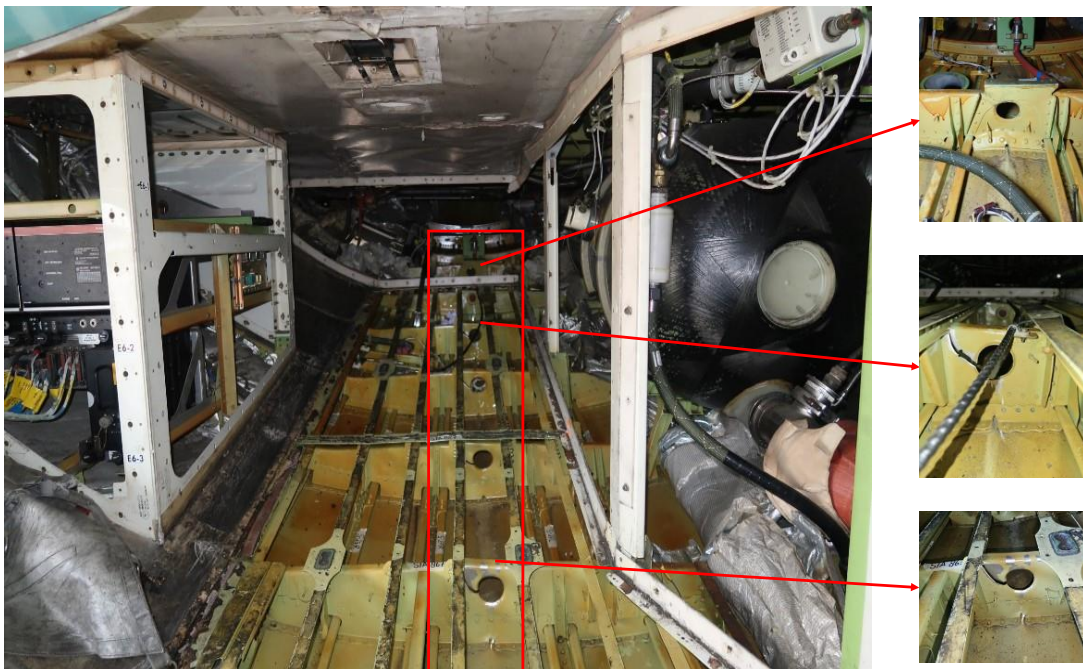
**Figure 2. Internal damage on lower surface of the aft fuselage**

The damages were also found on the aft fuselage structure which consisted of crack and deformation on the frame, stringer, and clip. The details of the damage are shown in figure 2.

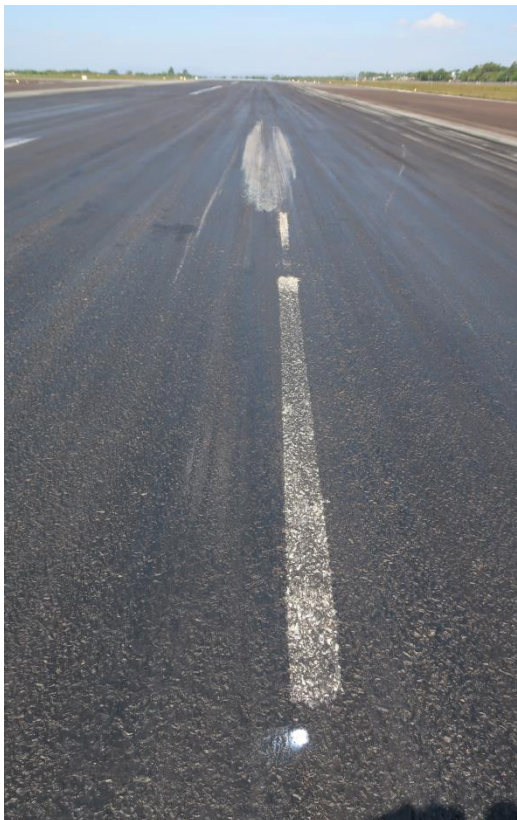
**Figure 3. Scratch marks on the runway**

Scratch mark was found on the runway, approximately 400 meters from the beginning Runway 10 and about 3.5 meters on the right of runway centerline. The length of the scratch mark was approximately 18 meters and widest part was about 80 centimeters.
