**KOMITE NASIONAL KESELAMATAN TRANSPORTASI
REPUBLIC OF INDONESIA**

KNKT.23.08.14.04

Aircraft Accident Investigation Report

B737-800; PK-GNM

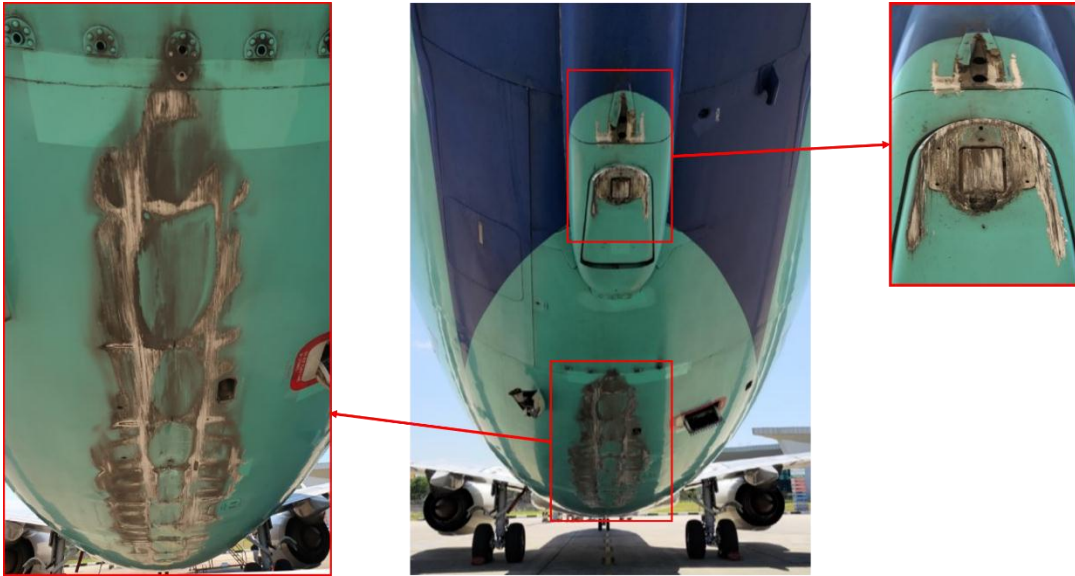
The damage was found on the lower surface of the aft fuselage and the tailskid damper on the section 46 to 48, from station 827 to 1088. The damages were scratches, cracks, and punctures on lower surface of the aft fuselage skin. The widest scratch marks dimension found on the lower aft fuselage skin was 78 cm. The tailskid damper was detached. The details of the damage are shown in Figure 1.

Figure 1. External damage on lower surface of the aft fuselage

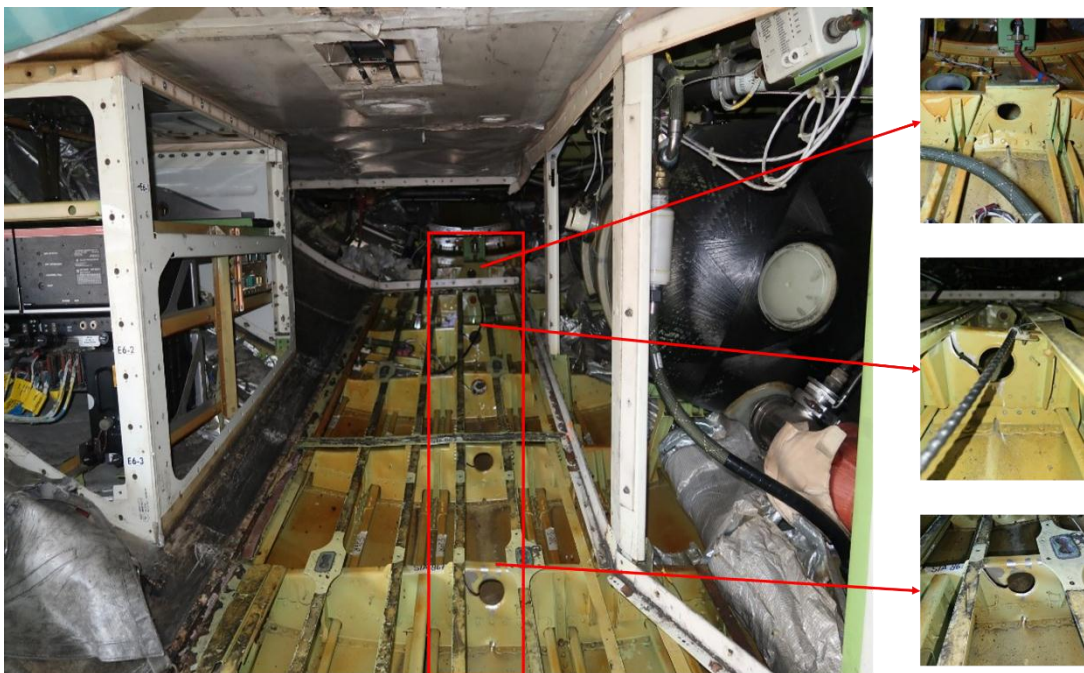
The damages were also found on the aft fuselage structure which consisted of crack and deformation on the frame, stringer, and clip. The details of the damage are shown in figure 2.

Figure 2. Internal damage on lower surface of the aft fuselage

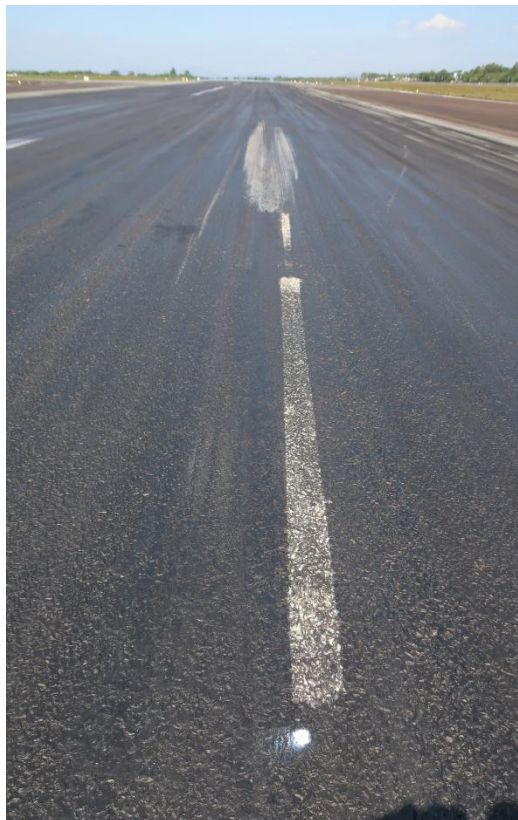
Scratch mark was found on the runway, approximately 400 meters from the beginning Runway 10 and about 3.5 meters on the right of runway centerline. The length of the scratch mark was approximately 18 meters and widest part was about 80 centimeters.

Figure 3. Scratch marks on the runway

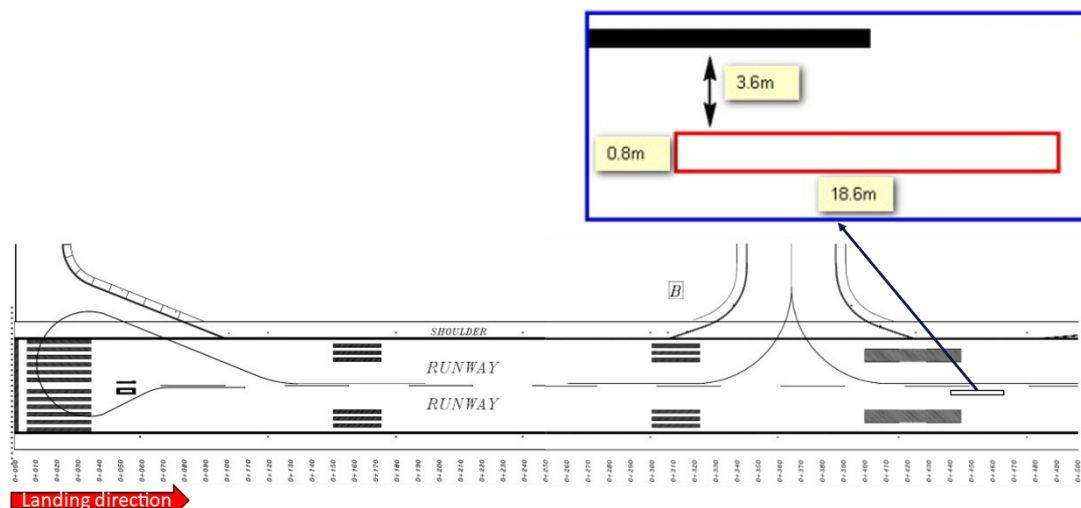
Figure 4. Location of the marks found on the runway
