**KOMITE NASIONAL KESELAMATAN TRANSPORTASI
REPUBLIC OF INDONESIA**

Aircraft Accident Investigation Report

Beechcraft Baron G58; PK-LRV

5 October 2023

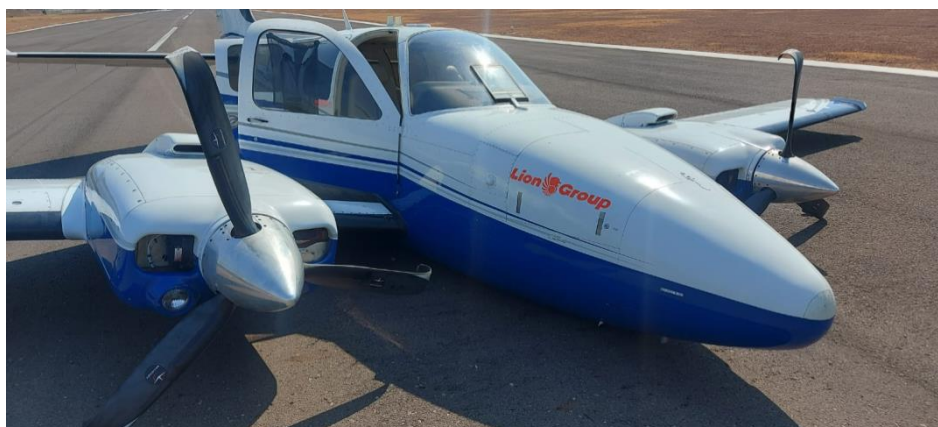
Figure 1: The aircraft condition after the stop

The aircraft was substantially damaged as a result of the occurrence.

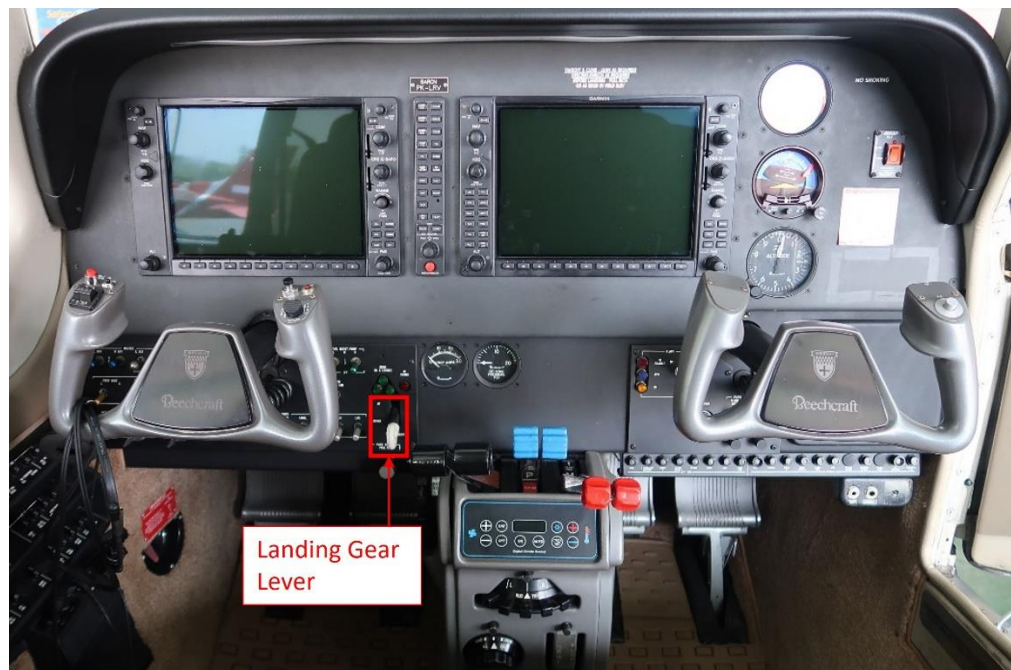
The landing gear of the aircraft was retractable and can be controlled by a two-position switch on the right side of the pilot's subpanel. The switch handle must be pulled out of the safety detent before it can be moved to the opposite position.

Figure 2: The landing gear lever position

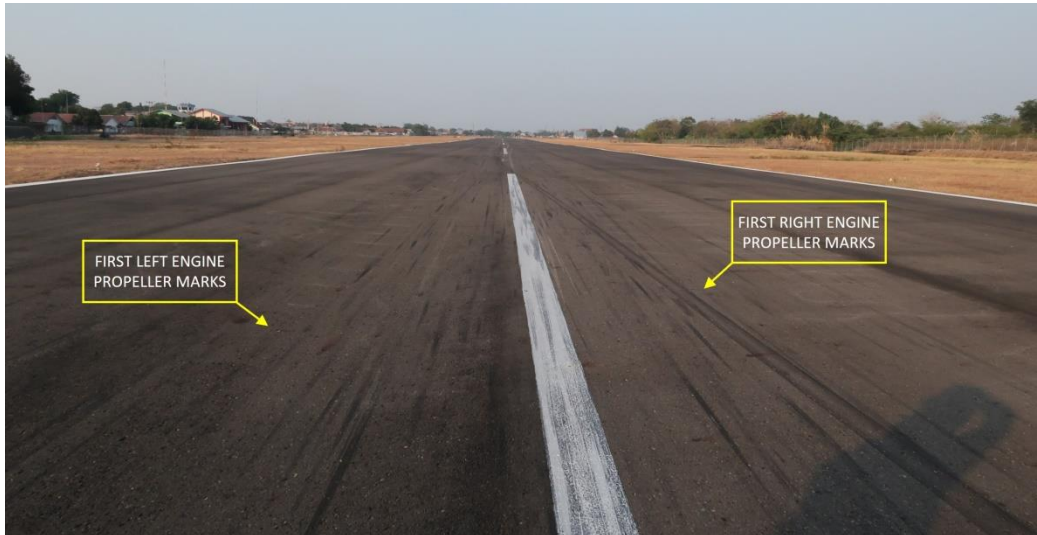
The aircraft propeller marks were found on the runway and were able to be identified about 390 meters around the runway centerline and from the beginning of Runway 04. The aircraft lower fuselage marks were found about 2 meters from the propeller marks and continued to the aircraft stop position.

Figure 7: The propeller marks found on the runway

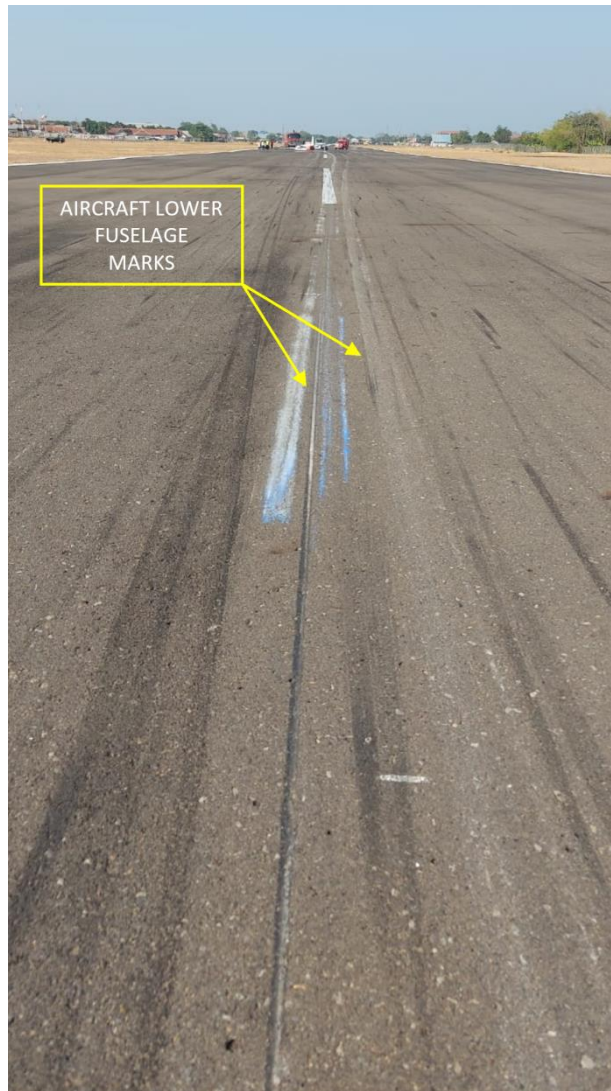
Figure 8: The aircraft lower fuselage marks found on the runway

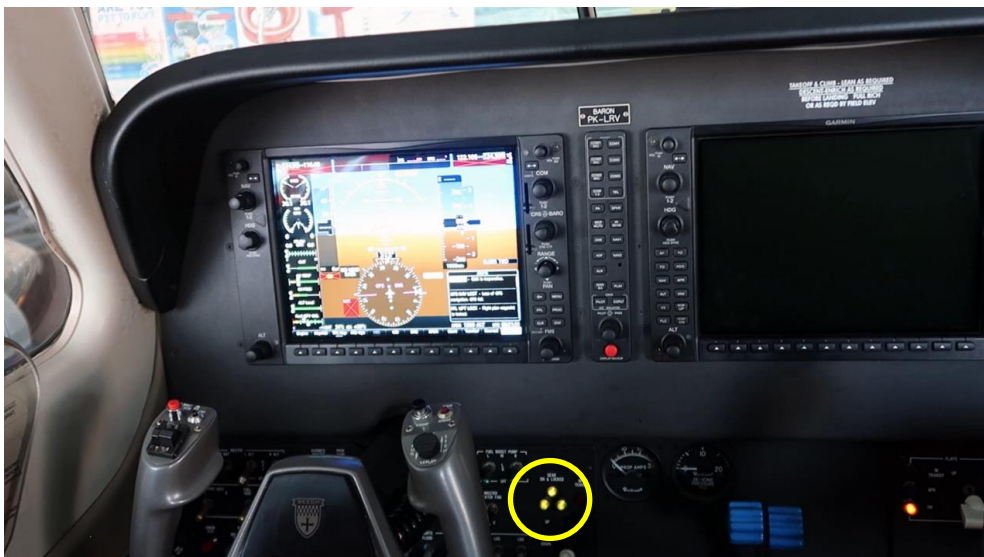
1. When both master switches were placed in the ON position, the aircraft avionic system was working properly.

Figure 11: The yellow circle showed the three green lights were illuminated

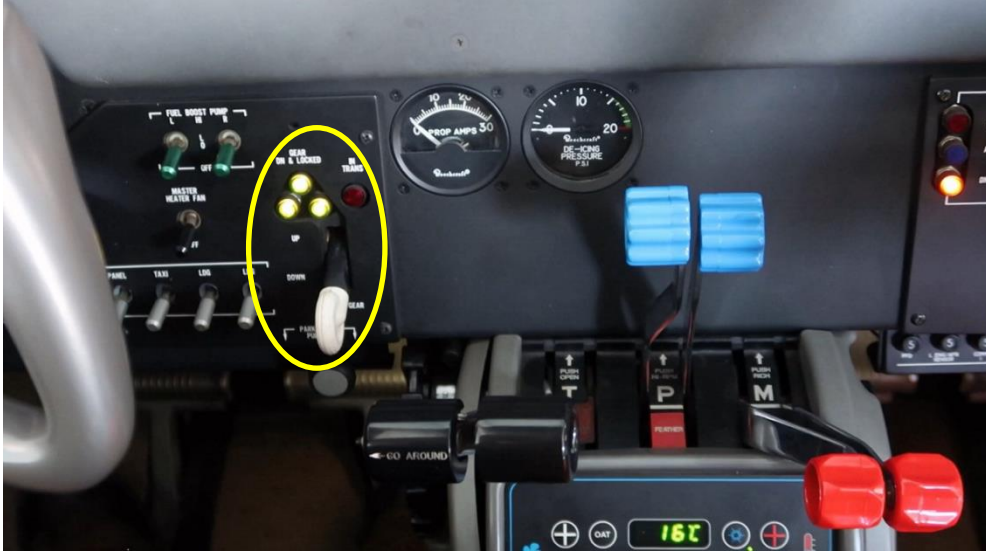
2. The three green landing gear lights were illuminated normally.

Figure 12: The yellow circle indicates the three green lights and the landing gear lever states in the down position

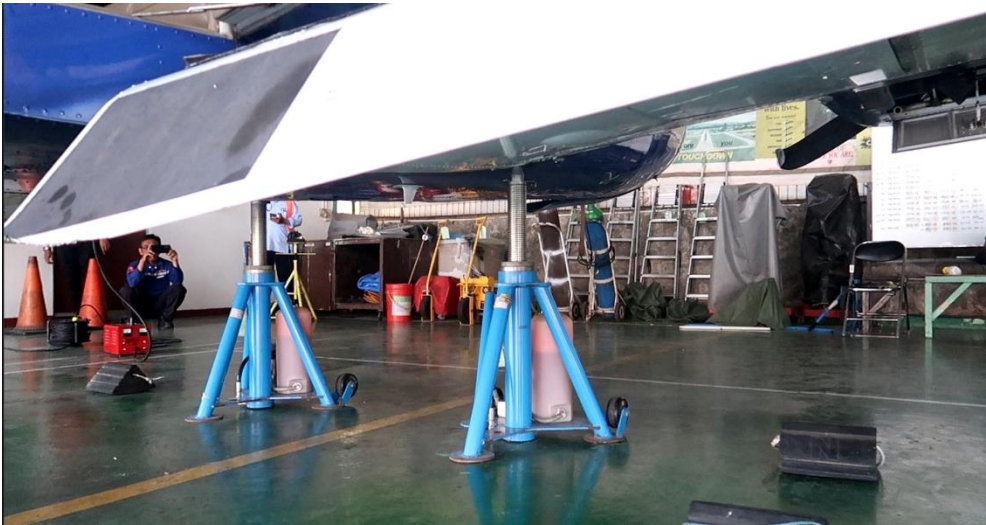
3. When the landing gear lever was selected from the down to the up position, the landing gear was retracted. It took 4 seconds starting from the selection of the landing gear in the down position to the up position until both landing gear doors were closed and the landing gear lights were not illuminated.

Figure 13: The landing gears were in the up position while the flap was extended

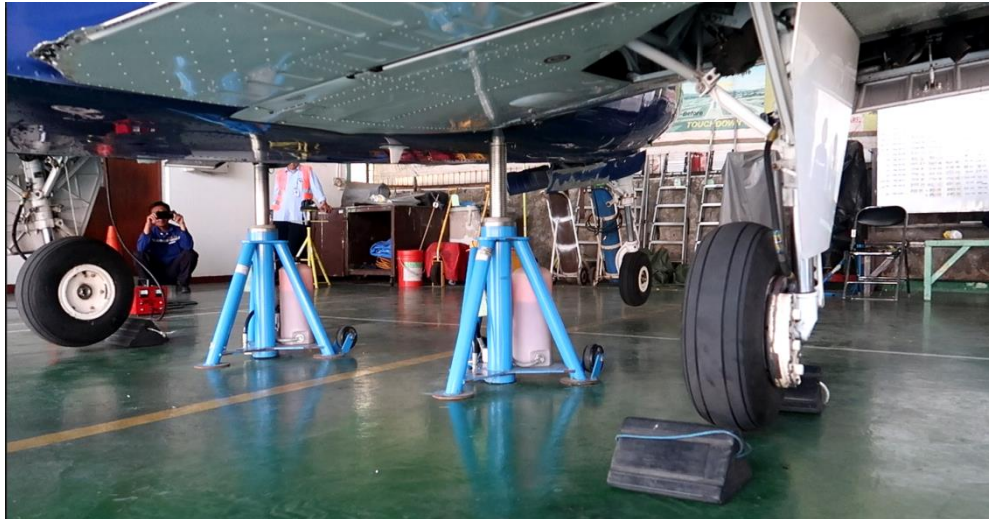
4. When the landing gear lever was selected from the up the down position, the landing gears were extended. It took 4 seconds starting from the selection of the landing gear from the up position to the down position until the landing gear doors were closed and landing gear lights were illuminated green.

Figure 14: The landing gears were in the up position while the flap was set in the up position

The up and down test of the landing gears concluded that the landing gears were operated normally.

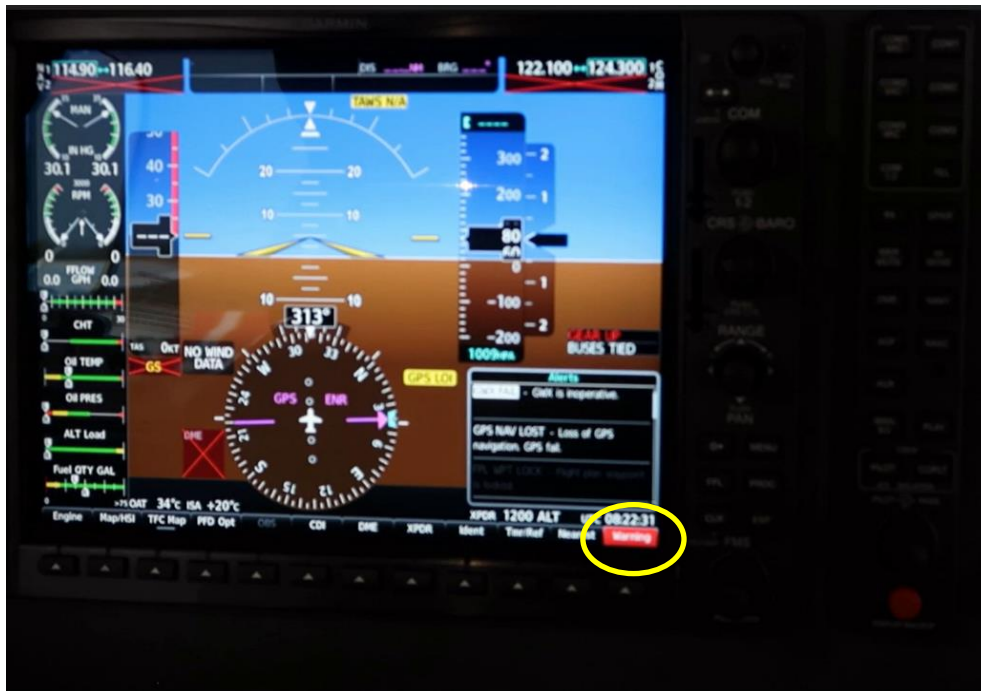
1. Both master switches were placed in the ON position, the landing gear warning horn aural warning was activated and the sound was significantly heard in the cockpit.
2. The landing gear annunciator was appearing in red color on PFD.

Figure 15: The yellow circle indicates the red warning in the PFD

The landing gear warning horn and annunciator test result showed that the warnings were activated normally as stated in the Pilot Operating Handbook (POH) and the Aircraft Maintenance Manual.
