**KOMITE NASIONAL KESELAMATAN TRANSPORTASI
REPUBLIC OF INDONESIA**

Aircraft Accident Investigation Report

Beechcraft G58 Baron; PK-LRV

Cakrabhuwana Airport, Cirebon

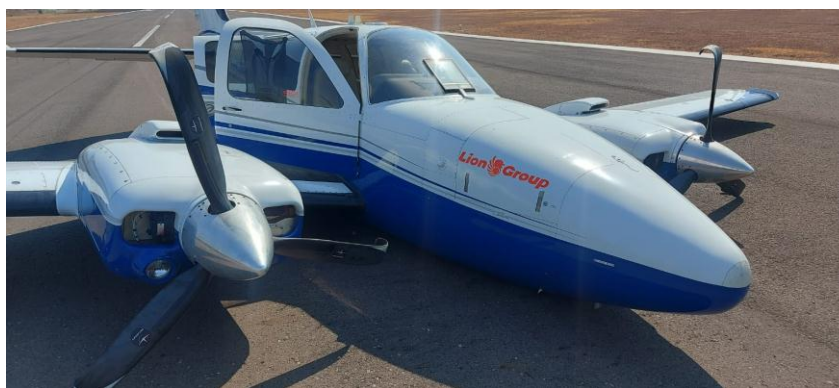
Figure 1: The aircraft condition after stop

The aircraft was substantially damaged as result of this accident.

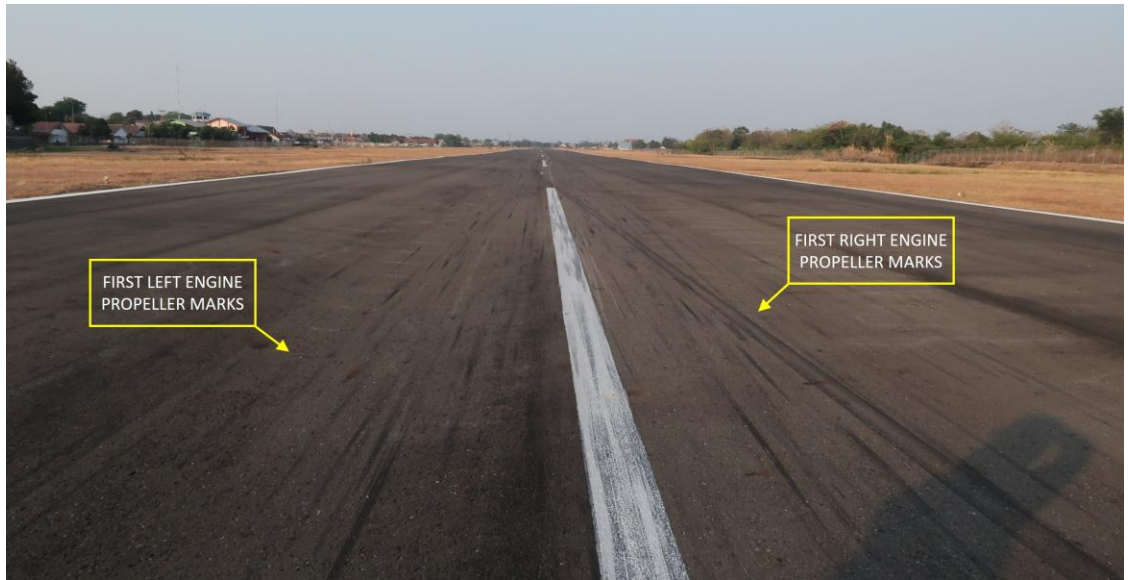
The aircraft propeller marks found on the runway and able to be clearly identified about 390 meters around the runway centerline and from beginning of Runway 04. The aircraft lower fuselage marks found about 2 meters from the propeller marks and continued to the aircraft stop position.

Figure 2: Propeller marks found on the runway

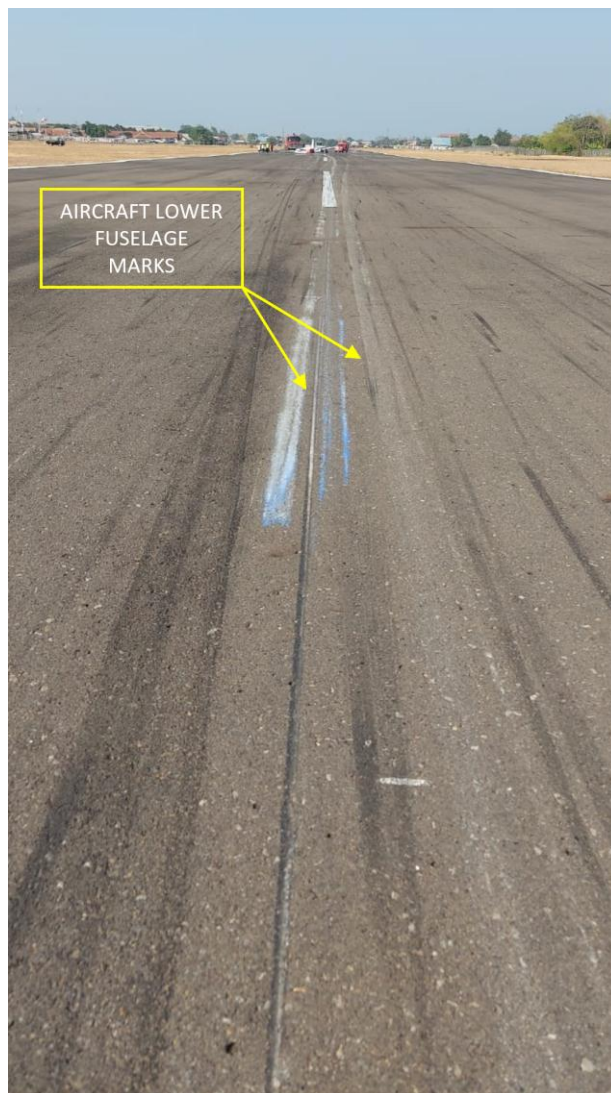
Figure 3: Aircraft lower fuselage marks found on the runway
