**KOMITE NASIONAL KESELAMATAN TRANSPORTASI  
REPUBLIC OF INDONESIA**

**Aircraft Accident Investigation Report**

**Bell 429; PK-WSW**

**20 February 2024**

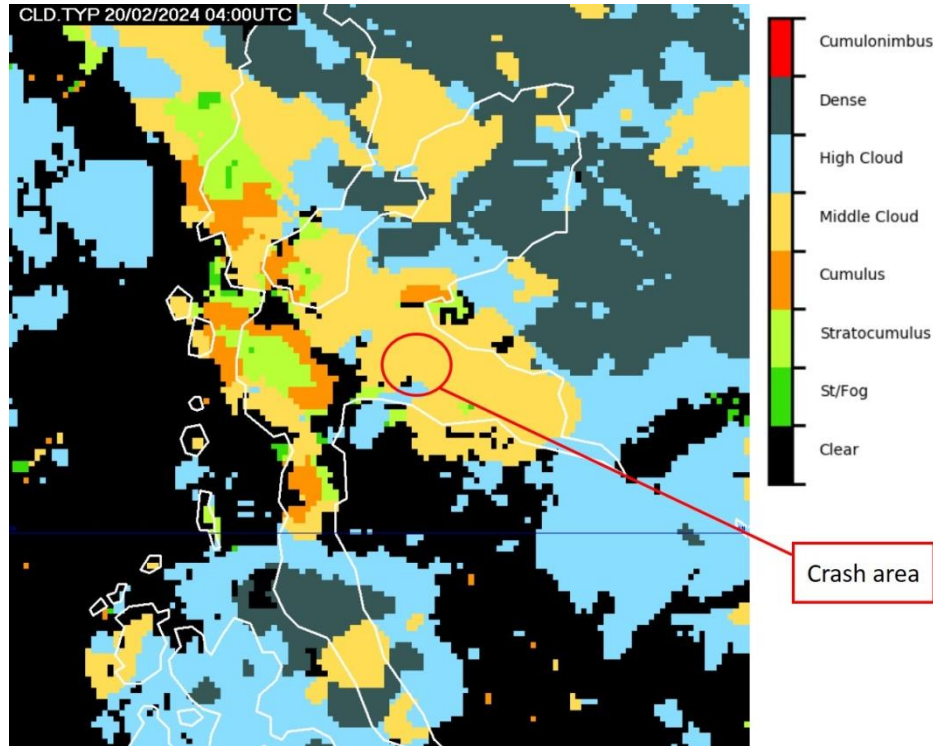
Figure 1: The weather situation at 1300LT

The satellite images of the weather situation showed that the area of the accident was covered by the middle cloud.

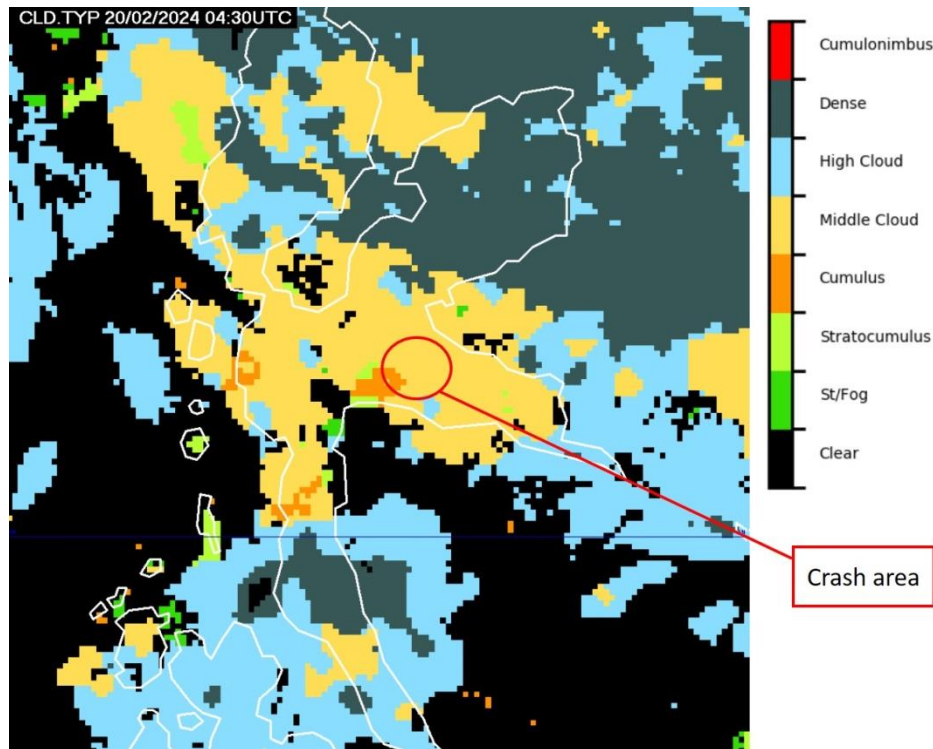
**Figure 2: The weather situation at 1330 LT**

The HDA who assisted the helicopter departure stated that about 2 minutes after the helicopter took off, the weather started raining and the visibility was degraded significantly. A witness who was in a shelter about 700 meters from the crash site stated that at the time the explosion was heard, the weather was raining and the visibility was degraded.

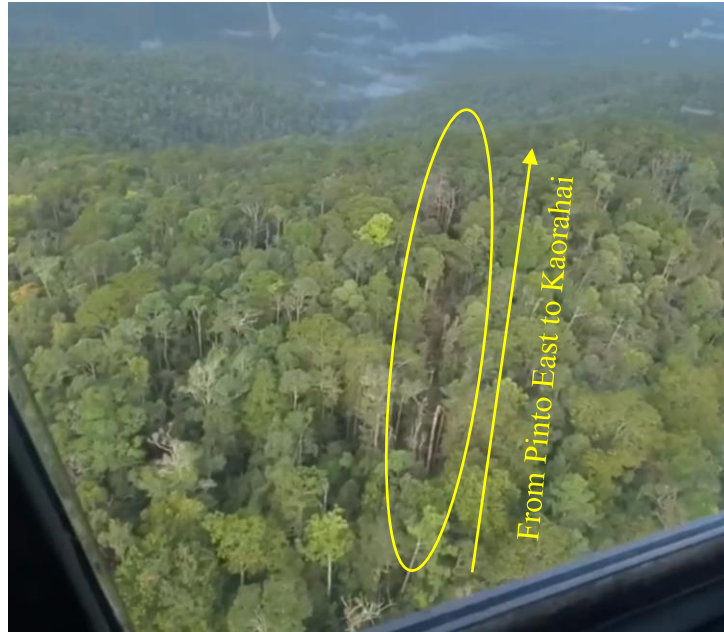
**Figure 5: The crash site location and impact trajectory**

The investigation identified that the helicopter impacted 7 big trees and several small trees before resting at the crash site. The cutting trees created an angle of about  $15^\circ$  down with a heading of  $285^\circ$ .

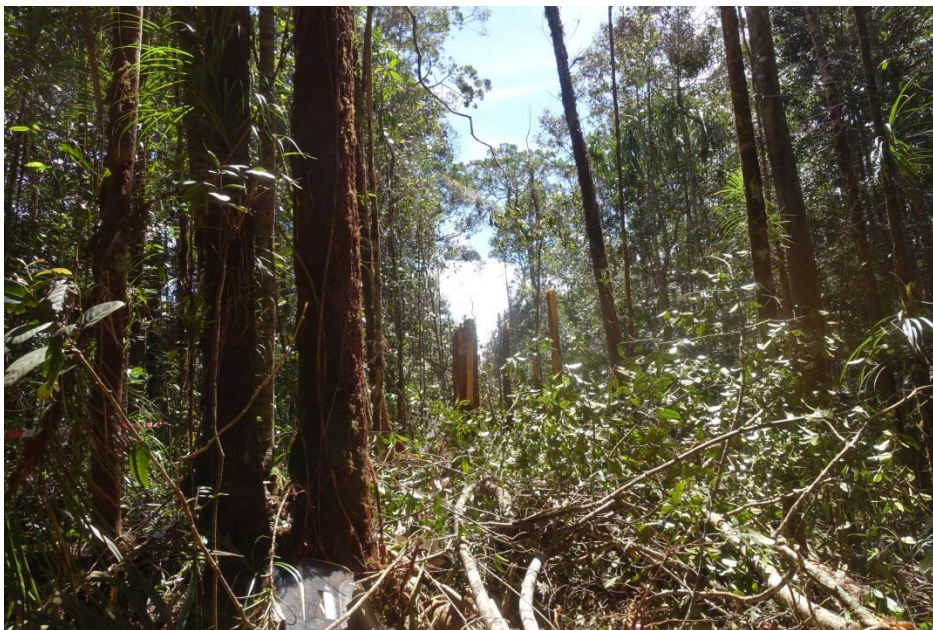
**Figure 6: The opening area created by the helicopter impact**

The helicopter impacted several trees and made a narrow opening in the forest as shown in the figure below.

The first tree impacted by the helicopter was the biggest tree with a diameter of about 50 centimeters. The trail of the first impacted tree up to the crash site was about 100 meters. The broken trees were consistent with the witness statement who took shelter about 700 meters from the crash site, which stated there were repetitive impact sounds

10. The examination of the accident site found that before resting at the crash site, the helicopter impacted seven big trees, and the biggest diameter of the tree was about 50 centimeters. The trail of the first impacted tree up to the crash site was about 100 meters.

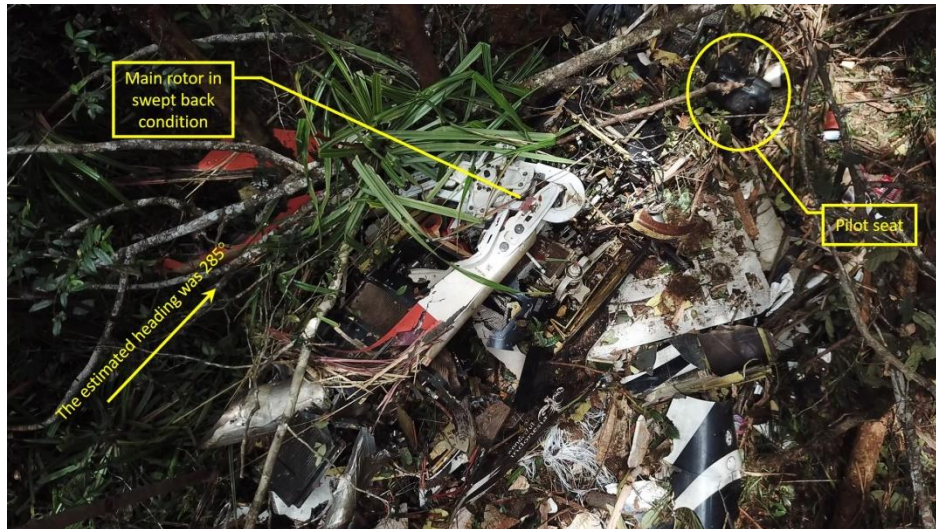
**Figure 7: The helicopter condition at the crash site**

The condition of the helicopter after impacting the trees is shown in the figure below.

During the data collection at the crash site, it was found that the Emergency Locator Transmitter (ELT) indicator light in front of the ELT unit was blinking and a “BEEP” sound was also heard while the activation switch was in the AUTO position. In addition, the ELT antenna cable was found broken.

12. The helicopter was destroyed by the impact force and it was found that the Emergency Locator Transmitter (ELT) was activated but the antenna line was broken.
