**KOMITE NASIONAL KESELAMATAN TRANSPORTASI  
REPUBLIC OF INDONESIA**

**KNKT.24.03.08.04**

**Aircraft Accident Investigation Report**

**Pilatus PC-6/B2-H4; PK-SNE**

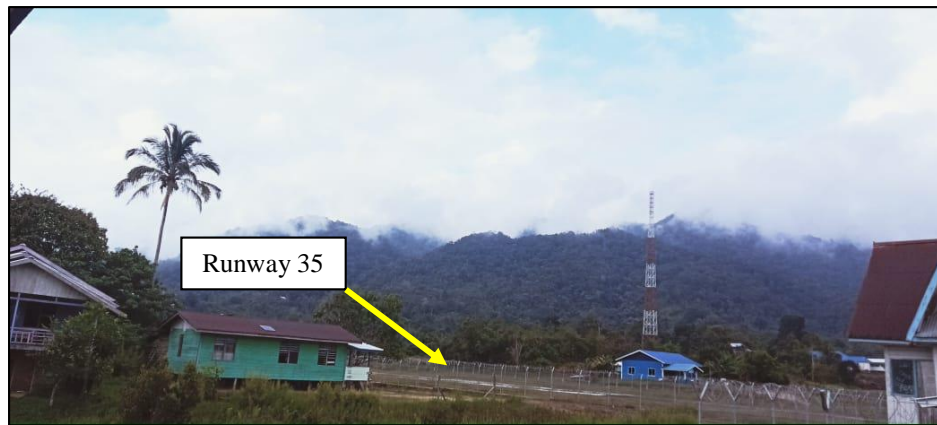
Prior to departure, Binuang resident provided pictures that depicted the weather conditions over the airstrip to the Tarakan FOO and forwarded it to the PIC. The weather at the time of the occurrence was cloudy, as shown in the following figures.

**Figure 2: Weather condition on Binuang (view looking to the south)**

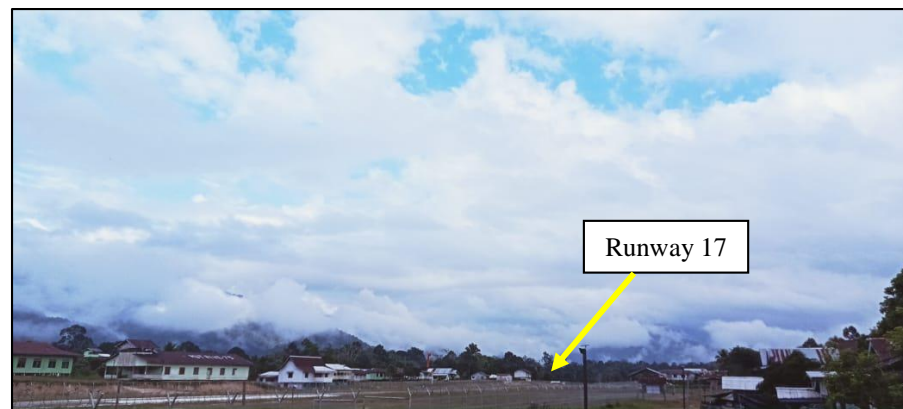
**Figure 3: Weather condition on Binuang (view looking to the north)**

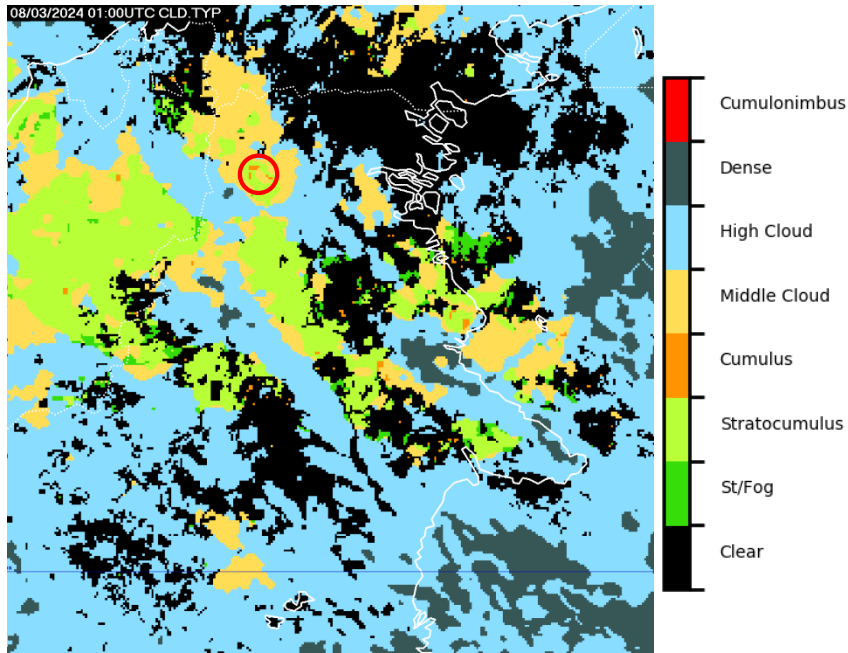
Based on the satellite images provided by BMKG as shown on the following figures, at 0900 LT and 0930 LT, it was shown that there were stratocumulus clouds, cumulus clouds, and middle clouds around the accident site (red-highlighted).

**Figure 4: The satellite images to show the cloud type at 0100 UTC (0900 LT)**

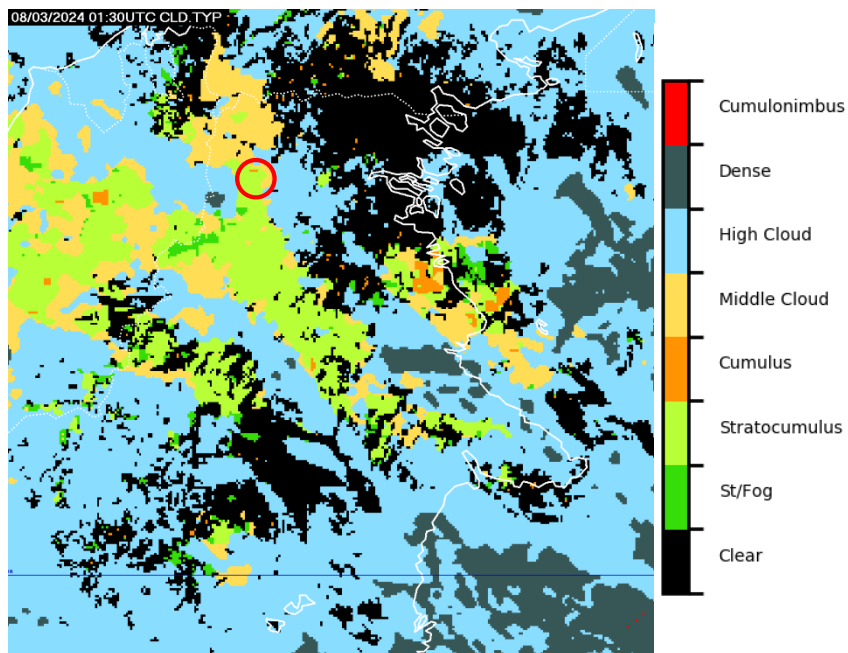
**Figure 5: The satellite images to show the cloud type at 0130 UTC (0930 LT)**

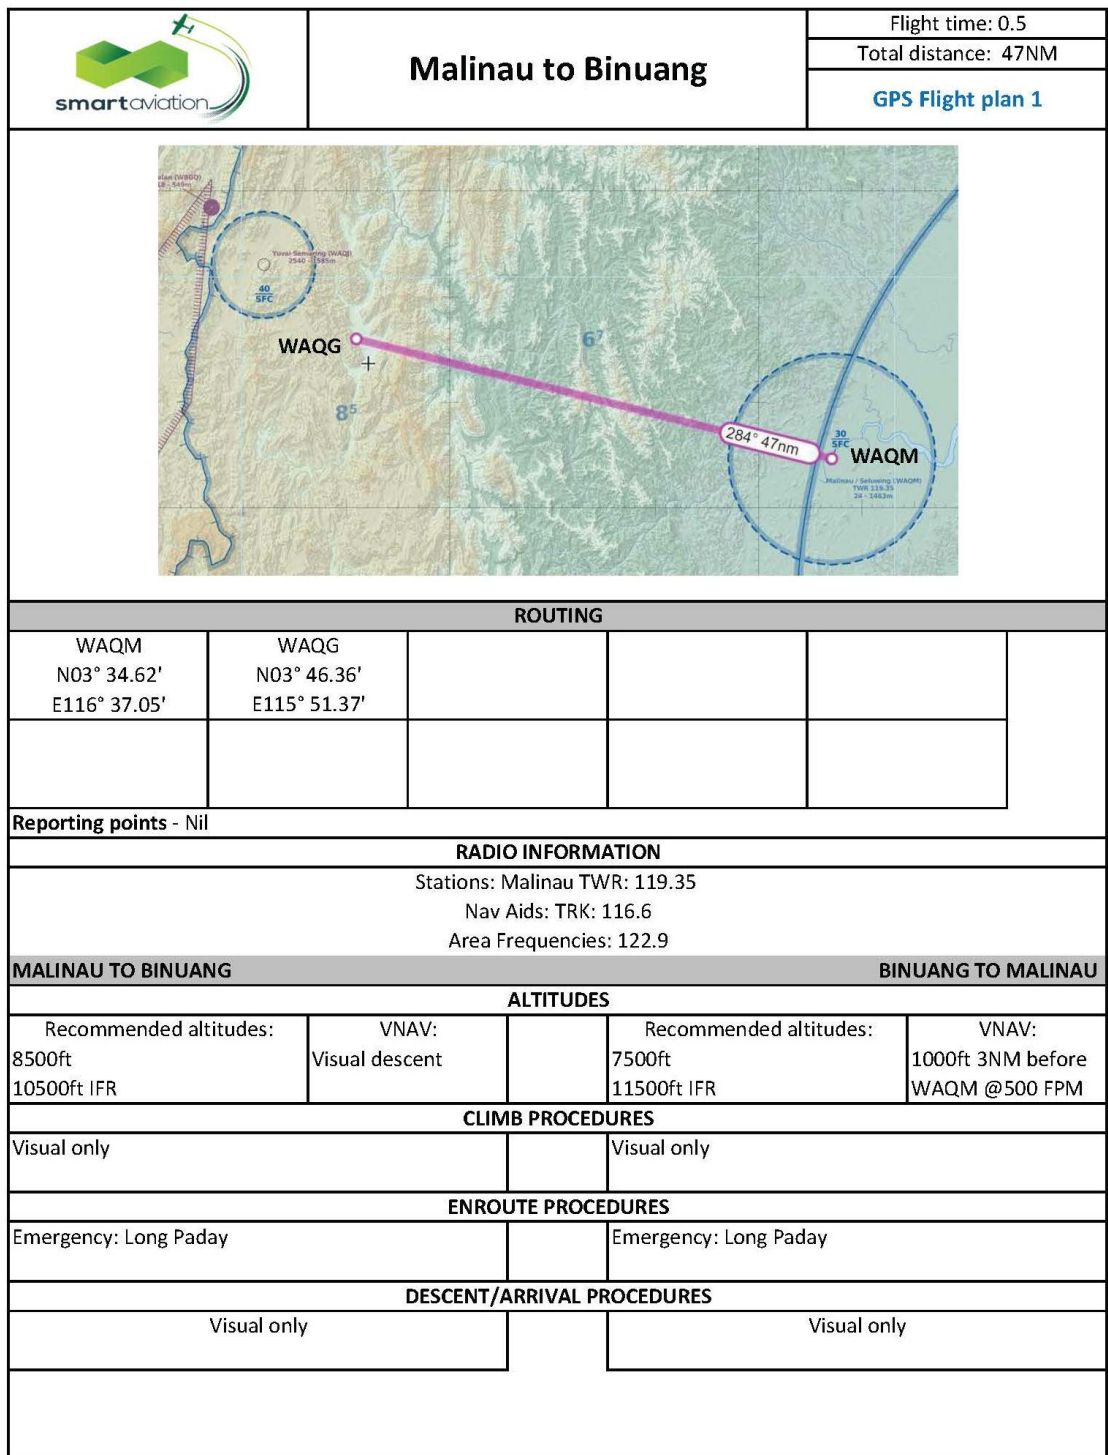
**Figure 9: Route information of Malinau to Binuang**

Smart Aviation Operation Manual Part C (OM-C) provided area, routes and aerodromes information that can be used for internal use. The OM-C provided information limited to aerodrome information of Binuang and route information of Malinau to Binuang (see the following figures).

Therefore, KNKT recommends Smart Aviation to develop and implement route guidance to conduct flights from Tarakan to Binuang.

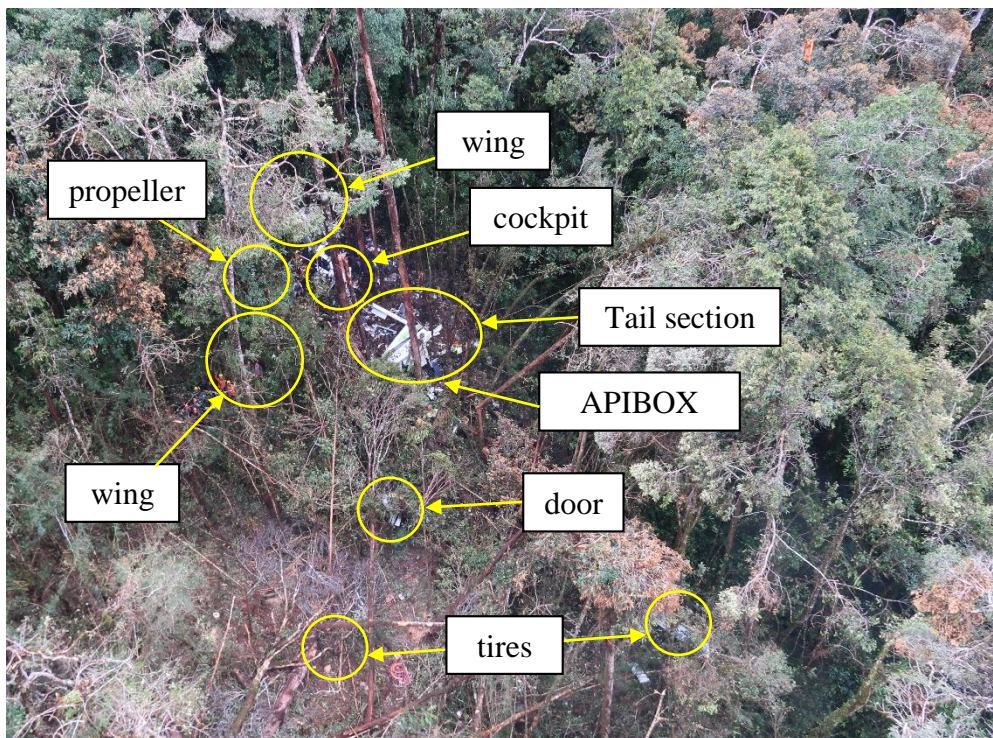
Figure 11: Wreckage Distribution

The aircraft wreckage was found at about 5.0 NM southeast of Binuang on a bearing of 305° with an elevation of about 4,500 feet at the ridge of a mountain with tropical rain forest.

The wreckage distribution of the accident was shown on below image.
