**KNKT.24.05.011.04**

**Aircraft Accident Investigation Report**

**Tecnam P2006T; PK-IFP**

**19 May 2024**

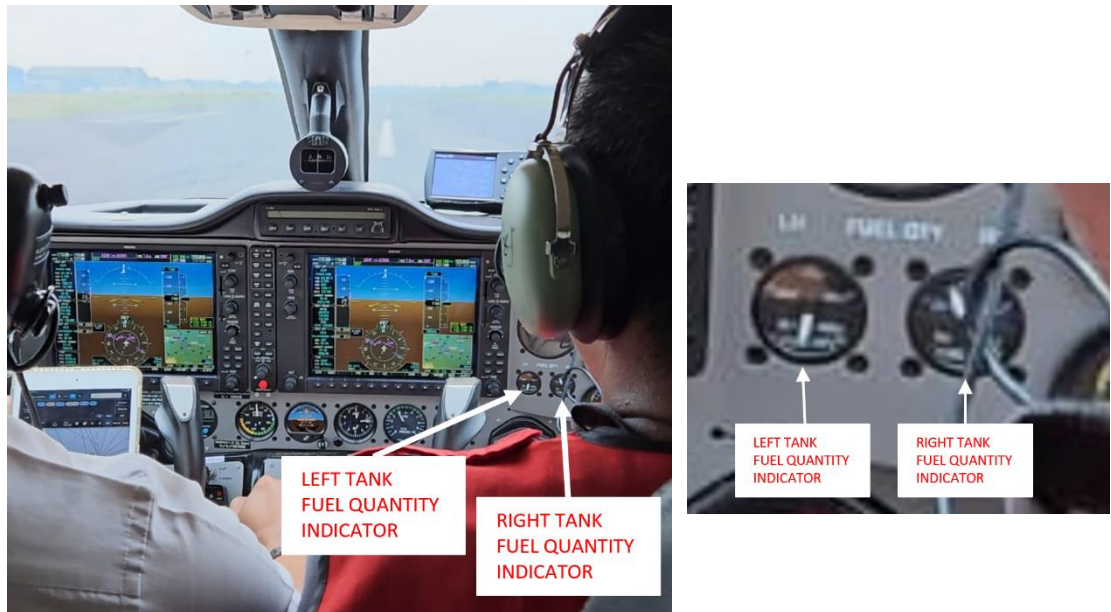
The Pondok Cabe ACO advised the pilot that Runway 36 was clear. During takeoff roll, the aircraft engineer recorded a video using his mobile phone that captured the cockpit situation from the backseat. The video showed that the needle of the left tank fuel quantity indicator was below the 0 lt value (on the electrical zero) while the needle of the right tank fuel quantity indicator was between 30 lt and 50 lt.

**Figure 1: The flight deck view during take-off roll at Pondok Cabe and the zoom in of the fuel quantity indicators**

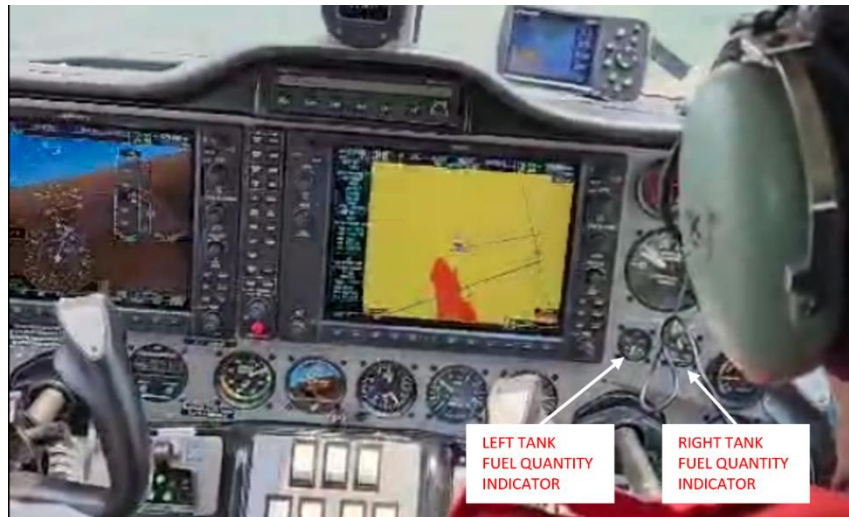
When the aircraft was approaching Tanjung lesung, the engineer recorded a video using his mobile phone again and captured the cockpit situation from backseat. The video showed that the needle of the left tank fuel quantity indicator remained below the 0 lt value (on the electrical zero) while the needle of the right tank fuel quantity indicator remained between 30 lt and 50 lt.

**Figure 2: The flight deck view during approach at Tanjung Lesung**

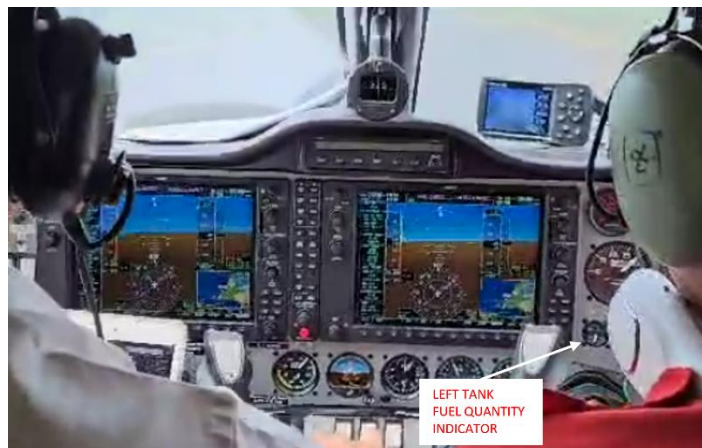
During the takeoff roll, the engineer recorded a video using his mobile phone again and captured the cockpit situation from backseat. At this time, the video only captured the LH fuel quantity indicator which remained below the 0 Lt value (on the electrical zero).

**Figure 3: The flight deck view during take-off roll at Tanjung Lesung.**

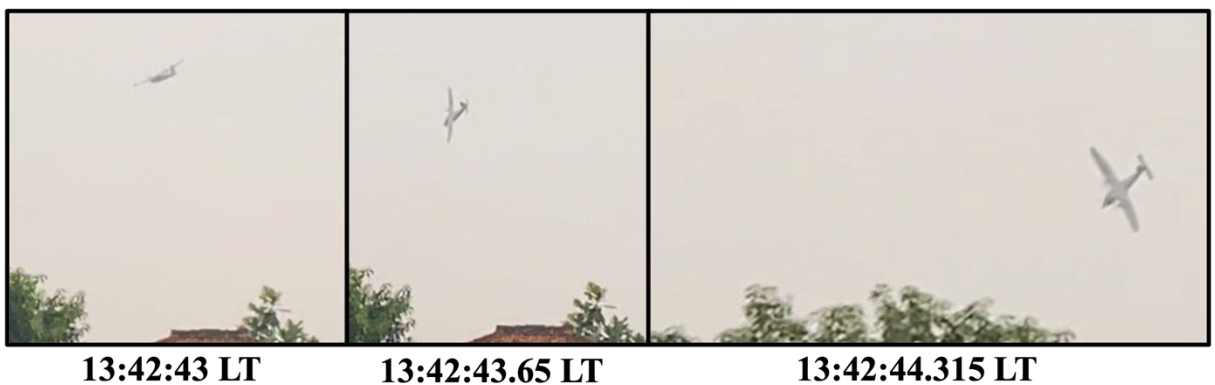
Several eyewitnesses on the ground near the aircraft flight path and near the accident site, saw the aircraft flying at low altitude and did not hear any engine sound. An eyewitness who located about 700 meters Northwest of the accident site recorded the aircraft maneuver using his mobile phone. The video record indicated the aircraft rolled to the left more than 45° and then dived down.

**Figure 5: The zoomed in and cropped screenshot images from eyewitness video recording**

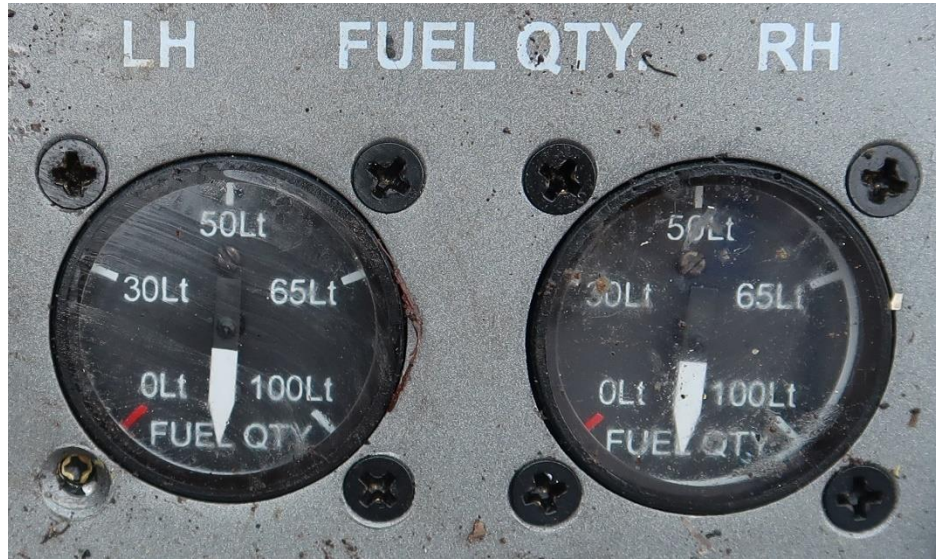
The following figure shows the fuel quantity indicators when on electrical zero condition.

Figure 7: The fuel quantity indicators found at the accident site

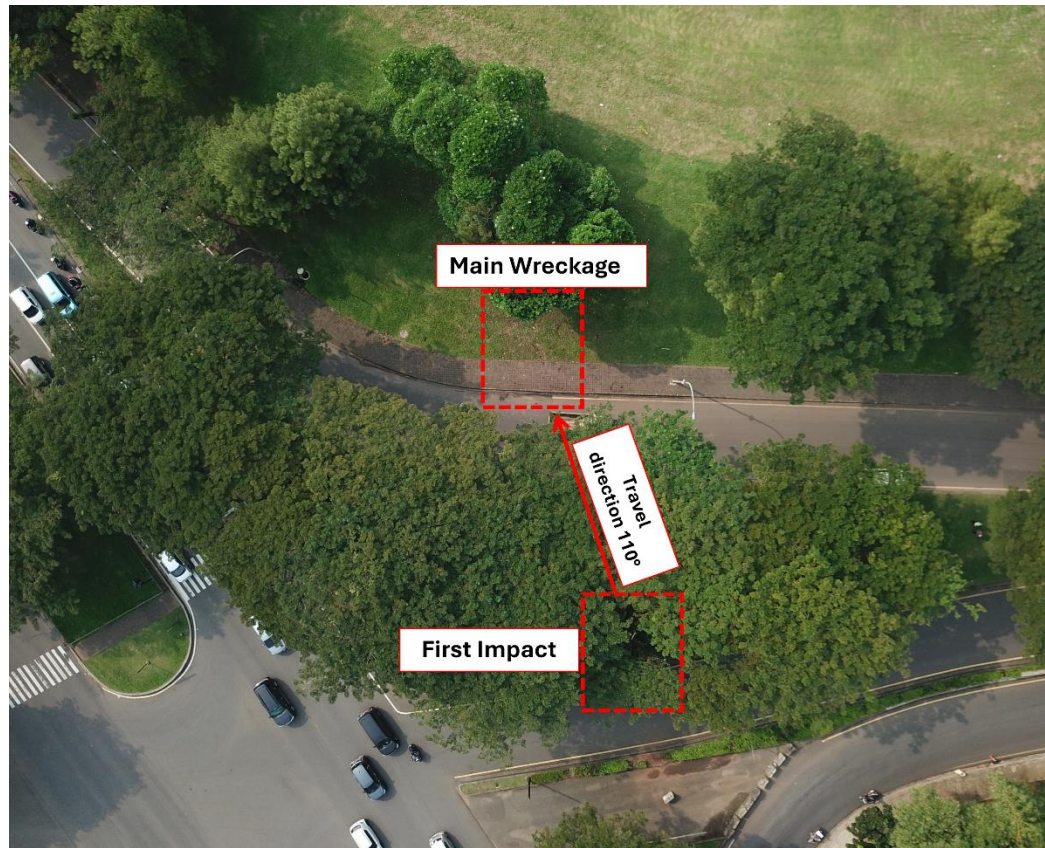
The aircraft collided with trees then impacted the ground with the estimated impact angle of  $40^{\circ}$ . The aircraft stopped across the street from the first impact point.

**Figure 10: The accident site**

The right engine detached from its engine bay and was found about 7 meters on the left side of the first impact point. The left horizontal stabilizer and right-wing tip was found near the first ground impact point. At the accident site, there was smell of fuel.
