**KOMITE NASIONAL KESELAMATAN TRANSPORTASI  
REPUBLIC OF INDONESIA**

**KNKT.24.06.14.04**

**Aircraft Serious Incident Investigation Report**

**Cessna 172 SP; PK-APA**

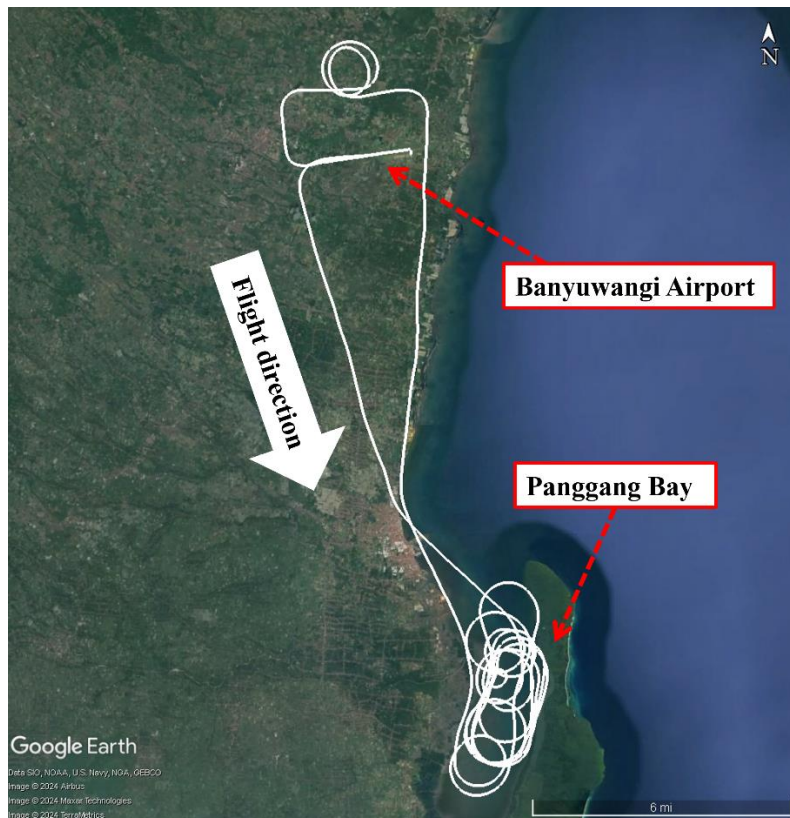
**Figure 1: The aircraft flight path**

At 09:04:26 LT, the aircraft passed the runway threshold at altitude of 96 feet with recorded IAS of 70 knots, engine RPM of 1,700 RPM and pitch angle of -2.7° (aircraft in nose down attitude). Thereafter, the pitch angle was increased and fluctuated between 0° up to 6°, the engine RPM was continuously reduced.

At 09:04:39 LT, the aircraft touched down at recorded altitude of 41 feet, normal acceleration<sup>4</sup> of 0.64 G, the IAS was 48 knots, engine RPM was 990 RPM and pitch angle was 5.5° (aircraft in a level attitude)<sup>5</sup>. During the touchdown, the student pilot felt that the main wheels and nose wheel contacted the runway almost at the same time (three-point landing). The aircraft then bounced four times with the nose wheel made contact first on each touchdown.

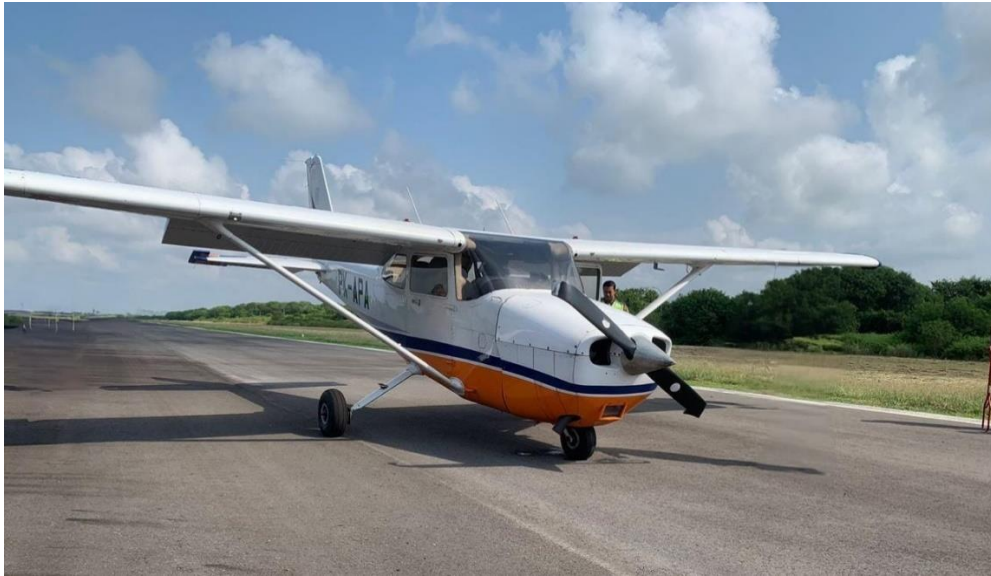
**Figure 2: The aircraft condition after landing**

The normal acceleration on the last touchdown was 1.36 G. The nose landing gear was damaged, and propeller blades struck the runway. The aircraft then stopped on the runway, and the student pilot declared a distress message to the Banyuwangi Tower controller.

The aircraft was minor damaged. The details of the damage are as follows:

- a. Both propeller tips were bent.
- b. The nose landing gear assembly were damaged.
- c. The engine exhaust muffler was dented.
- d. The front lower skin and engine cowling were dented.

In June 2024, the academy conducted a safety briefing for student pilots focused on stabilized approaches and bouncing recovery (Go Around Procedure) and revised the student guidance handbook to include the bouncing recovery procedure. Additionally, in September 2024, the API Banyuwangi held a socialization session on the bouncing recovery procedure for all flight instructors, providing the FAA Airplane Flying Handbook as a reference for flight instruction.
