**KOMITE NASIONAL KESELAMATAN TRANSPORTASI
REPUBLIC OF INDONESIA**

1st INTERIM STATEMENT

Aircraft Accident Investigation Report

Airbus A330-343; T7-MMM

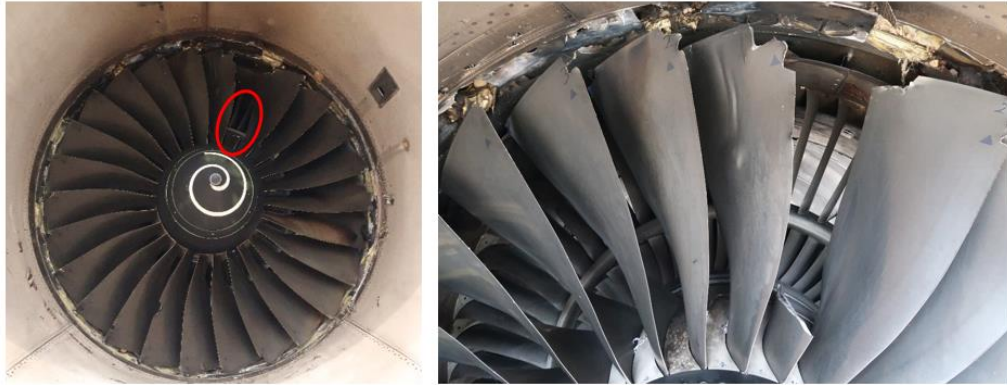
- One fan blade at position 26 was fractured approximately 23 cm from the base of the blade root. The released section of the blade aerofoil and associated debris were contained within the fan case and nose cowl.
- Significant rubbing and damage were observed around the entire 360° circumference of the fan case rotor path. Impact damage was also present on the nose cowl acoustic panels.

Figure 1: The fan blade release and heavy rubbing around the fan case.

A substantial portion of the fan blade aerofoil was found lodged between the Outlet Guide Vane (OGV) and the rear of the fan rotor. Three annulus fillers were also missing from the engine area. Additionally, debris spiralling forward due to the engine's rotation caused noticeable impact damage to the nose cowl. The honeycomb structure and facing sheet of the nose cowl also sustained impact damage from the debris.

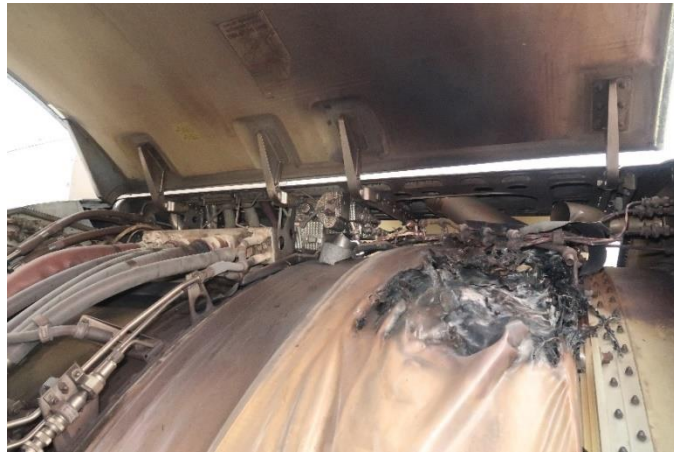
- Burning of the fan case kevlar wrap was visible around the engine's Top Dead Centre (TDC) region, as shown by Figure 2 below.

Figure 2: The damage to the Kevlar layer

The release of a fan blade occurred in engine number one, where it penetrated the aluminium fan case and retention panel, lodging into the Kevlar shroud. The fan case was completely worn through at the impact site. Despite the significant impact, the retention panel remained mostly intact, though signs of overheating and friction were evident. Burned Kevlar was observed around the Top Dead Center (TDC) location, with the Kevlar coating completely burned through.

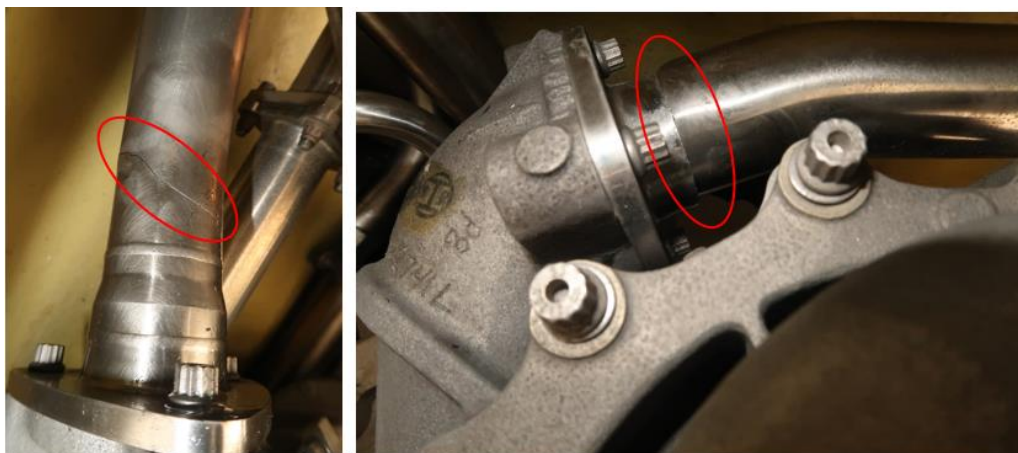
- Two LP fuel tubes upstream of the Fuel Oil Heat Exchanger (FOHE) were found fractured, as shown in Figure 3 below.

Figure 3: Fractured LP fuel tubes upstream of the Fuel Oil Heat Exchanger

Further examination of the wreckage revealed several detached components within the engine cowl, including ignition units, a remote charge converter, a section of the starter duct, and the SAV. Two low-pressure (LP) fuel supply lines were found to be cracked due to impact.

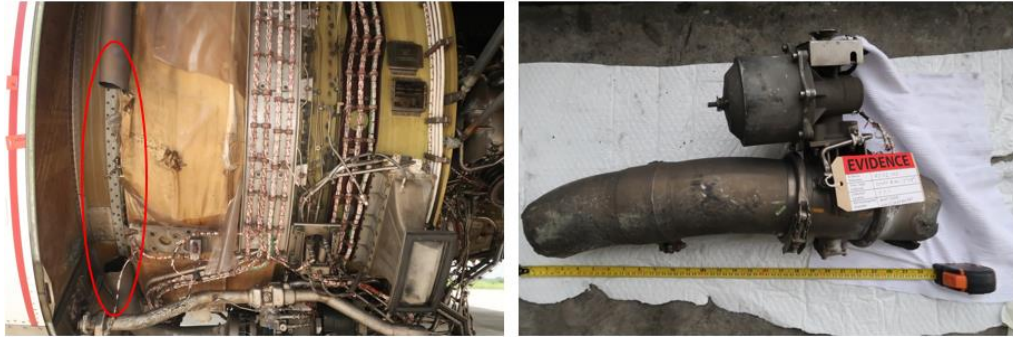
- The starter air duct pipe was fractured, and a large section, including the Starter Air Valve (SAV), had detached as shown in Figure 4 below.

Figure 4: The detached starter air duct pipe, including the Starter Air Valve (SAV).

The front acoustic panels, located near the impact area, sustained severe damage, while the rear acoustic panels were either absent or severely damaged. A Kevlar wave was also detected in the area, which caused significant damage to the starter duct and led to the expulsion of a large portion of the duct along with the Starting Air Valve (SAV).
