**KOMITE NASIONAL KESELAMATAN TRANSPORTASI
REPUBLIC OF INDONESIA**

Aircraft Accident Investigation Report

PT Whitesky Aviation

Bell 505; PK-WSP

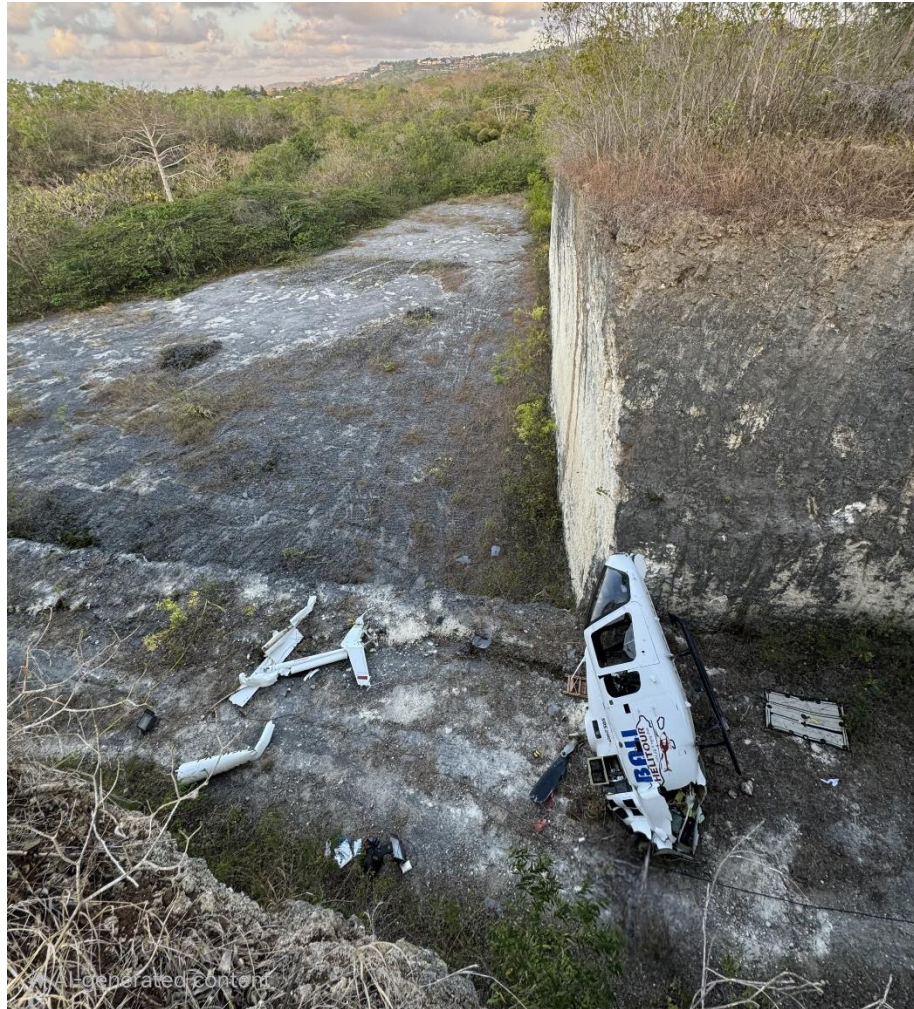
Figure 2: The wreckage situation

The helicopter was found between man-made cliffs at coordinates 8°49'13.62"S; 115°5'36.89"E, about 5.8 Nm on radial 224° from I Gusti Ngurah Rai Airport, or about 4.5 Nm on radial 260° from the GWK Helipad, with the kite string wrapped around both the main and tail rotor masts.

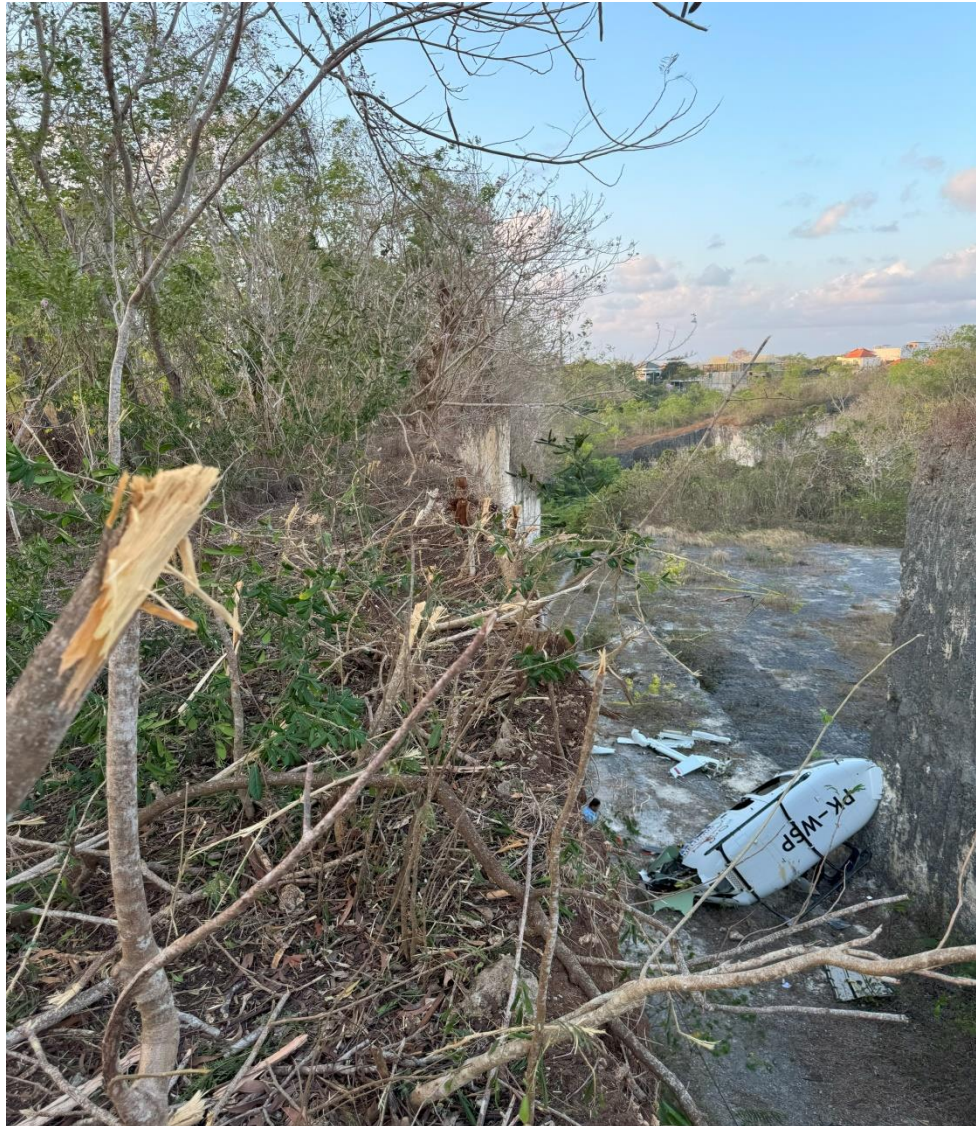
Figure 7: The helicopter location seen from the incoming direction

The main rotor cut several trees at the top of the cliff before crashing down in the field. The direction from the initial impact point to the helicopter's final stop position was about 030°. An open area near the man-made cliff had served as the pilot's intended site for the emergency landing.

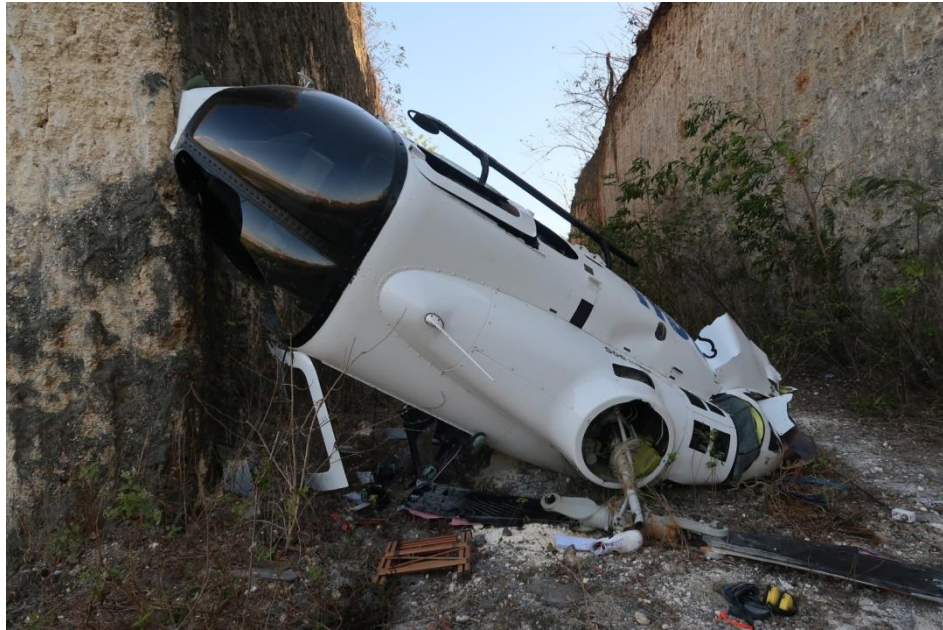
Figure 8: The helicopter condition after impact

The helicopter faced a heading of about 047°, with the windshield angled about 45° on the ridge as shown in the Figure 8. The tail boom and tail rotor were separated and found at about 5 meters from the helicopter.

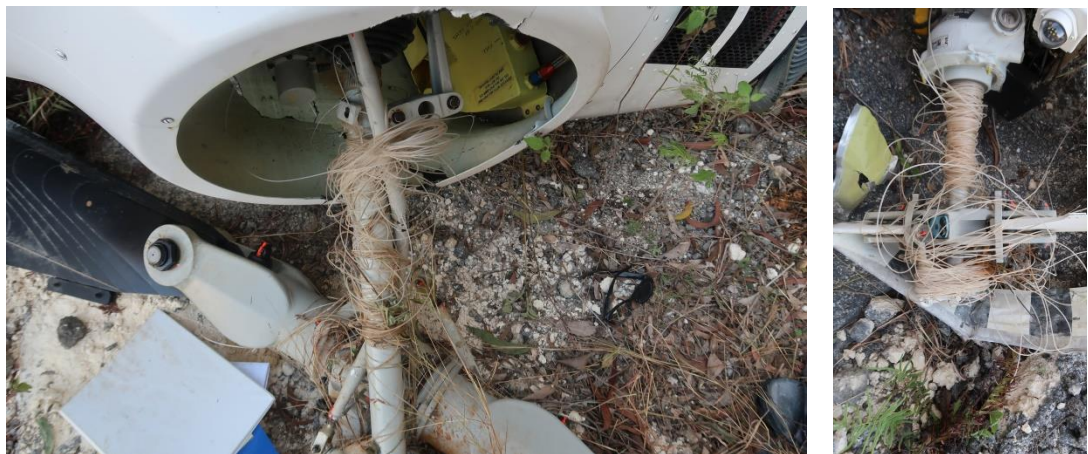
Figure 9: The kite string on the main rotor and tail rotor mast

The main rotor mast exhibited damage, with the main rotors being detached. Part of the main rotors was found about 20 meters from the main wreckage above the man-made cliff.

Evidence of the kite string wrapped around the main rotor mast resulted in deformation of the flight control rod. The tail rotor also exhibited damage, and kite string was also found wrapped around the tail rotor mast. The kite was not found at the accident site.

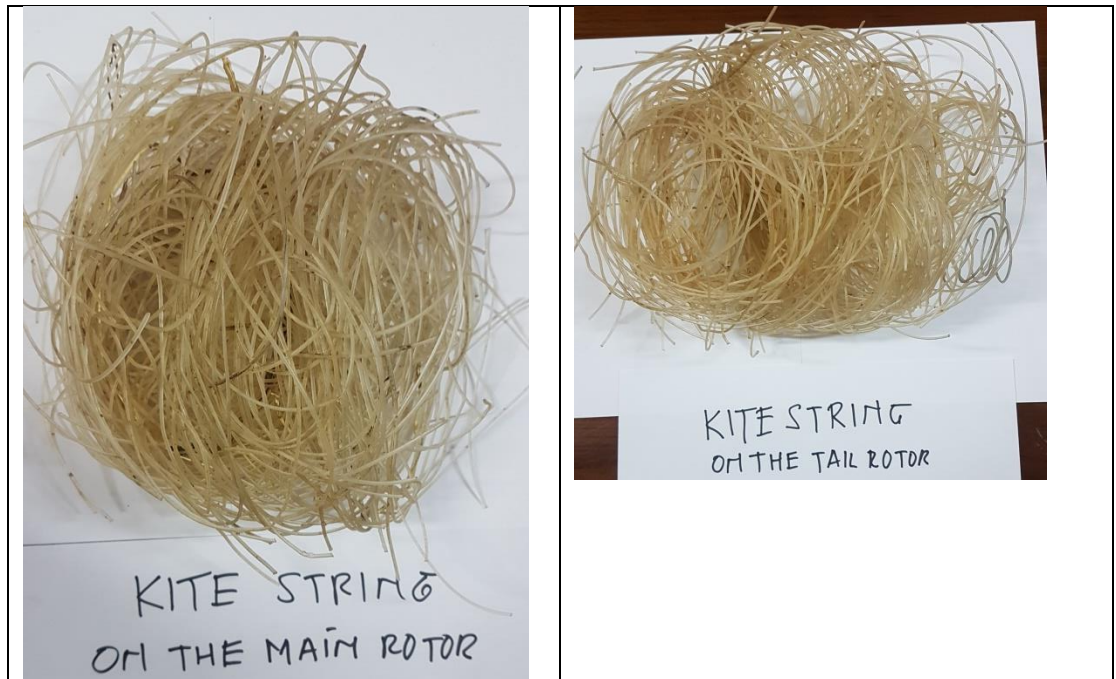
Figure 10: The kite string on the main rotor and tail rotor

The investigation collected the kite string that was entangled in the helicopter main and tail rotors as shown in the following figure.

The entangled kite string on the main rotor was estimated at more than 200 coils, and on the tail rotor at more than 120 coils.

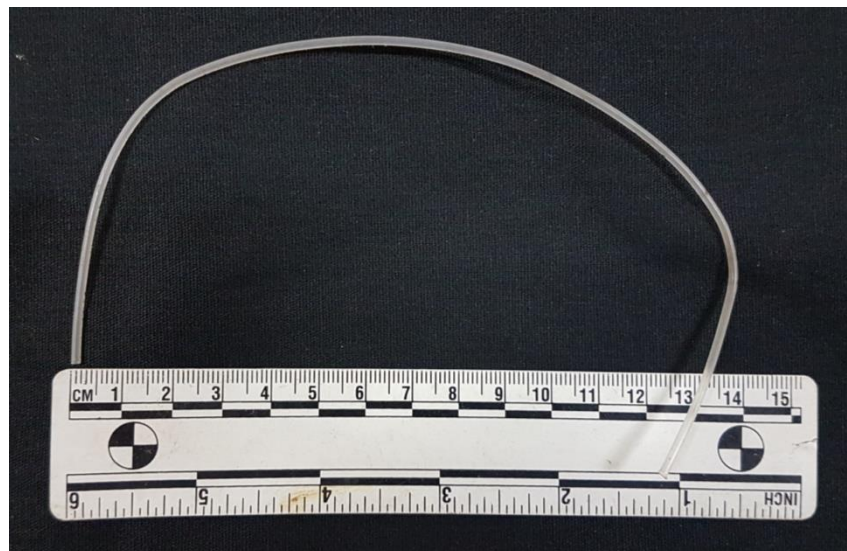
Figure 11: The diameter of the kite string

The diameter of the kite string was about 2 millimeters, as shown in the following figure.

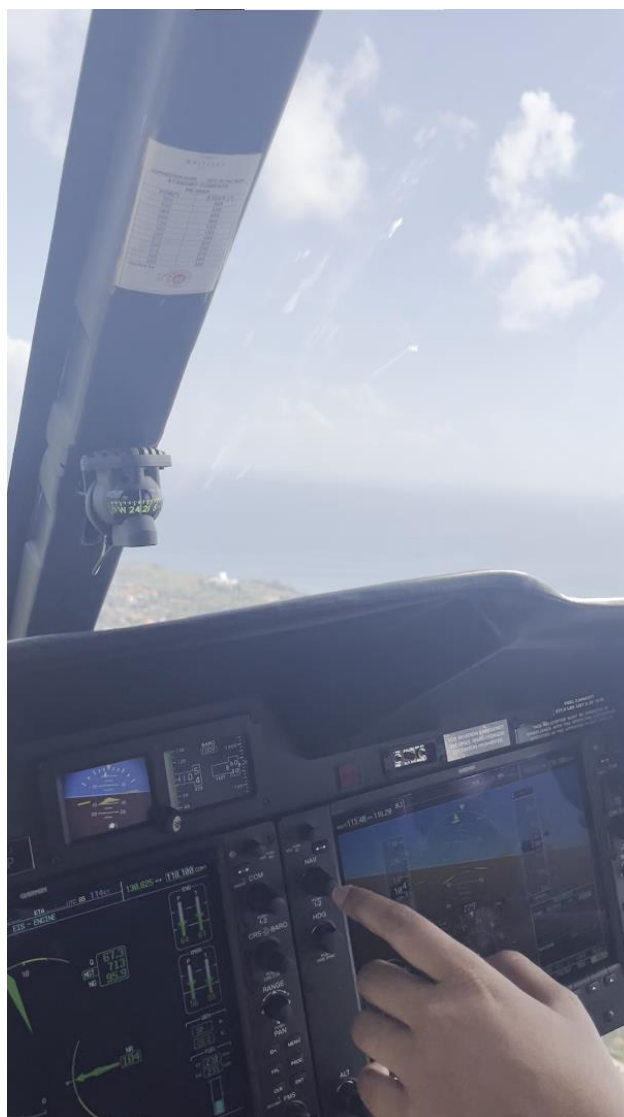
Figure 14: Recorded video at 14:36:23 LT

2. At 14:36:23 LT, the video recorded sound similar to helicopter contacted with kite string (Figure 14).

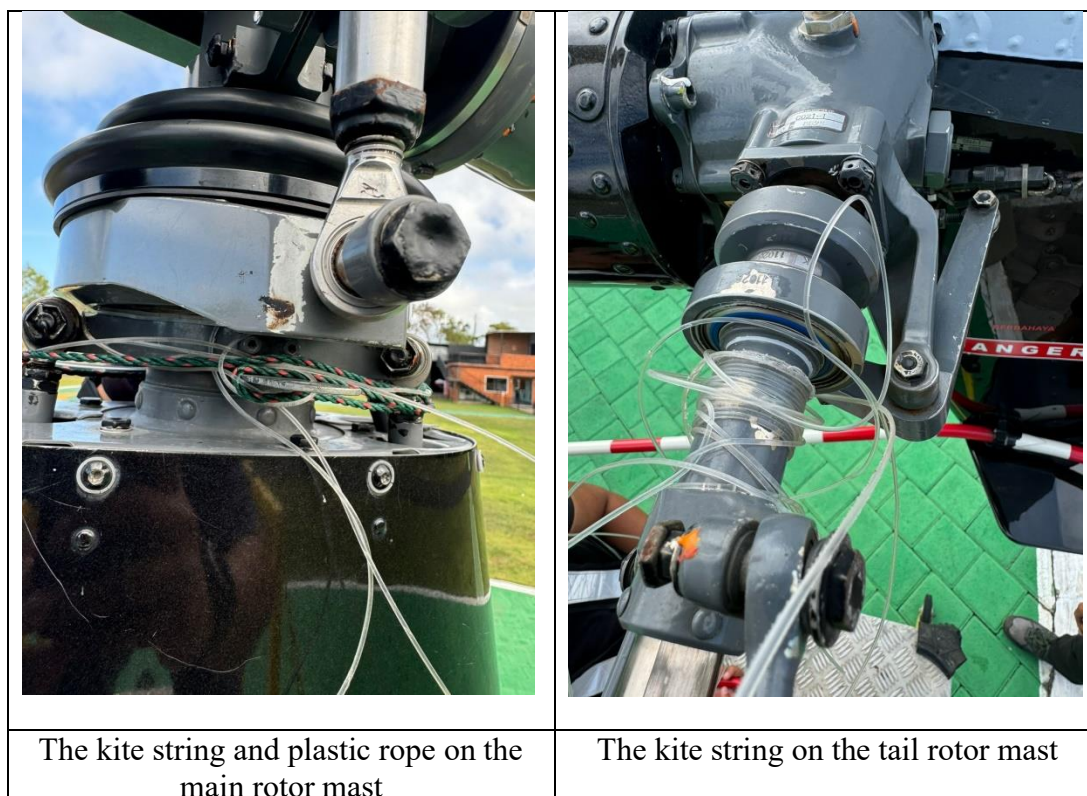
Figure 15: The kite strings found on the main and tail rotor mast of the PK-VPJ

After landing, it was found that the main and tail rotor masts were entangled with kite strings, as shown in the following figures.

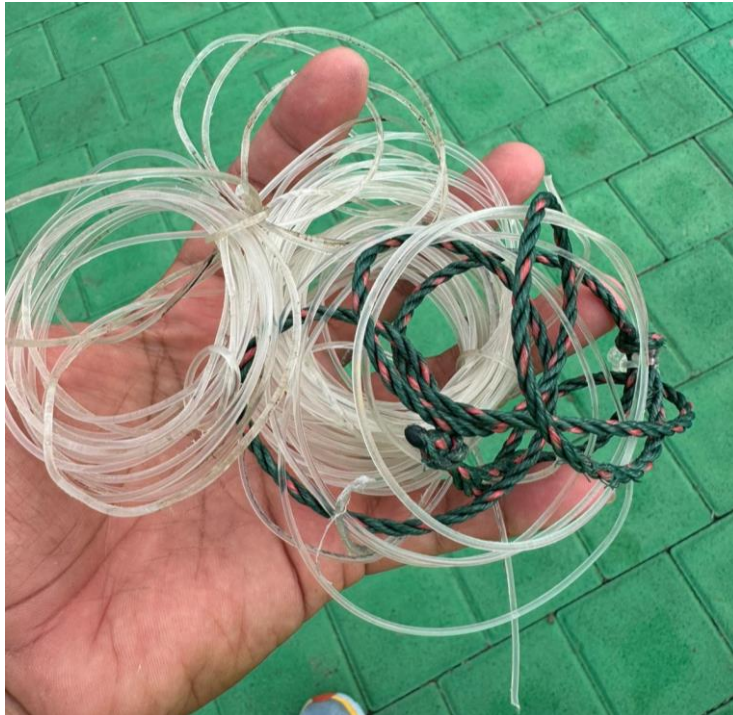
Figure 16: The kite string and plastic rope that were removed from the main rotor and tail rotor masts

The diameter of the kite string was similar to the PK-WSP occurrence. The dimension of the plastic rope was estimated to be about twice of the kite string.

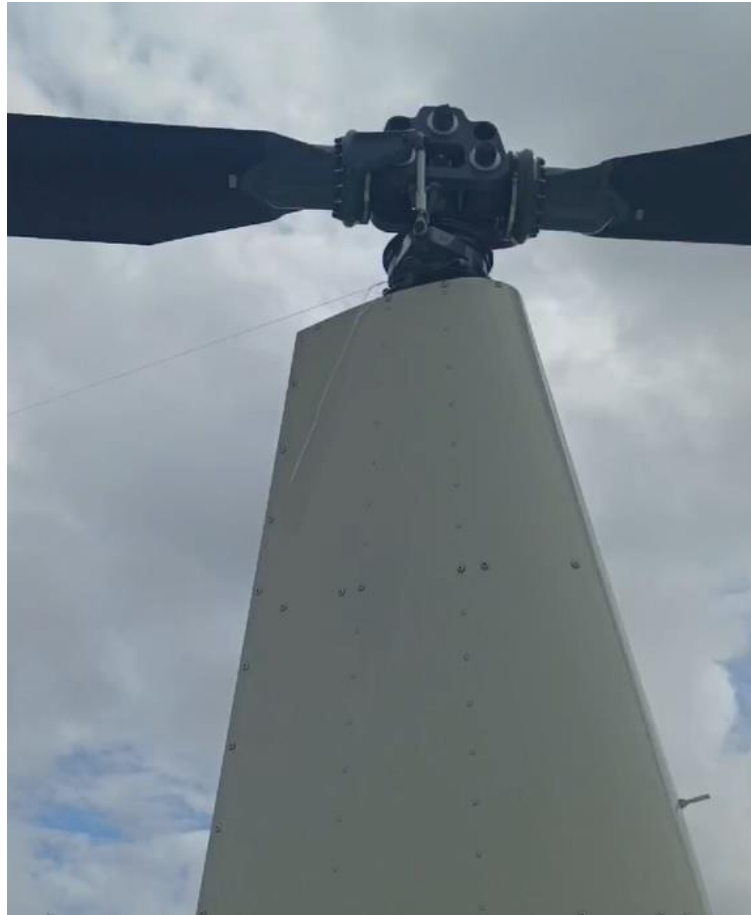
Figure 17: The PK-VPN kite strike occurrence

After landing, the radio operator advised the pilot that the main and tail rotor masts had been wrapped with kite strings, as shown in the following figure.

No one was injured in this occurrence, and no damage was found to the helicopter.
