**KOMITE NASIONAL KESELAMATAN TRANSPORTASI
REPUBLIC OF INDONESIA**

KNKT.24.10.22.04

Aircraft Serious Incident Investigation Report

Boeing 737-800; PK-GMP

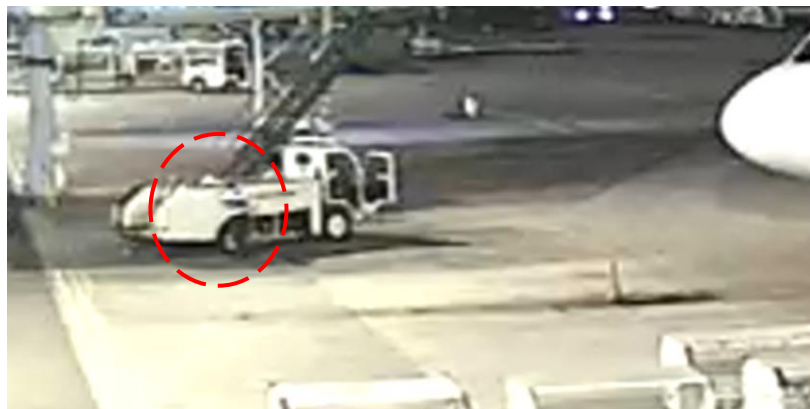
At 2124 LT, after the LST was parked, the GSE Operator 1 left the LST= cabin and walked to the right aft tire to place the wheel chock. He then closed the right cabin door and walked toward Parking Stand W30 to operate the Aircraft Towing Tractor (ATT) for another aircraft scheduled to depart. Based on airport Closed-Circuit Television (CCTV) footage, no other person was recorded entering the LST cabin or removing the wheel chock after the GSE Operator 1 left the LST until it impacted the aircraft.

Figure 1: The CCTV records when GSE Operator 1 placed the wheel chock (zoomed, cropped, and annotated by KNKT)

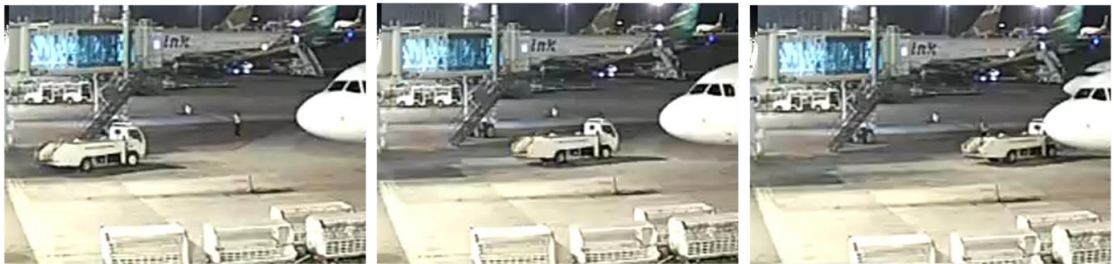
At 2126 LT, the airport CCTV recorded that when the aircraft was aligned with the parking stand, the LST began moving unaided. When the aircraft reached the parking position and stopped, the LST impacted the tail section of the aircraft.

Figure 2: The recorded CCTV showed the movement of the LST (zoomed and cropped by KNKT)

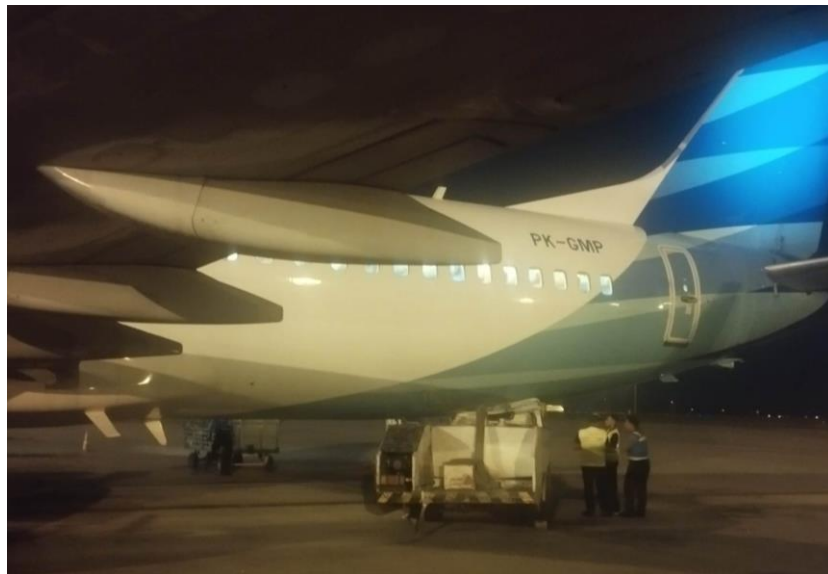
Figure 3: The LST impacted the tail section of the aircraft

The LST impacted the tail section of the aircraft and resulted in damage to the aircraft. The documentation of the LST cabin after the occurrence indicated that the parking brake handle was not set.

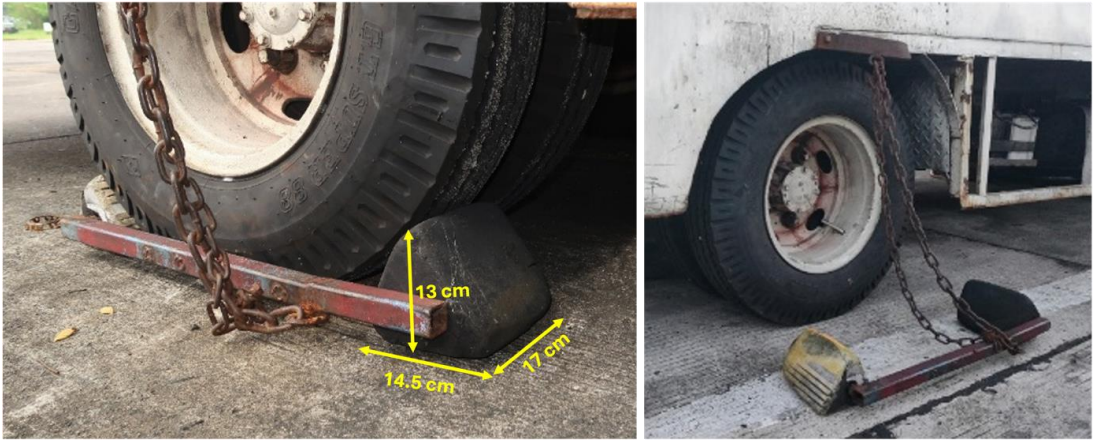
The LST was equipped with a two-triangle wheel chock chained to the aft right wheel fender (see Figure 7). The dimensions of the triangles are shown in the following figure.

Figure 7: The dimension wheel chock of the LST (left figure) and the chained position of the wheel chock (right figure)

Therefore, KNKT recommends that PT Gapura Angkasa develop a mechanism to verify the proper placement of the wheel chock.

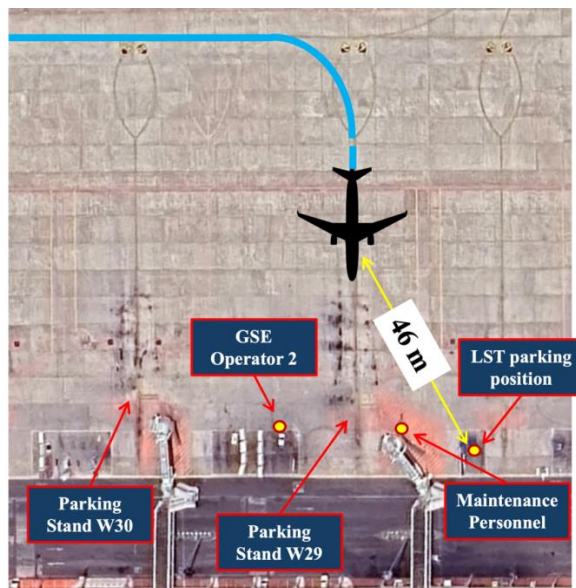
The slope between the parking position and the impact point was measured by comparing height differences using a theodolite. The measured surface was a 0.57% downslope.

Based on CCTV footage and FDR data, the LST started to move when the aircraft was taxiing, along the lead-in line toward Parking Stand W29, at a distance of about 46 meters away.

Figure 10: The illustration of the occurrence site

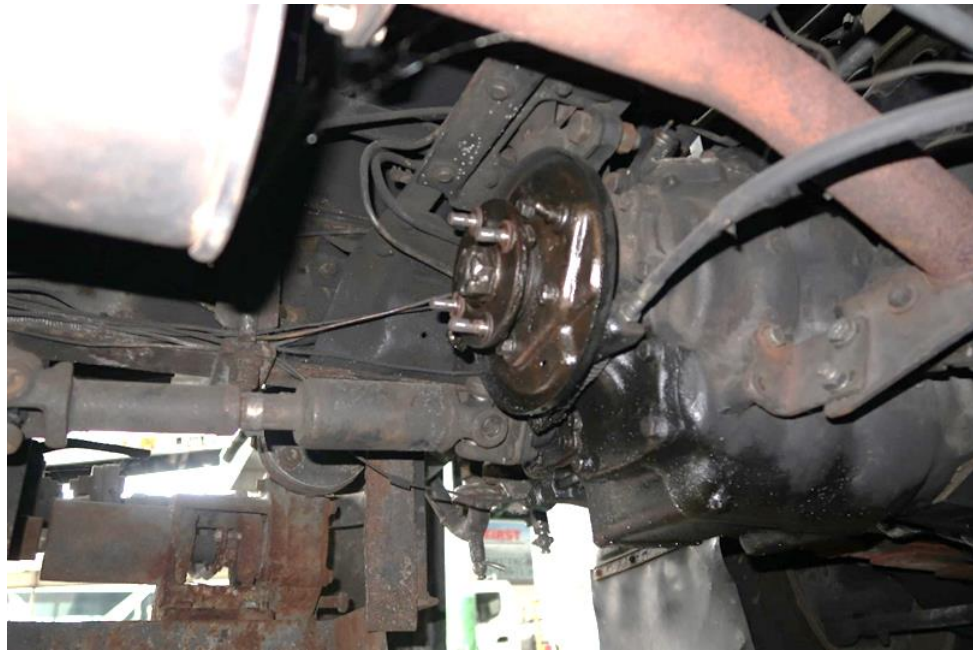
The investigation examined the parking brake system. When the brake handle was pulled, it could be extended approximately 16.5 cm from its full forward position, and the ratcheting mechanism could be locked at any position. When the handle was pulled and pushed, the cable connecting the handle to the brake drum was able to move without any obstruction.

While the parking brake was pulled to its full position, the truck was pushed and moved freely. The brake drum was disassembled, and it revealed that the brake shoe, linings, and other components were not installed in the drum brake.

Figure 11: The parking brake drum without internal components

5. The LST maintenance record dated 13 September 2023 showed that the parking brake shoe and lining of the LST were removed for an unknown reason. The replacement of the brake shoe and lining of the LST was not performed until the occurrence.

Therefore, KNKT recommends that PT Gapura Angkasa to ensure the serviceability of the parking brake of the GSE to prevent the risk of collision.
