Aircraft Serious Incident Investigation Report

Perkasa Flying School

PA28-161 Warrior III; PK-PBC

Cemara Sewu Coastline, Cilacap

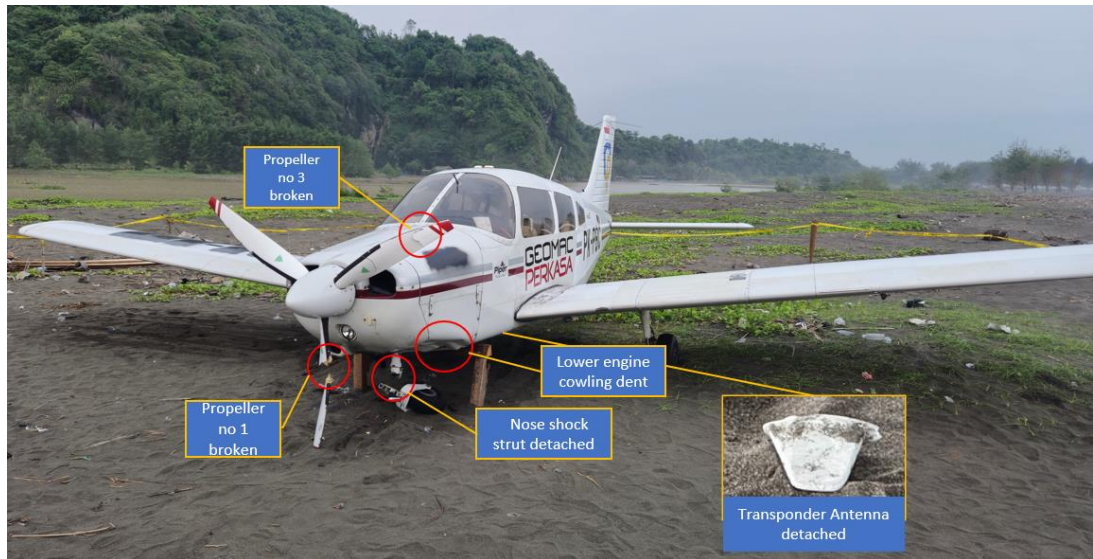
Figure 2: Damaged Aircraft Parts

The aircraft sustained minor damage, including fractured 2 of 3 propeller blades, the nose shock strut and wheel were detached, the transponder antenna was separated, and the engine cowling was dented.

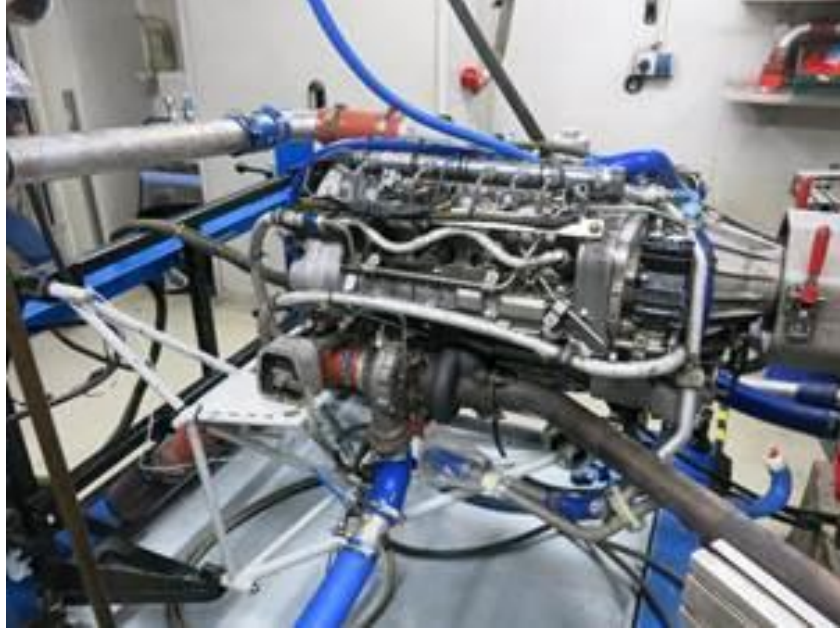
Figure 3: Engine on Test Bench

The summary of the engine run test is as follows:

The engine ran test result, suspecting a problem on Injector No. 2. The test continued to measure the resistance of the coil in Injector No. 2, and the result was 0.2 Ohm.

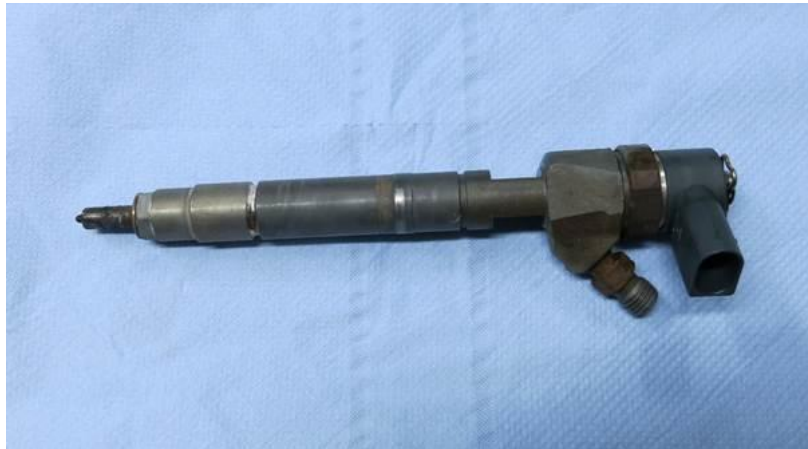
Figure 4: Injector No. 2

Considering that the resistance of the coil in the new injector was between 0.4 to 0.5 Ohm⁹, the result indicated an internal malfunction in the Injector No. 2.

Injector No. 2 was re-examined in detail to assess its condition and to identify any anomalies. Within the limits of the achievable geometric resolution, damage was identified on one solenoid coil terminal pin, accompanied by degradation of the adjacent sealing element.

Particulate and foreign material were observed in the affected area, which may indicate localized thermal effects, such as melting or thermal residue.

No evidence of connector rotation relative to the injector housing was found. In addition, no significant structural damage or functional abnormality was identified in the solenoid coil assembly as a whole.

The post-occurrence engine examination revealed that Injector No. 2 had malfunctioned, producing abnormal electrical resistance that resulted in reduced fuel injection to the corresponding cylinder. This malfunction might have led to abnormal combustion performance, limiting the available engine power to approximately 71 kW instead of the expected 99 kW.

At the time of issuing this investigation report, KNKT had been informed of several safety actions taken by Perkasa Flying School in response to this occurrence. The flying school revised its Company Maintenance Manual by adding a Maintenance Ground Run-Up Procedure that must be performed by an engineer.

The revised manual also included several new procedures, such as the Anomalies Monitoring Procedures and the Maintenance Pre-Flight Procedure.
