**KOMITE NASIONAL KESELAMATAN TRANSPORTASI
REPUBLIC OF INDONESIA**

Aircraft Accident Investigation Report

PT Matthew Air Nusantara

Airbus Helicopters EC 130 T2; PK-CFX

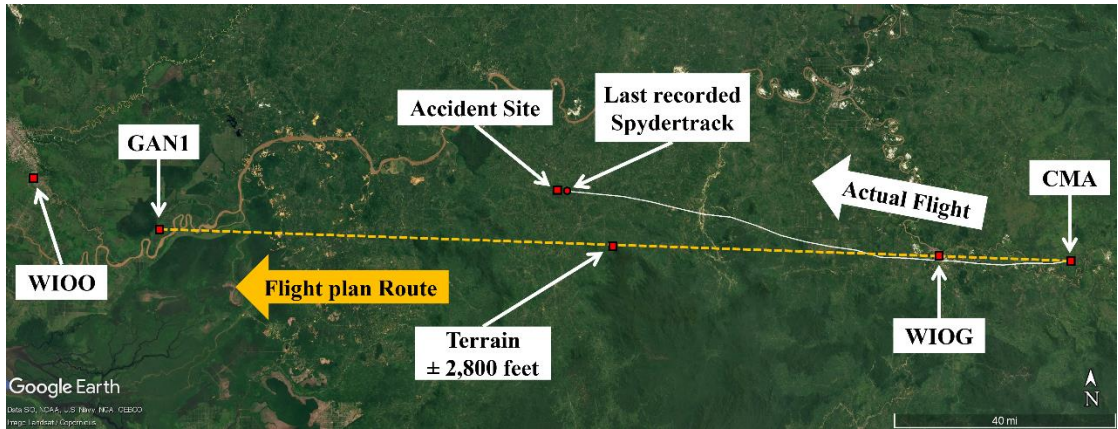
Figure 1: The flight route of PK-CFX

Based on the filled air traffic control (ATC) flight plan, the flight would be operated under Visual Flight Rules (VFR) with a cruising altitude of 1,500 feet, the total estimated elapsed time was 1 hour 15 minutes, and the fuel endurance would be sufficient for a two-hours flight. The route in the ATC flight plan indicated that the helicopter would fly from CMA landing spot to GAN1 landing spot via Nanga Pinoh Airport (WIOG), Melawi. Along the flight plan route, there was a terrain area with highest terrain elevation of about 2,800 feet (see Figure 1).

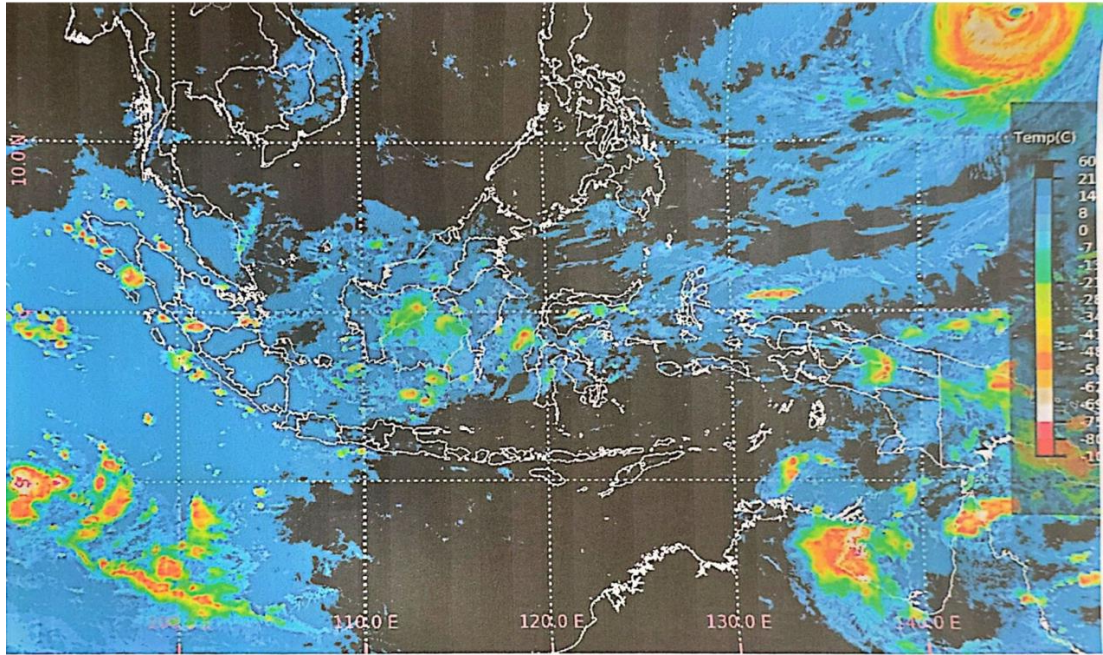
Figure 2: Satellite imagery in the flight dispatch document

The flight dispatch form signed by the PIC for the accident flight indicated that the meteorological information had been obtained prior to commencing the flight. The meteorological information included in the document was an enhanced infrared weather satellite imagery⁶ from *Badan Meteorologi, Klimatologi, dan Geofisika/BMKG* (Meteorology, Climatology, and Geophysical Agency of Indonesia) at 0600 LT (2300 UTC) for the whole Indonesia territory (see figure 2) and weather forecast for Supadio Airport (WIOO), Pontianak at 0600 LT. The investigation did not find any weather forecast along the route of the accident flight.

Therefore, KNKT recommends Matthew Air Nusantara ensure that weather report and/or forecast along the route to be flown are available and used as references to minimize operational risks, particularly flight operations in close proximity to terrain.

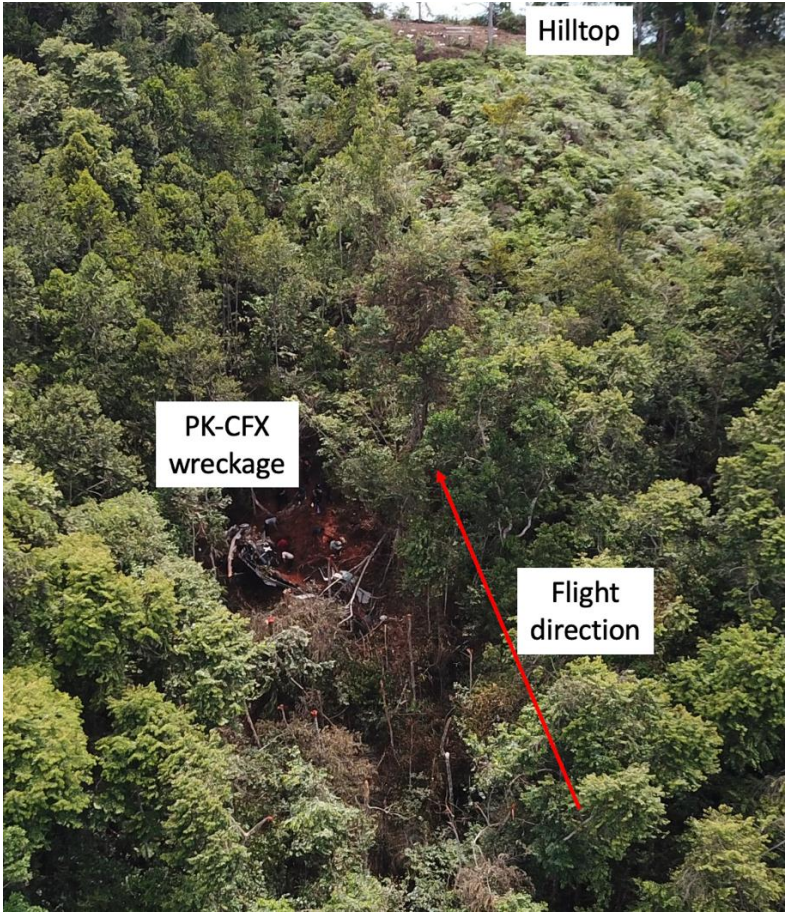
Figure 3 The accident site

The accident site was located in a hilly area characterized by steep terrain. The wreckage was found at an elevation of approximately 1,500 feet, at coordinates 0°10'38.24" S, 110°45'42.84" E. All wreckage was contained within a radius of 15 meters and was located approximately 43 meters from the hilltop.

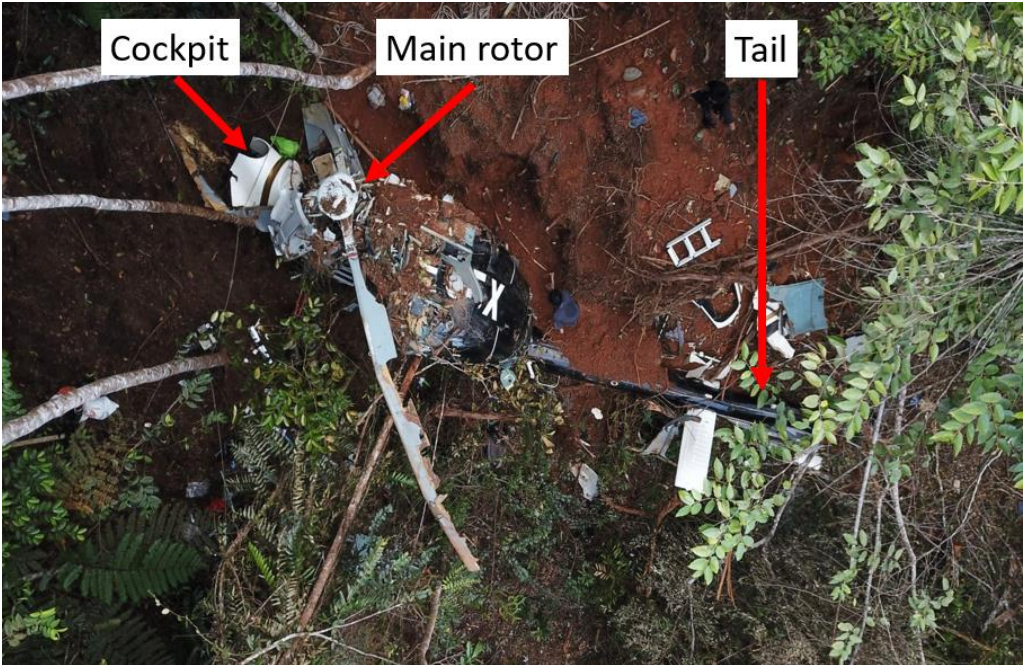
Figure 4 PK-CFX wreckage

The helicopter was destroyed.
