# **FINAL** KNKT 09.01.01.04

Aircraft Serious Incident Investigation Report

PT. Merpati Nusantara Airline Boeing 737-400 ; PK – MDO Sultan Hasanuddin Airport, Makassar, South Sulawesi Republic of Indonesia

16 January 2009

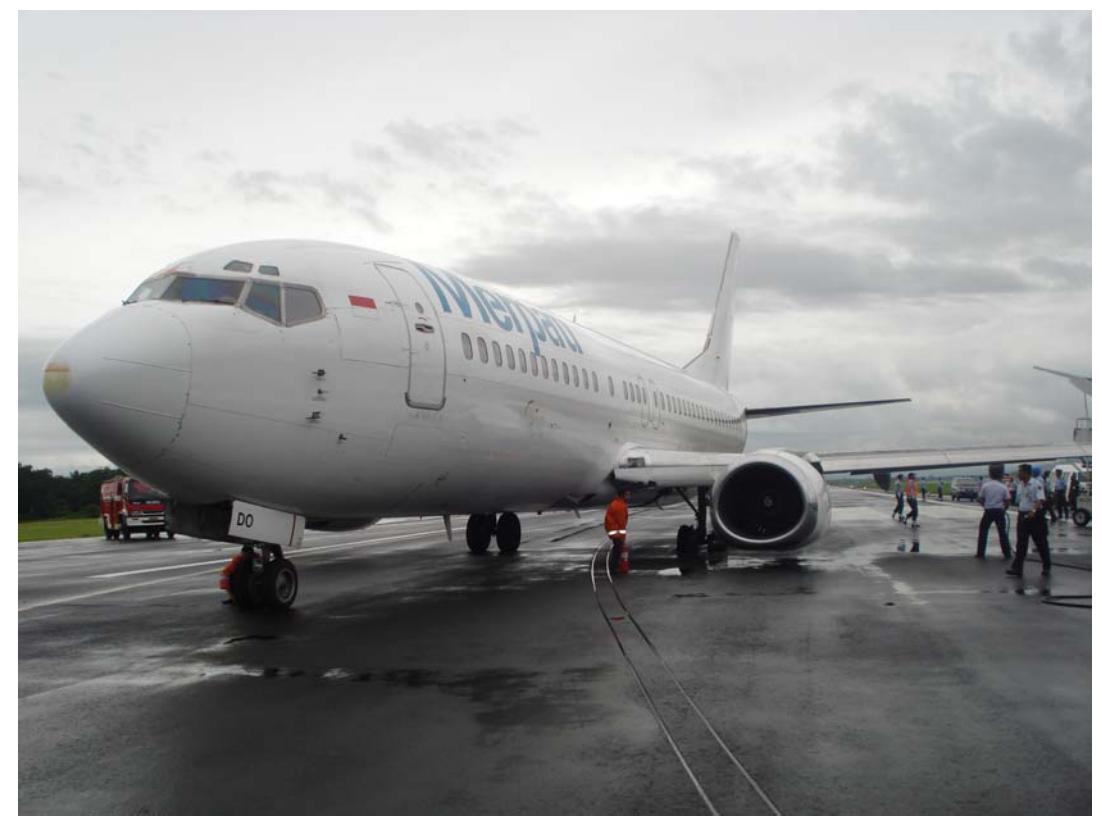
The PIC stopped the aircraft on the runway turning area. Both left tires were severely damaged. Both right main wheel tires deflated as the fuses had melted by overheat. Part of the left main landing gear door detached.

Figure 1: The aircraft after the incident being prepared to be towed to apron. (Note: the scratch on the runway was originated from the first occurrence on 20 October 2008)

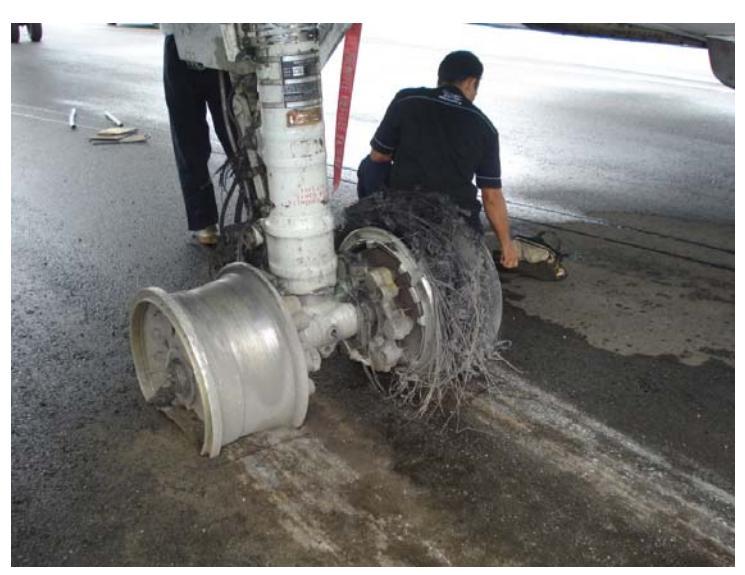
Both tires on left main wheel (position number 1 and 2) were seriously damaged and only a small portion of the tires were remain intact to the wheel hubs. Moreover both brake assemblies and the wheel hubs were severely rubbed by the runway.

Figure 2: The damage of wheel hub number 1 and 2

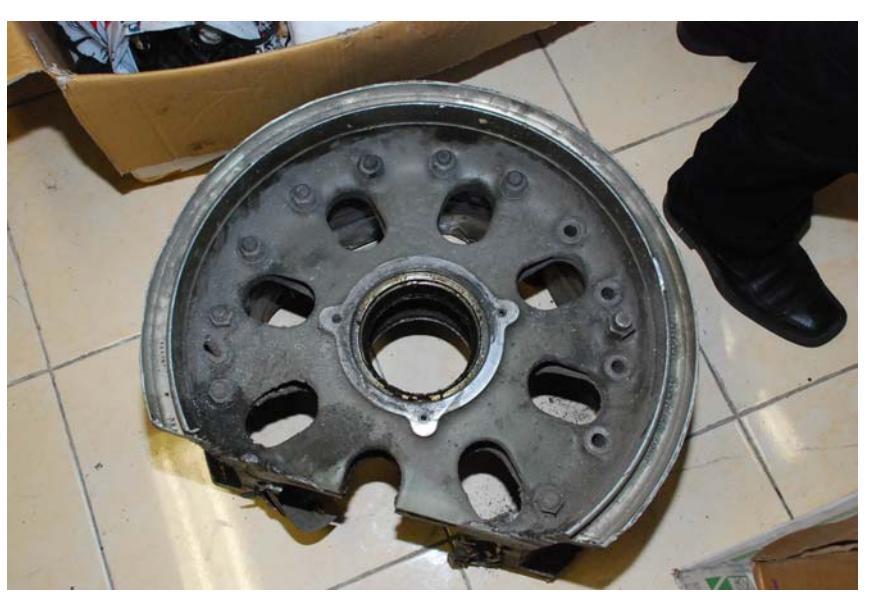
The number one wheel hub which was severely worn-out had four missing tie bolts (see Figure 3).

Figure 3: The number one wheel hub

The investigation determined that during takeoff roll, the wheel number one experience tire deflation due to loosening of the wheel hub halves. It was due to the failure of four out of sixteen tie bolts.

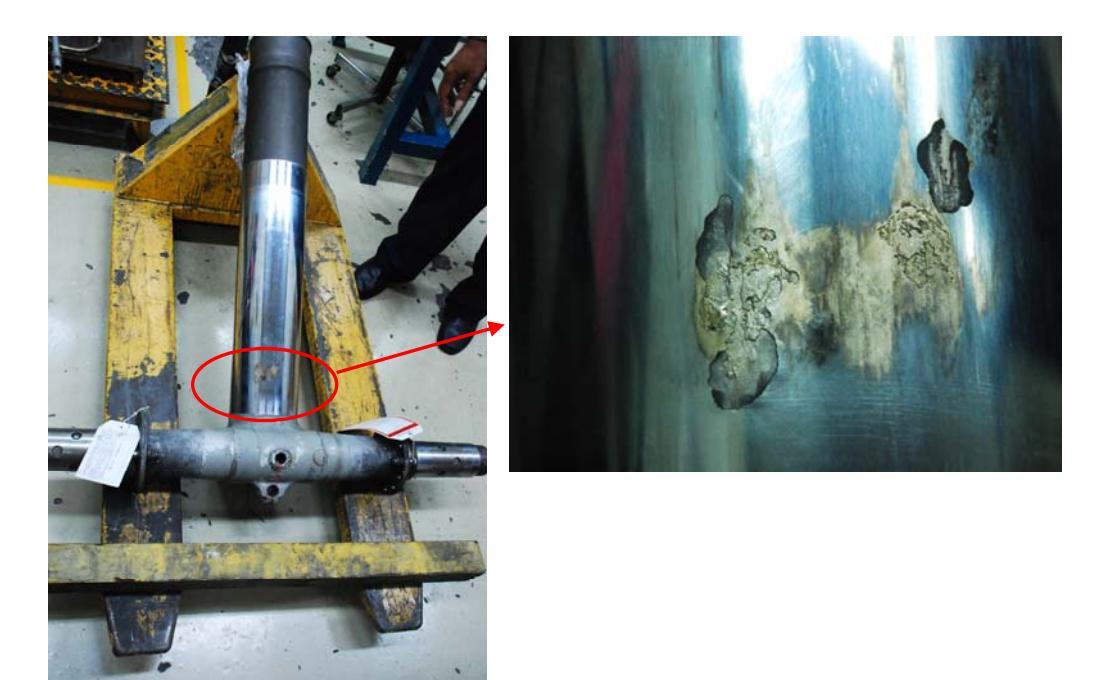
During the course of investigation, it was revealed of peeling off hard chromium plating on the lower strut of the left hand main landing gear. However, this finding would not jeopardise safety of the flight and was not relevant to this serious incident (see Figure 4).

Figure 4: The lower strut left hand main landing gear

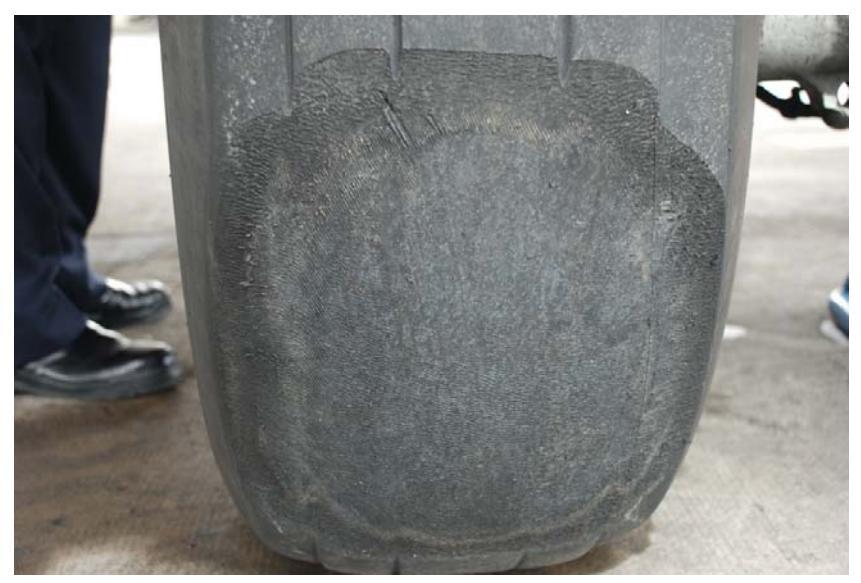
The runway was wet and the braking action during aborted takeoff had led to hydroplaning. It was indicated by the reverted rubber on the tire number 3 and 4 (see Figure 5). The hydroplaning caused a blocking of the brake system. Furthermore, the hydroplaning caused all wheels did not rotate. Wheels number 1 and 2 which tire had deflated experienced wheel hubs friction with the runway. The friction was so intense so that the wheel hubs and the brakes assemblies abraded to about ten centimetres deep.

The number 3 and 4 wheels which at that time still had tire pressure experienced reverted rubber due to friction with the runway.

Figure 5: Reverted rubber

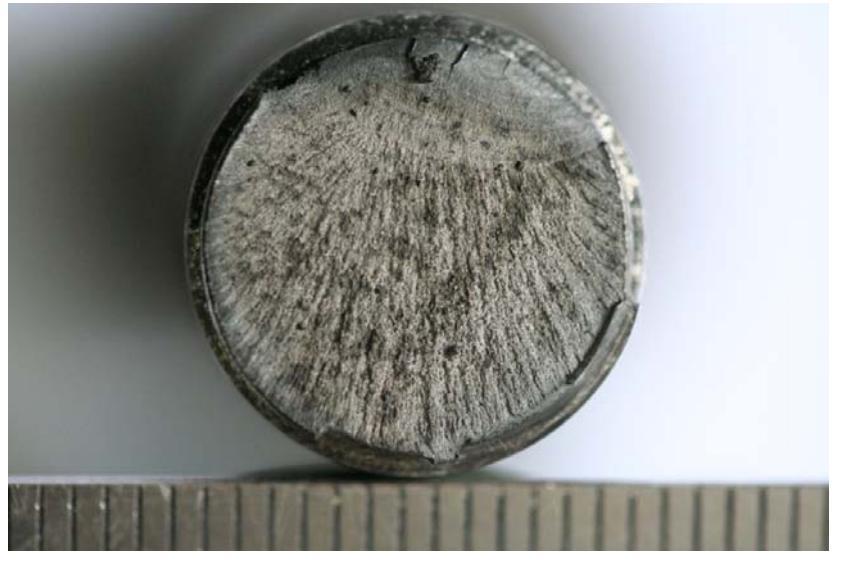
The four tie bolts failed due to premature fatigue (see Figure 6). The disintegration of those bolts occurred during the take off roll. The bolt pieces were recovered at the runway of Makassar airport.

Figure 6: Fatigue failure on the tie bolt

Fatigue cracks were originated from the bolt threads. The sequences of bolt failure were identified. The first occurrence of failure was characterized by the largest fatigue area. The fatigue crack propagation occurred sometimes during the operation. The crack on the bolt thread was likely initiated at locations where corrosion started. The high strength bolt start to corrode at location which cadmium plating peeled off.

If a tie bolt broken, the adjacent tie bolts will carry extra load causing a series of bolt fatigue failure. Following tie bolts fatigue failure, all the remaining bolts shall be rejected.

The fatigue crack initiation on the bolts was most likely due to damage of cadmium plating. The CMM instructed to perform cadmium re-plating

after ten times of wheel hub assembling. However it was not done, so that initial corrosion to the bolt thread may lead to the fatigue crack initiation.

The National Transportation Safety Committee recommends that the PT. Merpati Nusantara Airline should perform cadmium re-plating to the tie bolts after ten times wheel hub assembling as stated in the CMM.

- For single bolt failures, each tie bolt adjacent to the broken bolt should be removed and scrapped.
- For multiple bolt failures, all tie bolts in the wheel should be scrapped

- Operator should adopt a life-limit replacement plan for the wheel hub machine bolts to the life limit at 8,000 landings.
- Cadmium plating should be restored on the machine bolt after 10 nut installations.
