KOMITE NASIONAL KESELAMATAN TRANSPORTASI REPUBLIC OF INDONESIA

FINAL KNKT.18.04.10.04

Aircraft Accident Investigation Report

PT Whitesky Aviation Helicopter Bell 429, PK-WSX Morowali, Sulawesi Tengah Republic of Indonesia 20 April 2018

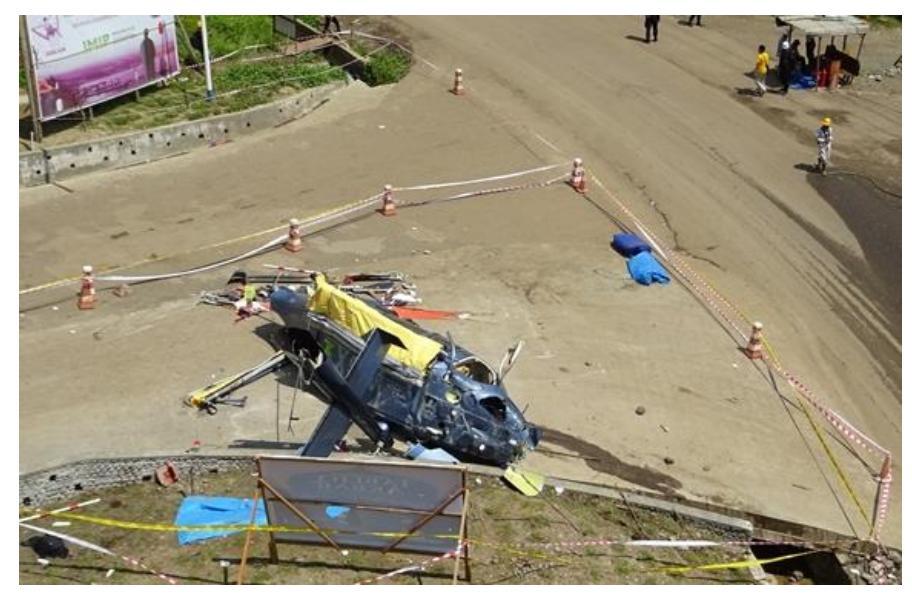
Figure 11: Aerial view of the helicopter

The last helicopter position was rolled over to the left on heading approximately 080° . The wreckage occupied the dimension approximately 10 meters \times 10 meters situated on the intersection IMIP factory access road as shown in the figure below.

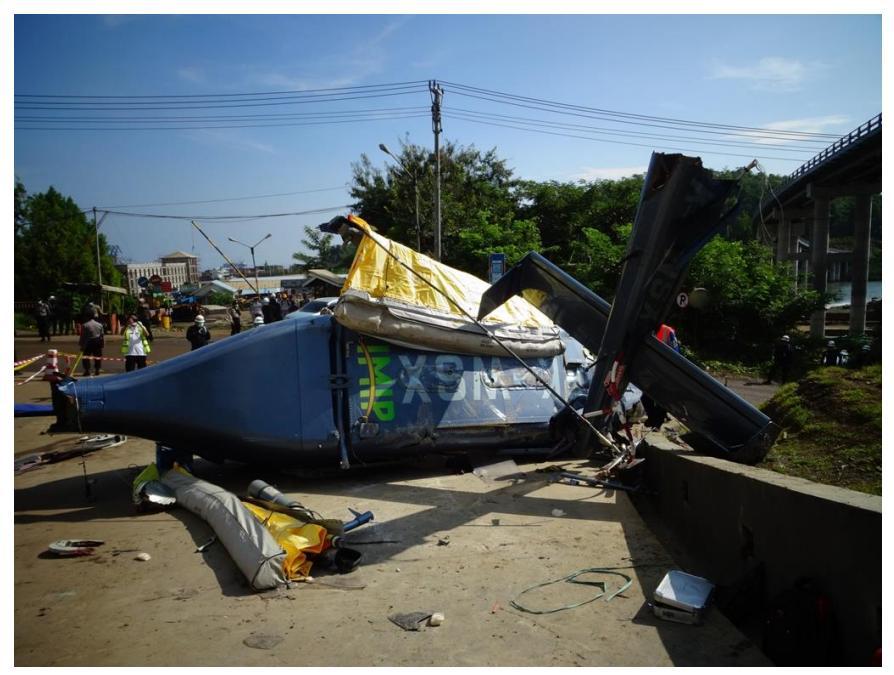
Figure 12: The wreckage of the helicopter

All main rotor blades were broken and detached from the main rotor hub. The tail boom broken and found on the right of the helicopter and all the tail rotor blades were still intact.

The left landing gear skid detached and found on the right of the helicopter while floatation device was slightly open but not expanded. The right landing gear skid intact and the floatation device unfurled but not expanded.

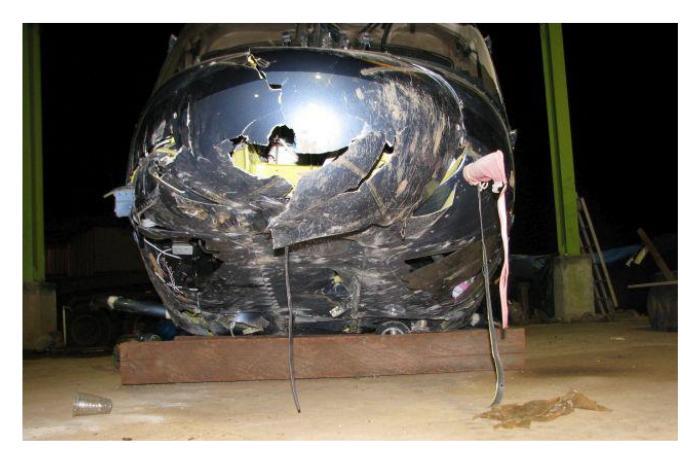
Figure 13: The nose and belly condition

The airframe fuselage exhibited significant damage from impact forces on a concrete road. Airframe damage is consistent with a relatively level, but slightly nose low hard impact. Numerous fractures were observed in the airframe structure. The nose and aircraft belly surfaces exhibited crushed skin and structure from ground impact forces as shown in the figure below.

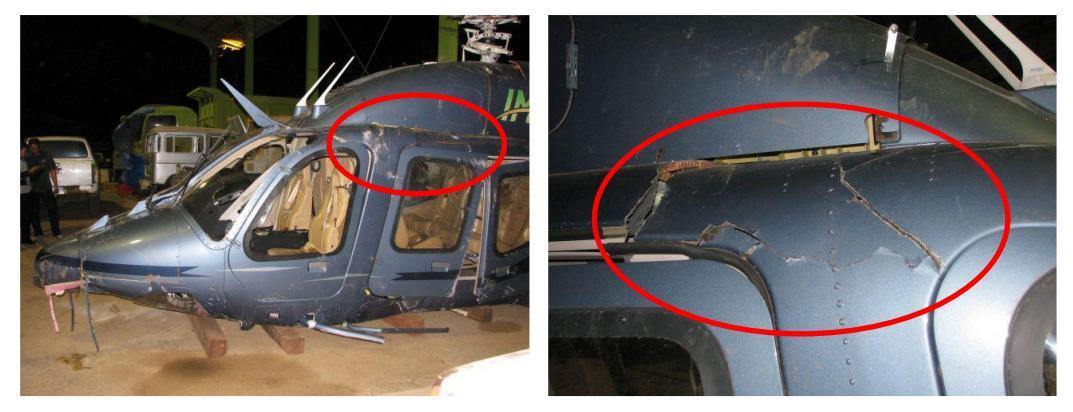
Figure 14: The fracture of the airframe roof structure

Above the pilot and copilot seats was observed fractured airframe roof structure as shown in the figure below.

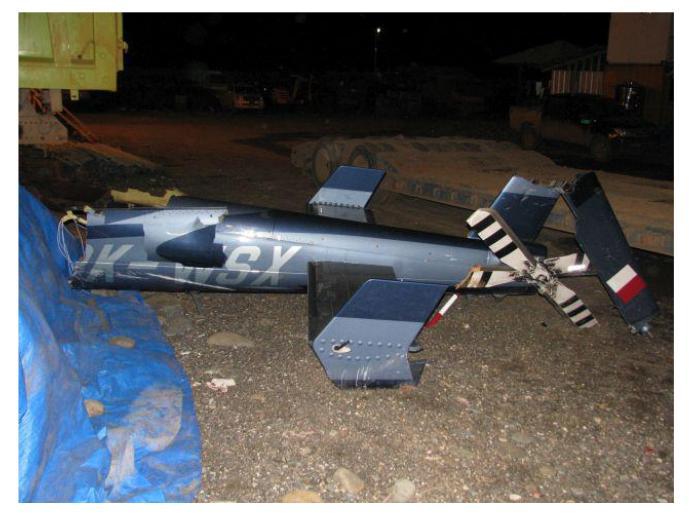
Figure 15: The tail boom condition

The tail boom was fractured from a forward location due to overload forces during the impact sequence and separated from the main fuselage as shown in the figure below. A puncture in a fuel cell resulted in fuel leaking out after the accident.

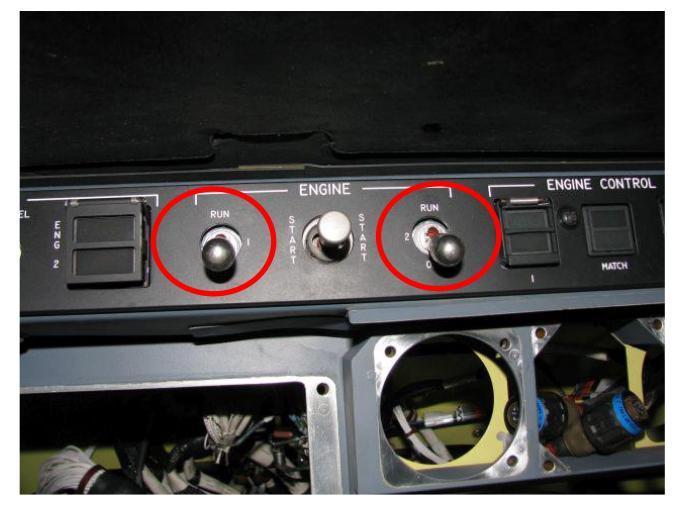
Figure 16: The engine switch in the cockpit

All circuit breakers were "in". The battery switch was found in the "Off" position. Both engine switches were found to be "Off". It was reported that the pilot turned off the engines (as shown in the figure below) before egressing the helicopter. Video of the accident helicopter revealed that the main rotor remnants were rotating after impact until it appeared that the engines were shutdown.

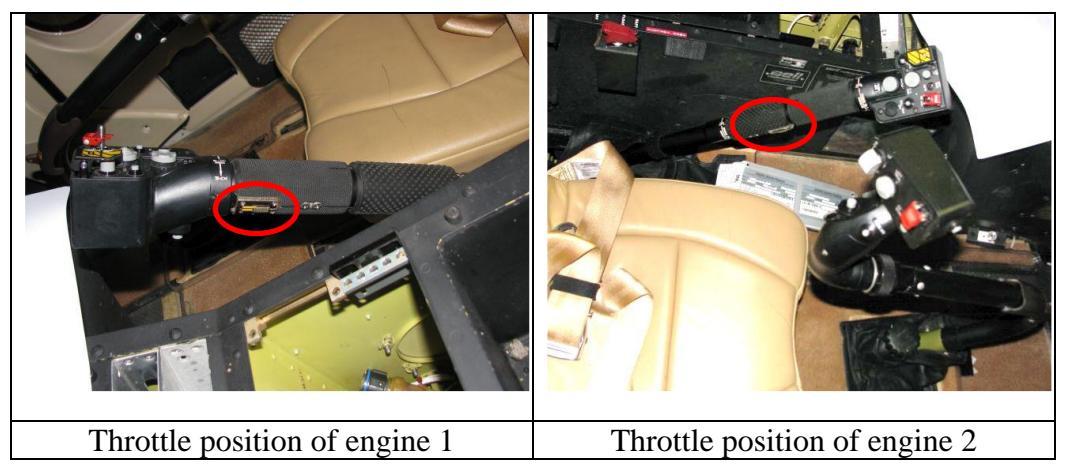
Figure 17: The throttle position after accident

The collective was at up position however the angle was not measured. The throttle of engine 1 was found above the maximum position and the throttle of engine 2 was found at the idle position as shown in the figure below.

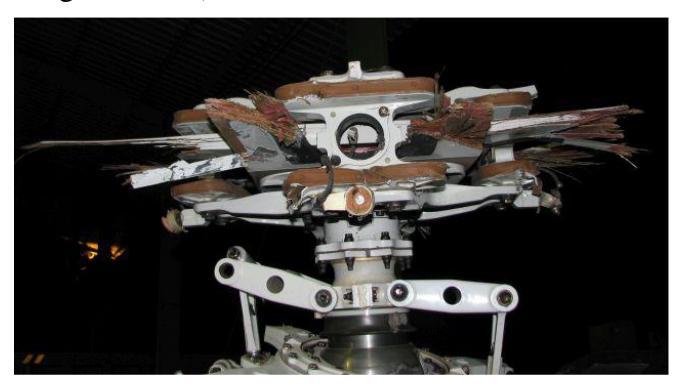
Figure 18: The main rotor condition

During impact, the helicopter rolled over to the right with the engines still powering the main rotor and tail rotor driveshaft on the aft fuselage as observed from the video of the accident taken from the security post CCTV camera. As a result, all four main rotor blades fractured away from the main rotor hub and into numerous pieces because of rotating contact with the concrete road. Additionally, the main rotor hub assembly exhibited fractured yoke flexures from rotating contact with the road after initial impact (see figure below).

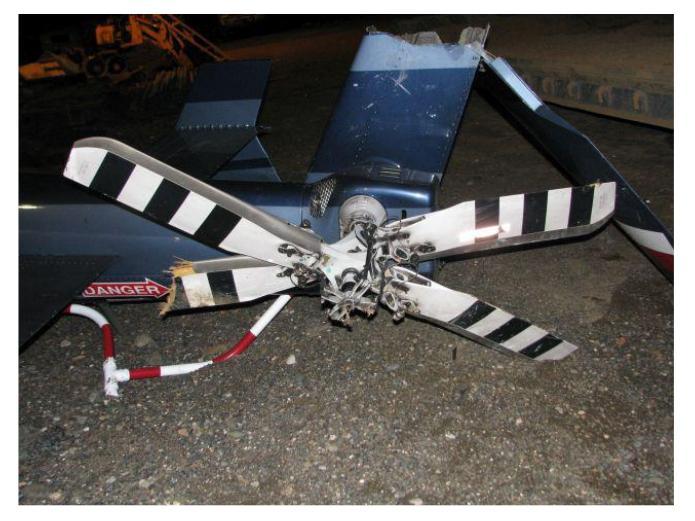
Figure 19: The tail rotor condition

The tail rotor hub and blades exhibited ground impact damage from the impact sequence. The Blue tail rotor blade exhibited a mid-span chord wise overload fracture as shown in the figure below.

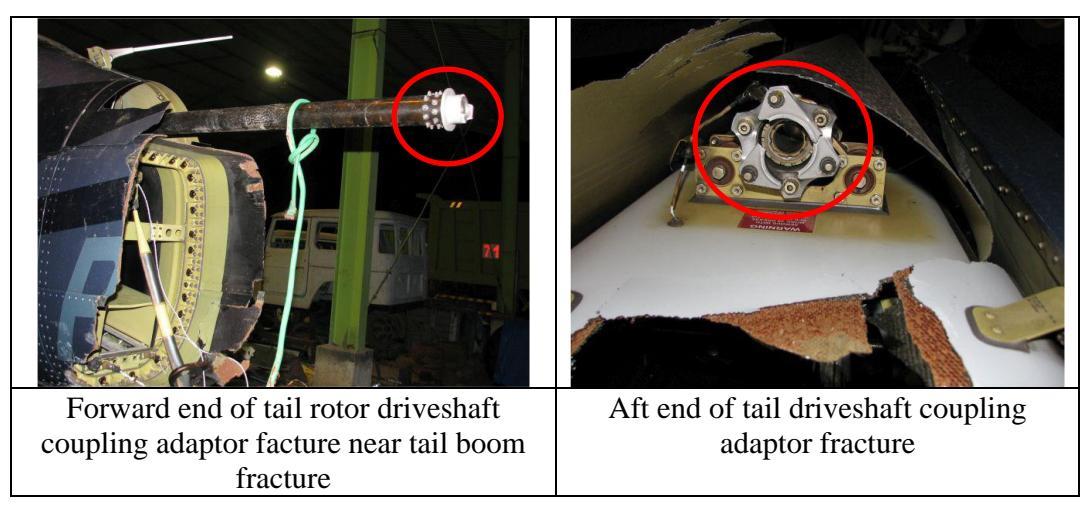
Figure 20: The tail rotor drive shaft

A tail rotor driveshaft on the main fuselage was rotated freely by hand and rotation of the main rotor was observed, demonstrating drive continuity of the main transmission. The tail rotor system was rotated by hand freely and corresponding rotation through the tail rotor gearbox was observed at fractured tail rotor driveshaft coupling adaptor located near the forward fractured tail boom location (see figure below).

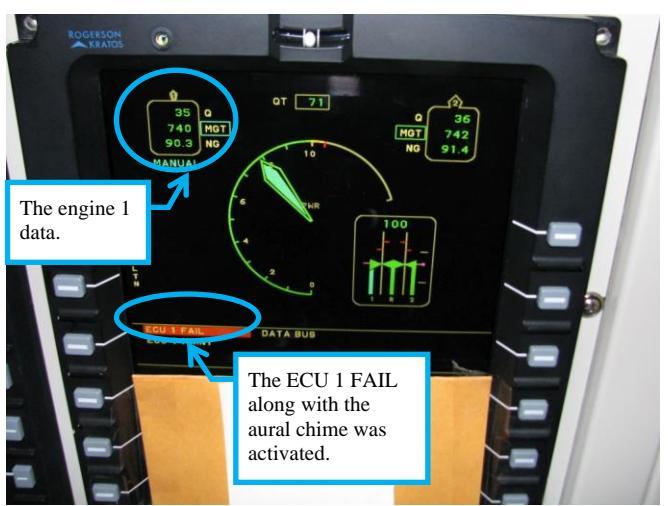
Figure 22: The first indication of the DU based on the aural chime point

When the first aural chime was recorded in CVR, the red warning of ECU 1 FAIL was displayed on the DU in conjunction with the 'MANUAL' message below the engine data as shown in the figure 22 below. At the time, both needles on the PSI indicated the same value which correlated to equal engine power. The needle color of the failure ECU would turn to cyan.

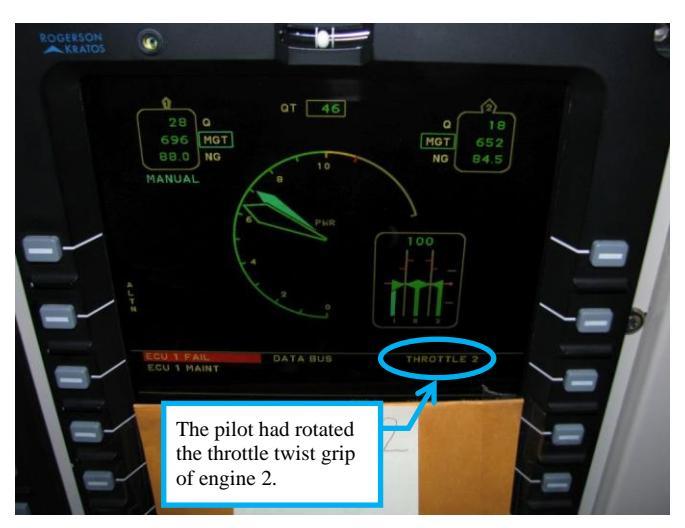
Figure 23: The pilot rotated the throttle engine 2

In the figure 23 below, the DU showed a message 'THROTTLE 2' which mean that the pilot had manipulated the throttle twist grip engine 2 manually.

As shown in the figure 23 below, the power (PWR) needles on the Power Situation Indicator (PSI) had split. The hollow green color (the engine 2) showed slightly below the solid green color (the engine 1) as the pilot manually controls the throttle twist grip of engine 2.

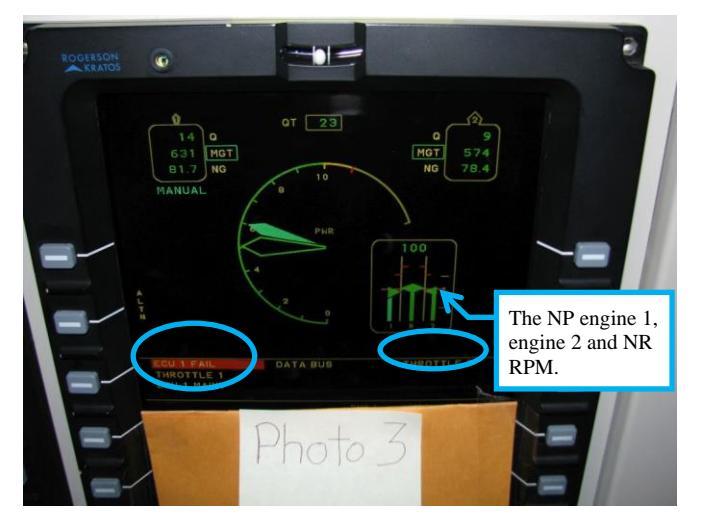
Figure 24: The PWR needle in the PSI showed the lower value

In the figure 24 below, the 'THROTTLE 1' and 'THROTTLE 2' messages were shown on the DU while both needles showed decreasing.

Since 09:27:03 LT the 'THROTTLE 1' and 'THROTTLE 2' messages alternately showed, indicated that the pilot had rotated the throttle twist grip engine 1 and engine 2 manually. In addition, during this situation, the NR RPM was still showed the green color (above 95% NR RPM).

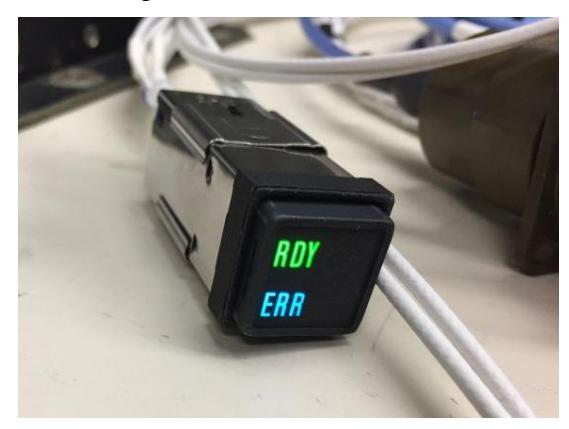
Figure 25: The error message of the HUMS

The attempt to download of the Health and Usage Monitoring Systems (HUMS) box was unsuccessful. An error message (ERR) was displayed and no data was downloaded as shown in the figure below.
